Service Bulletin

Bulletin No.: 13-06-01-003I

Subject: Excessive Oil Consumption – Perform Oil Consumption Test and/or Install Piston and Piston Ring Kit

Models: 2010-2013 Buick LaCrosse
2011-2013 Buick Regal
2012-2013 Buick Verano
2010-2013 Chevrolet Equinox
2012-2013 Chevrolet Captiva, Orlando (Canada Only)
2010-2013 GMC Terrain
Equipped with 2.4L Engine (RPOs LAF, LEA)

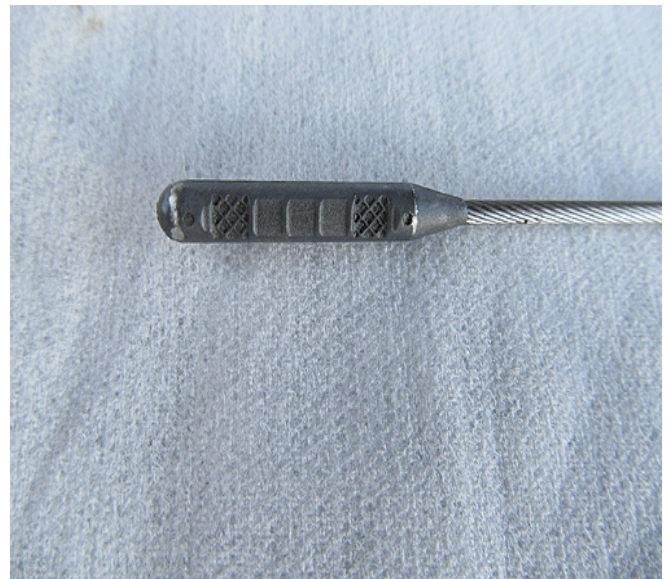
3339530

Important: When checking the oil level with the oil dipstick design shown below, please note that the oil volume per notch is not linear due to the shape of the block. The upper notches (relative to the top of the handle) equal 0.227 L (0.24 quart) between each notch while the lower notches only equal 0.132 L (0.14 quart) between each notch. As a result, no oil will appear on the dipstick if it is low on oil by approximately 1.18 L (1.25 quarts) or more. When determining the oil consumption rate, the oil volume added to return it to the starting location is the total amount of oil consumed. The consumption rate must be documented on a repair order.

Notice: Do not add too much oil. An overfill can lead to burn off of the excess oil. Advise the customer to wait until the oil is below the cross-hatched area at the tip of the dipstick before adding oil.

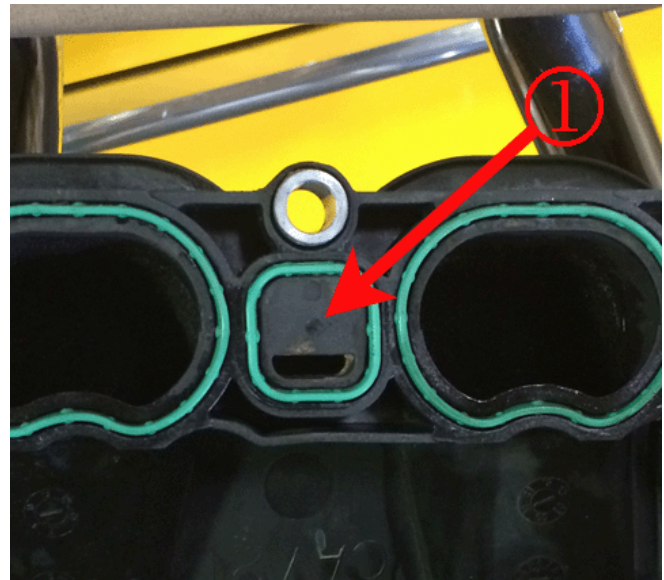
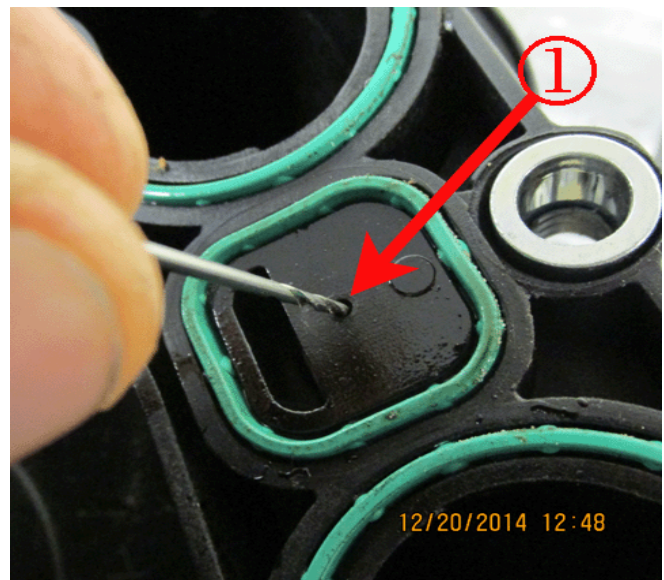
The oil consumption may have clogged/reduced PCV flow. The PCV system should be serviced.

- (1) PCV orifice in the intake manifold

Clean any ice/sludge/water/carbon out of the PCV pipes/hoses, the PCV nipple on the cam cover, the PCV orifice between the #2 and #3 intake runners (use a 1/16 inch drill bit as illustrated below).
