# Service Bulletin

## PRELIMINARY INFORMATION

**Subject:** Magnaride™ Magnetically Controlled Suspension Electrical Connector Not Seated, Service Suspension System Message, DTCs C0575, C0580, C0585 or C0590

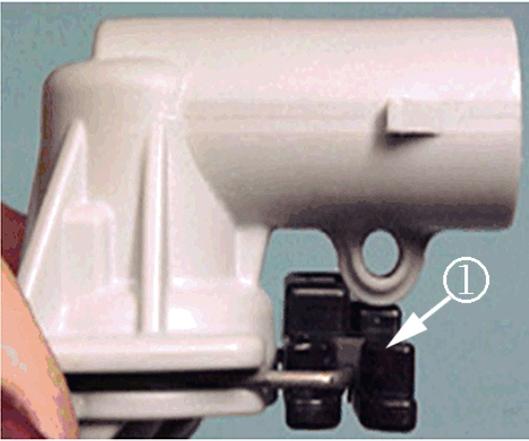
**Connector with Position Assurance (CPA) Tab (CTS Only)**

CTS Models built after February 22, 2011 have a CPA tab (1) as shown above as part of the connector. Vehicles built with this design should be less susceptible to being unseated. The CTS is the only vehicle to adopt this design change. All other products continue with the original style connector.

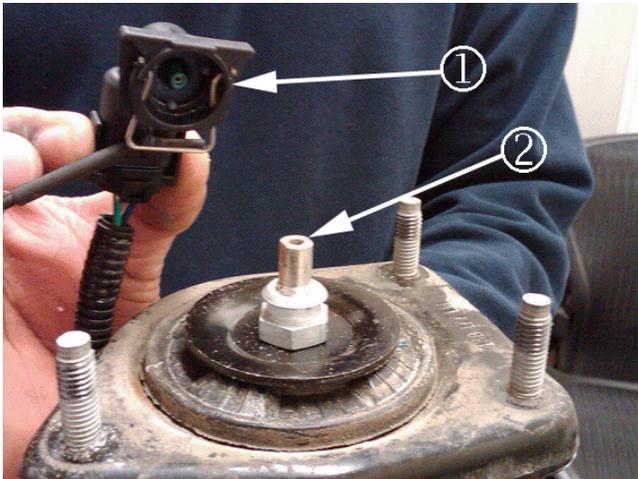
### Electrical Connector and Shock Absorber (Actuator) Contact

During the assembly process, it is possible that the 90 degree electrical connector at the top end of a shock absorber (actuator) may not have been fully seated or has been bumped firmly enough to partially disconnect it, or create an internal contact concern.

2. Disconnect the electrical connector (1) from the top of the applicable shock absorber (actuator) contact (2).
