Subject: Engineering Information – Water, Moisture and/or Condensation Leak in the Rear Tail Lamps

Brand:	Model:	Model Year:		VIN:		Engine:	Transmission:
		from	to	from	to		
Chevrolet	Equinox	2018	2019			All	All

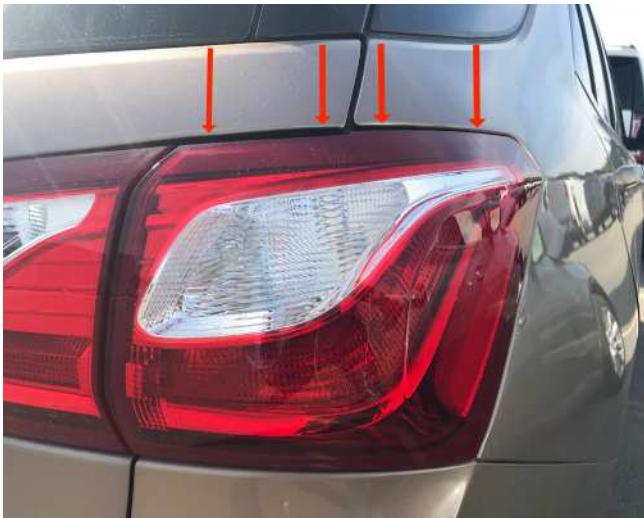
Involved Region or Country	North America
Condition	Important: If the customer did not bring their vehicle in for this concern, DO NOT proceed with this EI. Some customers may comment on a water, moisture and/or condensation leak in the rear tail lamps.
Cause	GM Engineering is attempting to determine the root cause of the above condition. Engineering has a need to gather information on vehicles PRIOR to repair that may exhibit this condition. As a result, this information will be used to "root cause" the customer's concern and develop/validate a field fix.

If you encounter a vehicle with the above concern, measure the gap between the tail lamp and the body side, at the locations shown in the picture above, and contact the engineer below with your findings.
