TECHNICAL SERVICE BULLETIN

Technical Service Bulletin: 51-0956

LCI 8800 SERIES WINDOW REPAIR

TSB Number:	15-001-19
Product:	LCI Window Repair
Date:	May 20, 2019

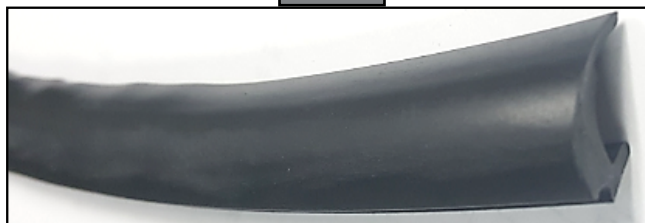
Fig. 1

1. **Vinyl:** Vinyl (Fig. 1) is a rubber seal to function as an initial water management barrier.

If the vinyl is damaged when it is removed and it cannot be reused, please order replacement vinyl (LCI Part # 213162) online by visiting <https://store.lci1.com>.

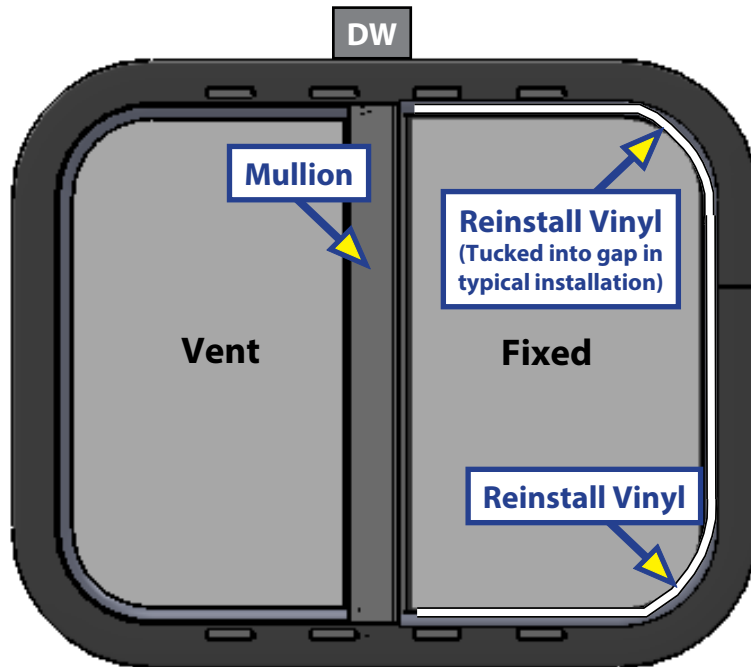
NOTE: Please utilize this table to verify sizes affected of the style window shown above.

8800 Series DW (Dual Weep)
8800 DW 18 X 18 G20 TP BK 8800-44076
8800 DW 18 X 22 G20 TP BK 8800-44077
8800 DW 18 X 22 OBS TP BK
8800 DW 24 X 15 CL TP BK 8800-44380
8800 DW 24 X 15 G20 TP BK 8800-44022
*8800 DW 48 X 29 CL TP BK 8800-44381
*8800 DW 48 X 29 G20 TP BK 8800-44025
*8800 DW 60 X 29 G20 TP BK 8800-44743
*8800 DW 60 X 29 G20 TP BK RED 8800-44402
*8800 DW 72 X 28 G20 TP BK RED 8800-44178

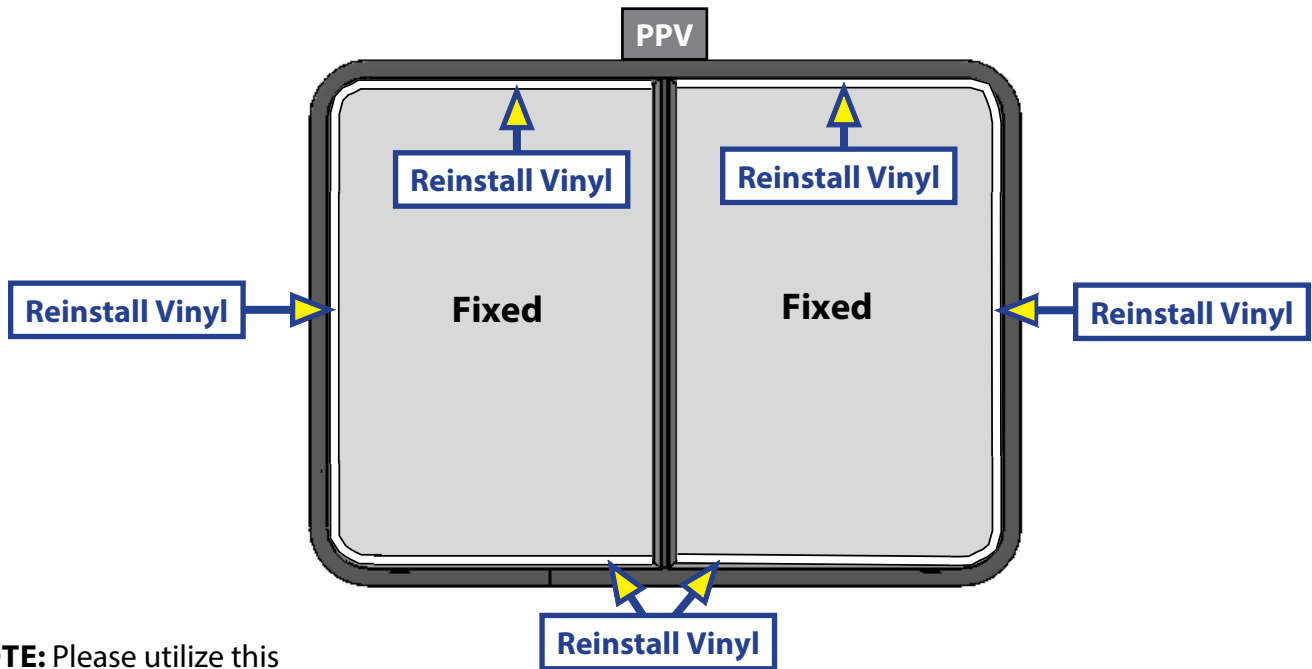
NOTE: Please utilize this table to verify size affected of the style window shown above.

8800 Series PPV (Picture Picture Vertical)
8800 PPV 72 X 22 G20 TP BK

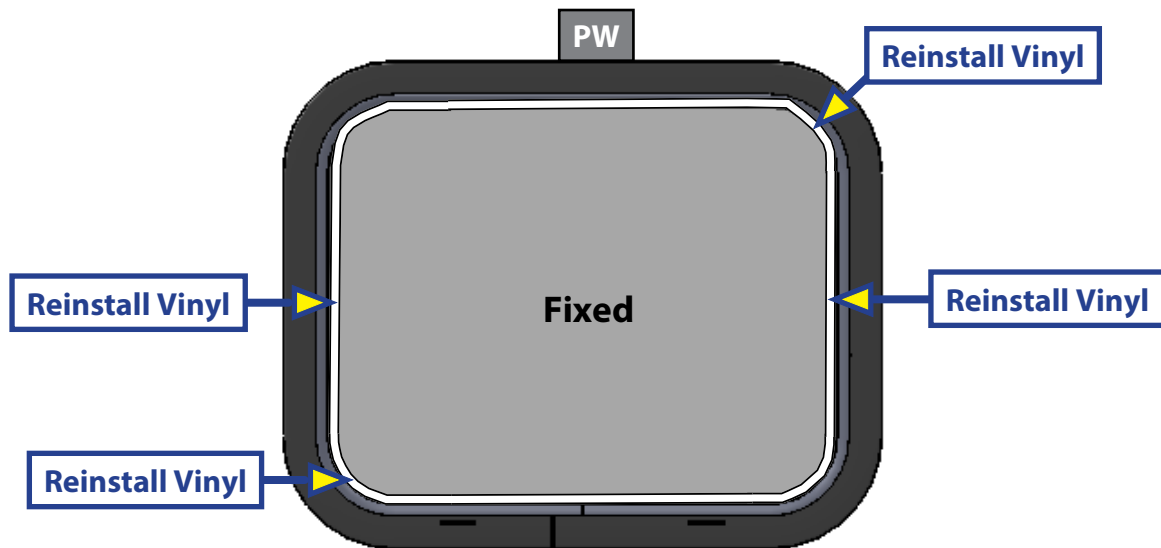
NOTE: Please utilize this table to verify sizes affected of the style window shown above.

8800 Series PW (Picture Window)
8800 PW 18 X 22 G20 TP BK 8800-44070
8800 PW 24 X 15 G20 TP BK 8800-44747
8800 PW 29 X 60 G20 TP BK 8800-44481
8800 PW 60 X 29 CL TP BK
8800 PW 60 X 36 G20 TP BK 8800-44442

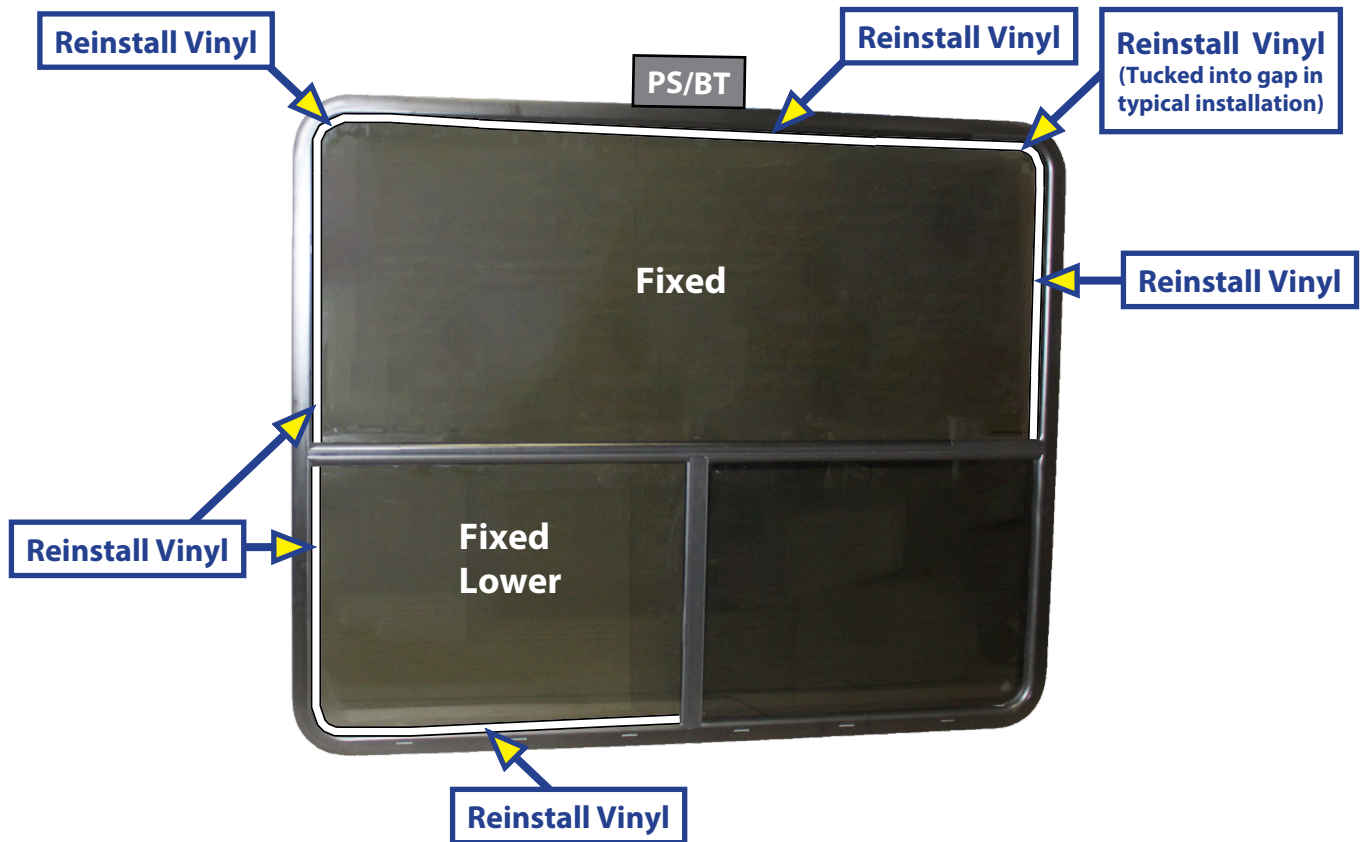
NOTE: Please utilize this table to verify sizes affected of the style window shown above.

PS/BT (Picture Slider Bottom T)
8800 PS/BT 36 X 36 X 9 G20 TP BK 8800-44093
8800 PS/BT 42 X 40 X 9 G20 TP BK 8800-44466
8800 PS/BT 48 X 36 X 9 G20 TP BK 8800-44102
8800 PS/BT 48 X 48 X 20 G20 TP BK 8800-44421
8800 PS/BT 60 X 35 X 20 G20 TP BK RED
8800 PS/BT 60 X 35 X 9 G20 TP BK
8800 PS/BT 60 X 36 X 20 G20 TP BK RED 8800-44172
8800 PS/BT 60 X 36 X 9 G20 TP BK 8800-44106
8800 PS/BT 60 X 42 X 20 G20 TP BK RED 8800-44498
8800 PS/BT 64 X 34 X 20 G20 TP BK RED
8800 PS/BT 70 X 34 X 20 G20 TP BK RED 8800-44176
8800 PS/BT 70 X 46 X 20 G20 TP BK RED
8800 PS/BT 72 X 34 X 20 G20 TP BK RED
8800 PS/BT 72 X 35 X 20 G20 TP BK RED 8800-44036
8800 PS/BT 72 X 48 X 20 G20 TP BK RED 8800-44179

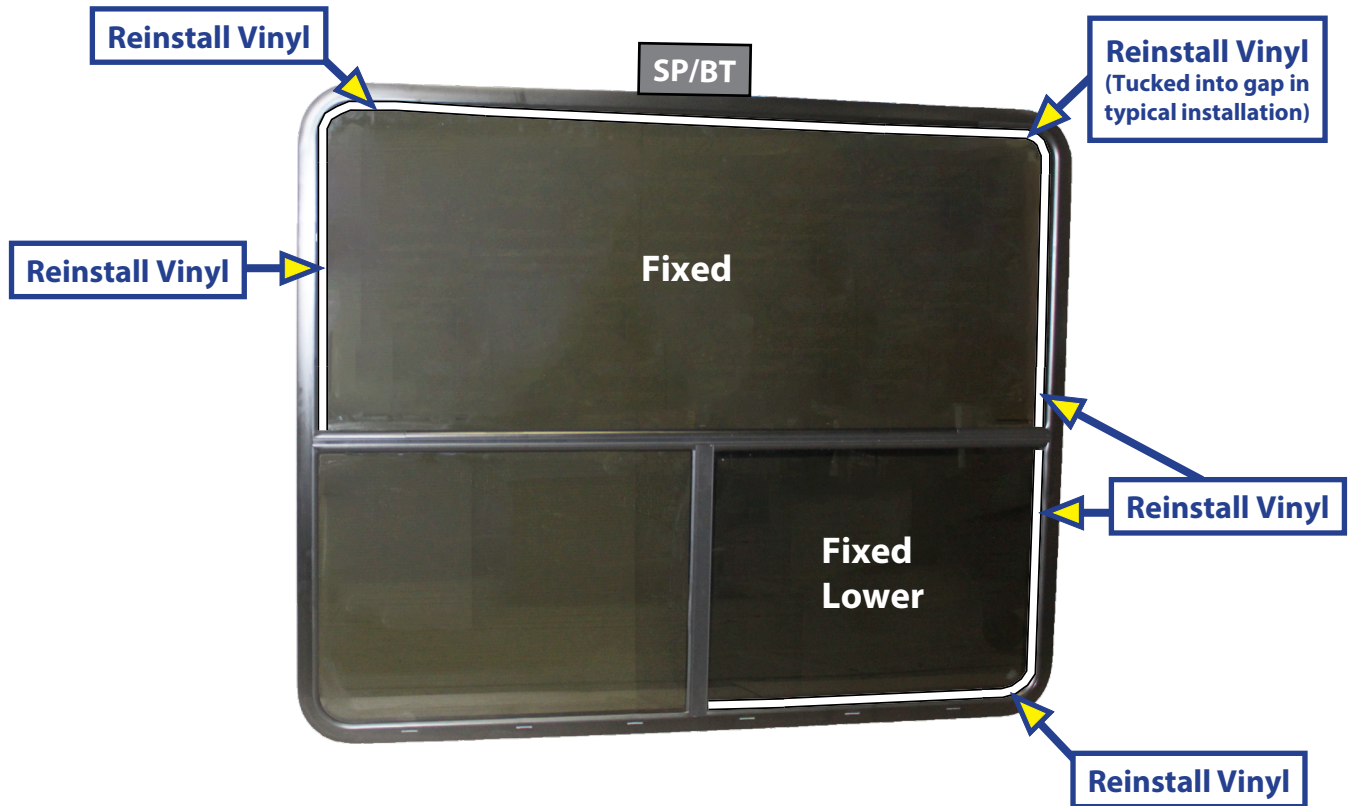
NOTE: Please utilize this table to verify sizes affected of the style window shown above.

SP/BT (Slider Picture Bottom T)
8800 SP/BT 36 x 36 x 9 G20 TP BK 8800-44094
8800 SP/BT 48 x 35 x 9 G20 TP BK
8800 SP/BT 48 x 36 x 9 G20 TP BK 8800-44013
8800 SP/BT 48 X 48 X 20 G20 TP BK 8800-44418
8800 SP/BT 60 X 35 X 9 G20 TP BK
8800 SP/BT 60 X 36 X 20 G20 TP BK RED 8800-44173
8800 SP/BT 60 X 36 X 9 G20 TP BK 8800-44639
8800 SP/BT 60 X 42 X 20 G20 TP BK RED 8800-44499
8800 SP/BT 60 X 42 X 9 G20 TP BK
8800 SP/BT 68 X 36 X 20 G20 TP BK RED 8800-44413
8800 SP/BT 70 X 46 X 20 G20 TP BK RED 8800-44177
8800 SP/BT 72 X 35 X 20 G20 TP BK RED 8800-44454
8800 SP/BT 72 X 35 X 9 G20 TP BK 8800-44403
8800 SP/BT 72 X 40 X 9 CL TP BK 8800-44445
8800 SP/BT 72 X 40 X 9 G20 TP BK 8800-44109
8800 SP/BT 72 X 40 X 9 G55 TP BK 8800-44318

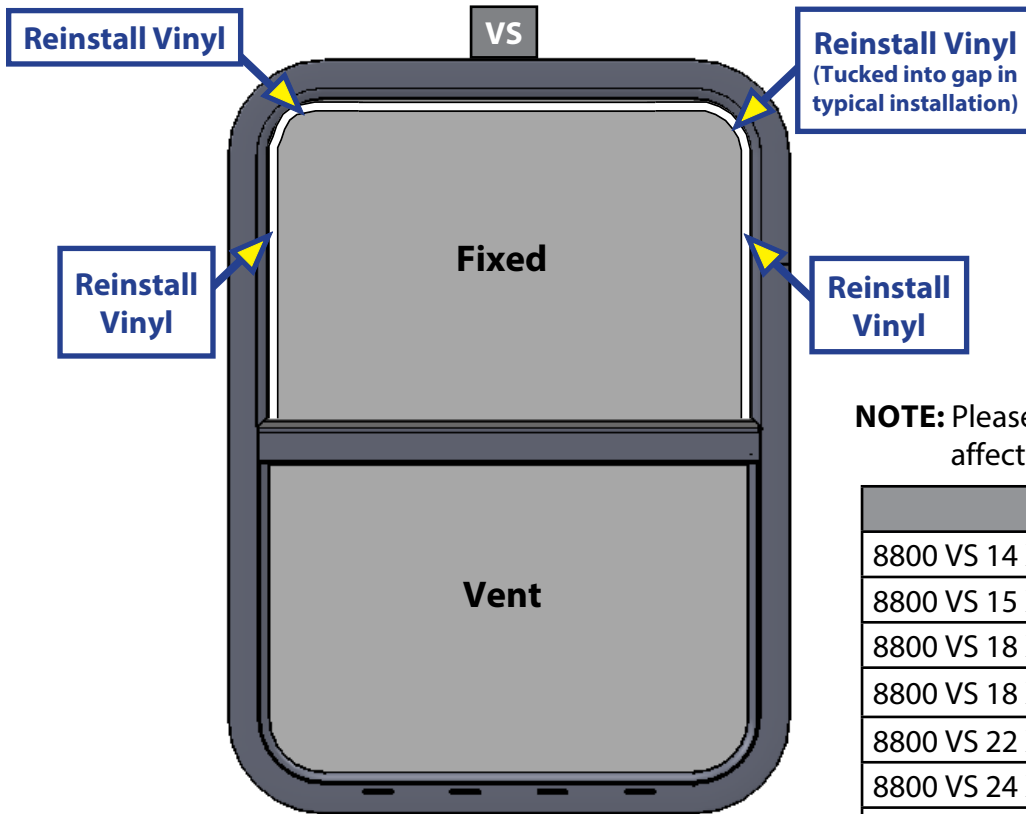
NOTE: Please utilize this table to verify sizes affected of the style window shown.

VS (Vertical Slider)
8800 VS 14 X 22 G20 TP BK 8800-44116
8800 VS 15 X 21 G20 TP BK 8800-44657
8800 VS 18 X 18 G20 TP BK 8800-44124
8800 VS 18 X 22 G20 TP BK 8800-44001
8800 VS 22 X 18 G20 TP BK 8800-44137
8800 VS 24 X 20 G20 TP BK 8800-44142
*8800 VS 27 X 50 G20 TP BK RED 8800-44724
