Service Alert

DTC C1001:92 OR B14F0:92 FORWARD SENSING CAMERA

Service Alert No.: SA-003/19

Last Issued: 07/30/2019

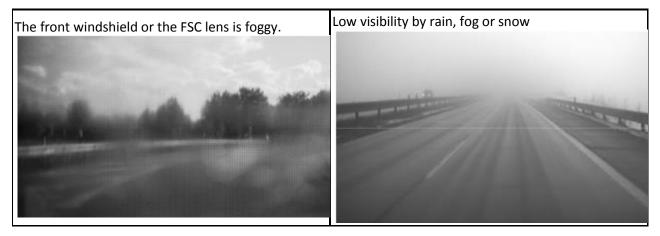
- 1. At night, when there is NO artificial lighting such as a traffic signal, street light or reflective surfaces.
- 2. When direct or reflected sunlight makes forward visibility difficult (Backlight).
- 3. When it's hard to see the traffic lane due to a wet or snow covered road reflecting lights.
- 4. When visibility is poor in front of the vehicle due to fog.
- 5. When driving on a road without markings.
- 6. In conditions where the windshield fogs easily.

Examples of driving under adverse conditions:
