Technical Service Bulletin

Topic	Bentayga - DTC C103129 - Air suspension warning displayed in Driver Instrument Panel
Market area	Bentley: worldwide (2WBE),Hongkong-Macau (5HK)
Brand	Bentley
Transaction No.	2051818/4
Level	EH
Status	Released for publishing
Release date	Jun 4, 2019

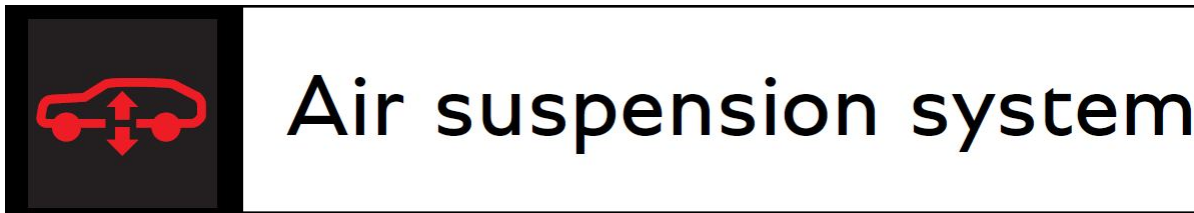
Air suspension system warning displayed in the Driver Instrument Panel (DIP)

Diagnostic Trouble Code (DTC) C103129 Level control pressure sensor Implausible signal symptom (DTC) stored in the Chassis control unit (Address 74)

This TPI is only applicable to Vehicles which have software version less than 1244 installed in the Adaptive suspension control unit - J197 (Address 74) Following a successful update, the part number will change to 4M0 907 777L with software version 1244
