# Technical Service Bulletin

<b>Topic</b>	Emission control system lamp illuminated - DTC P044100 evident
<b>Market area</b>	Bentley: worldwide (2WBE), Hongkong-Macau (5HK)
<b>Brand</b>	Bentley
<b>Transaction No.</b>	2053429/3
<b>Level</b>	EH
<b>Status</b>	Released for publishing
<b>Release date</b>	Jun 4, 2019

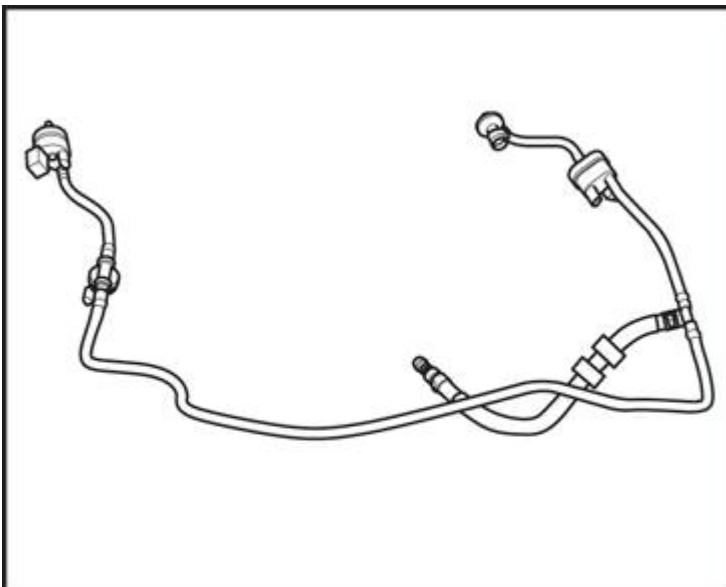
Figure 1

- 5) Replace the evaporative emission purge valve assembly (Figure 1) - Refer to repair manual Rep.Gr 20 - Evaporative emission purge valve - To remove and fit - pay attention to any debris/contamination falling from the ends of the line during disconnection, If contamination is found in the ends of the line or the engine ports please raise a DISS query

NOTE: The solenoid valves are connected together with a hose, and have to be replaced as a unit as these solenoid valves and hoses are not supplied separately

**IMPORTANT:** Please ensure the openings of the purge line assembly are fully sealed prior to returning back to Bentley Motors (Use the bungs which were fitted to new assembly for this purpose)
