Technical product information

Topic	Continental Series and Flying Spur - Camshaft Timing Over Advanced - V8T
Market area	Bentley: worldwide (2WBE),Hongkong-Macau (5HK)
Brand	Bentley
Transaction No.	2047762/3
Level	EH
Status	Approval
Release date

Continental GT, GTC and Flying Spur - V8T

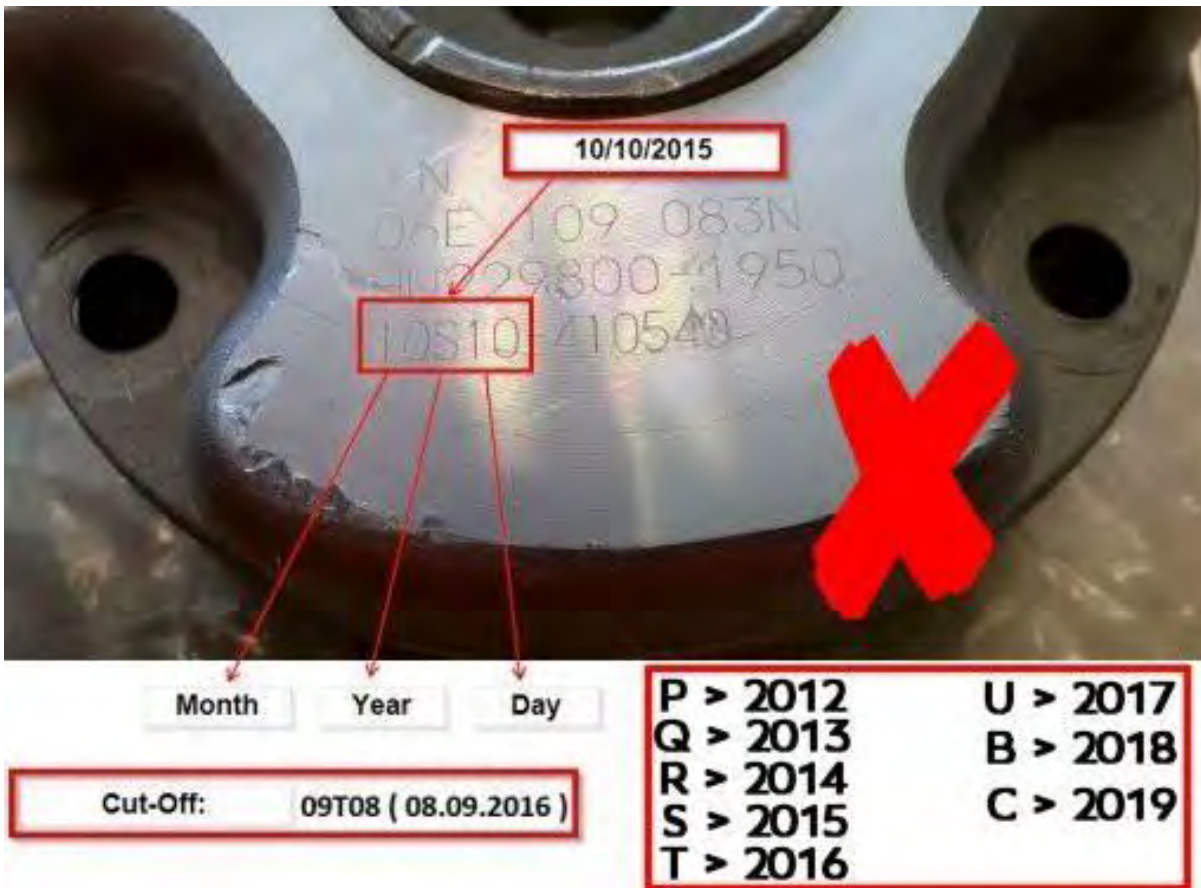
- Check the date code marked on each of the four Camshaft Adjusters, any found to be prior to 8/9/2016 (Date code 09T08) - Figure 1 - should be replaced. When changing a Camshaft Adjuster the relevant Camshaft Control Valve should also be replaced.
- Camshaft adjusters later than date code 8/9/2016 (09T08) do not need to be changed – Figure 2 - unless the fault code stored is specifically for that particular Camshaft Adjuster.

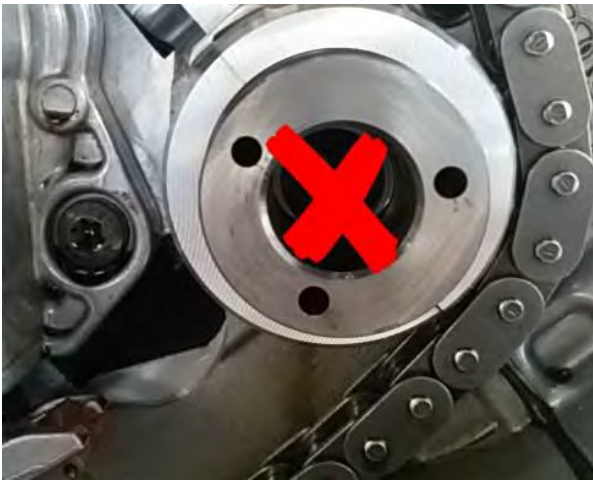
- When replacing the camshaft adjusters check and confirm the specification of ALL four camshaft mating faces IMPORTANT: Should the camshaft faces be smooth as shown in Figure 3 all four camshafts should be replaced

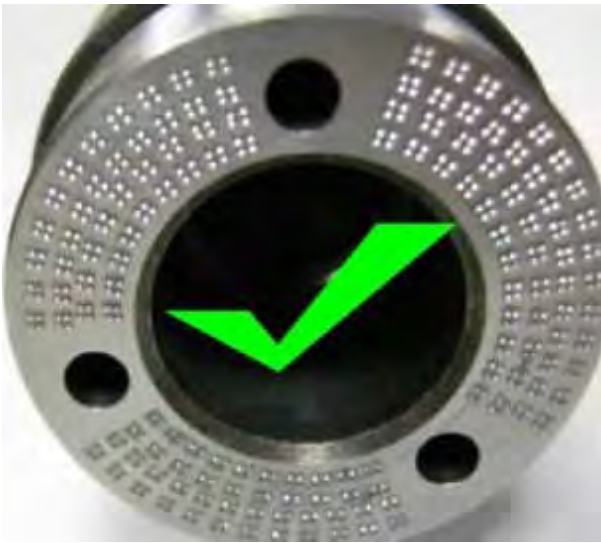
Figure 4

- Should the camshaft mating faces be machined patterned as Figure 4, there is no requirement to replace the camshafts
