## Technical product information

| <b>Topic</b> | Top view/Rear view camera - guidelines not visible |
| <b>Brand</b> | Bentley |
| <b>Transaction No.</b> | 2055254/1 |

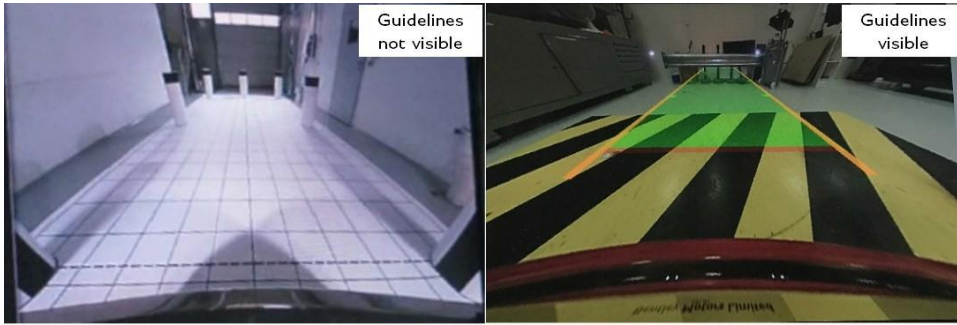
Guidelines not showing on display screen when reverse gear selected.

On the Top view camera system the guidelines are not visible on first reverse gear selection after engine start, the guidelines are visible on the second selection and thereon after. If the PDC button is pressed the guidelines are always visible.

On the Rear view camera system the guidelines are never visible.

Referring to the technical background section of this document, these are the correct operations of the Top view and Rear view camera systems and no further action is necessary.
