# Technical Service Bulletin

<b>Subject:</b>  CHECK ENGINE LIGHT ON WITH DTC P2096:00	<b>Bulletin No.:</b> 01-011/19
	<b>Last Issued:</b> 07/24/2019

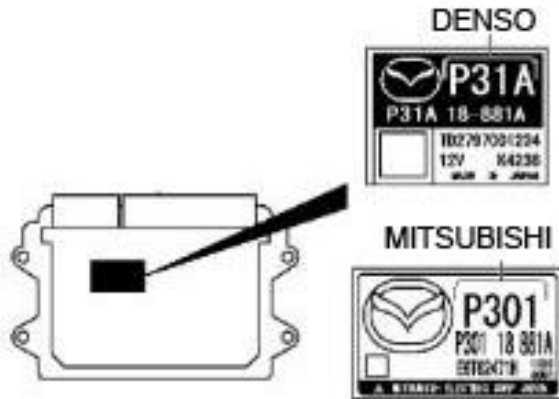
### PCM Identification

**NOTE:** This concern occurs only on vehicles with PCMs manufactured by MITSUBISHI.

1. Verify the customer concern.
2. Using the image above, verify the PCM in the subject vehicle is manufactured by MITSUBISHI, if yes, **read all cautions and notes below then proceed to "PCM REPROGRAMMING"**.
