**THIS IS A TECH TIP, NOT A TECHNICAL BULLETIN.  
TECH TIPS ARE NOT ASSOCIATED WITH WARRANTY CLAIMING.**

Model(s)	Year	Eng. Code	Trans. Code	VIN Range From	VIN Range To
Eos	2007-2010	All	All	All	All

Convertible Top inoperative due to possible lose or disconnected wire splice.

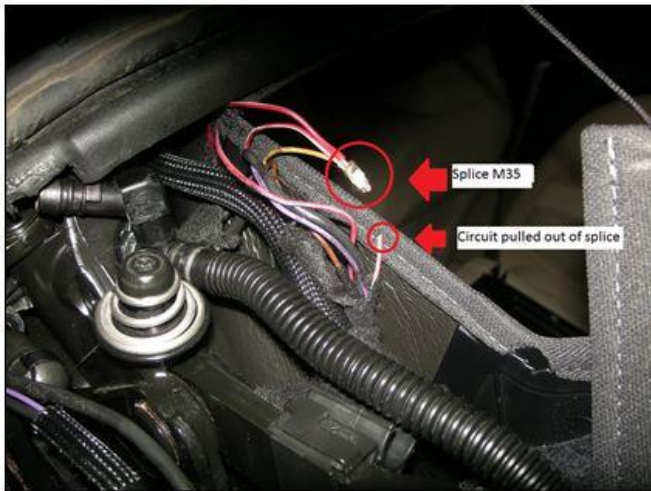
Figure 1

When diagnosing a customer concern of Convertible Top inoperative with faults 03053-008 "Left Roof Pillar Lock Sensor -**G558**- implausible signal", 03055-008 "Rear Window Frame Left Lock Sensor -**G560**- implausible signal", and/or 03057-008 "Rear Window Frame Opening Sensor -**G562**- implausible signal" stored in Convertible Top, start by inspecting M35 splice in Convertible Top harness. The splice is located near left rear Convertible Top Drain, Figure 1.
