Model(s)	Year	Eng. Code	Trans. Code	VIN Range From	VIN Range To
Eos	2007-2010	All	All	All	All

Convertible Top inoperative due to possible loose or disconnected wire splice.

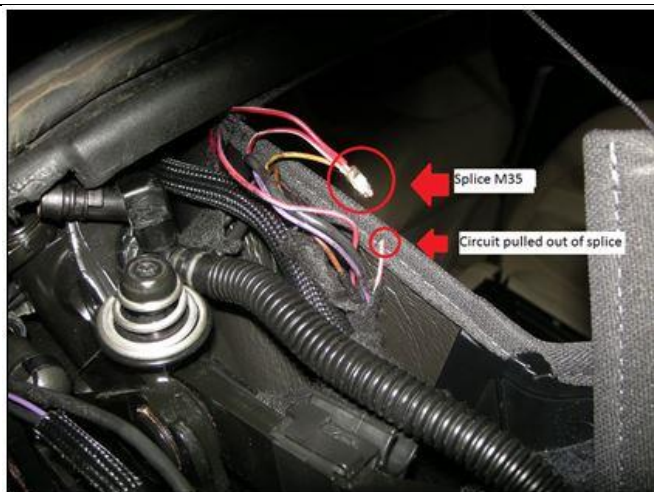
Figure 1

When diagnosing a customer concern of Convertible Top inoperative with faults 03053-008 "Left Roof Pillar Lock Sensor -**G558**- implausible signal", 03055-008 "Rear Window Frame Left Lock Sensor -**G560**- implausible signal", and/or 03057-008 "Rear Window Frame Opening Sensor -**G562**- implausible signal" stored in Convertible Top, start by inspecting M35 splice in Convertible Top harness. The splice is located near left rear Convertible Top Drain, Figure 1.
