Subject: CLICKING NOISE WHEN TURNING THE STEERING WHEEL	Bulletin No.: 08-002/19
	Last Issued: 07/12/2019

2019 Mazda3

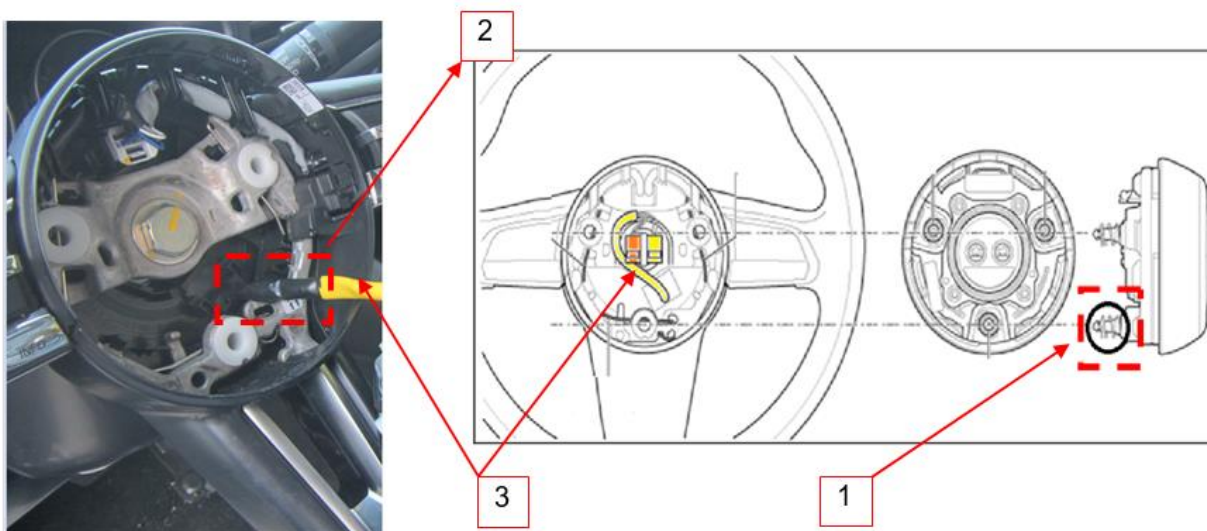
Some vehicles with the two-step deployment control air bag module may exhibit a clicking sound when turning the steering wheel. This is caused by the horn spring (1) of the airbag module interfering with the black color tape (2) of the clock spring harness (3), resulting in a stick-slip noise (click on attached sound file below).

To eliminate this concern, a material change of the harness tape is planned. Customers having this concern should have their vehicle repaired using the following repair procedure.
