# HONDA

19-023

# **High-Pitched Noise from the Heater Case**

# AFFECTED VEHICLES - HEATER CASE MIS-ALIGNMENT

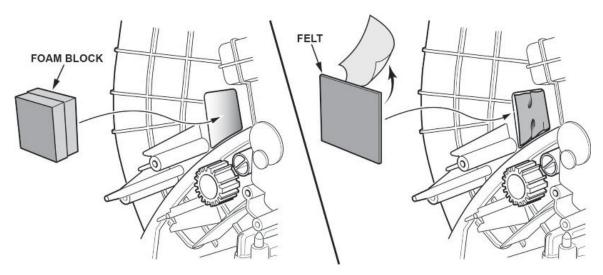
8. Locate the air leak path opening.

9. Install the foam block to the opening as shown.
