Technical Service Bulletin

48 Squeaking noises from rubber boot of intermediate steering shaft

48 19 80 2055733/1 July 26, 2019.

Model(s)	Year	VIN Range	Vehicle-Specific Equipment
A4	2017 - 2020	All	Not Applicable
A5	2018 - 2020	All	Not Applicable

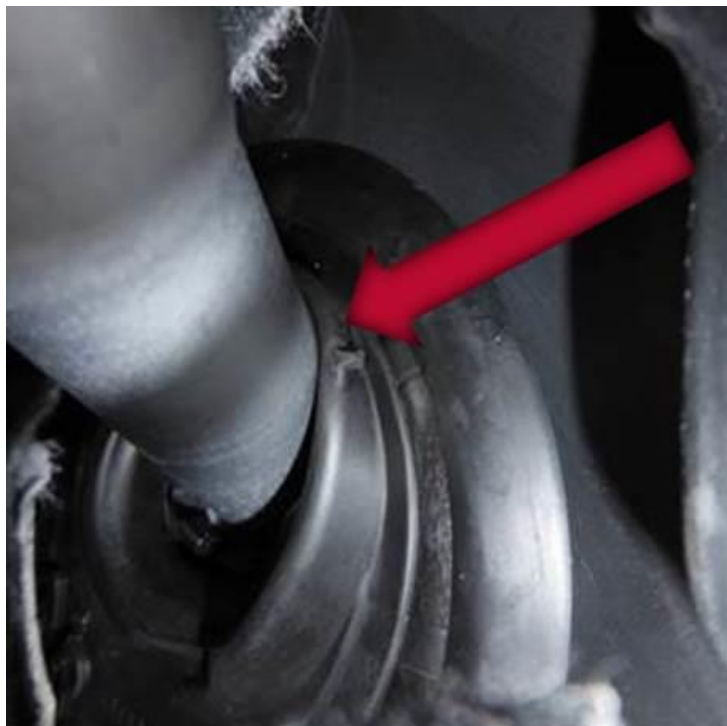
- The noise comes from the sealing sleeve/steering column opening on the bulkhead.
- The steering column adjustment is set in the lower range.
- The steering shaft rests on the cone of the sealing sleeve (Figure 1).

Figure 1. Steering shaft rests on the sealing sleeve (also known as sealing lip).

Incorrect positioning of the sealing sleeve (lip) in the bulkhead in connection with unfavorable tolerances of the components.

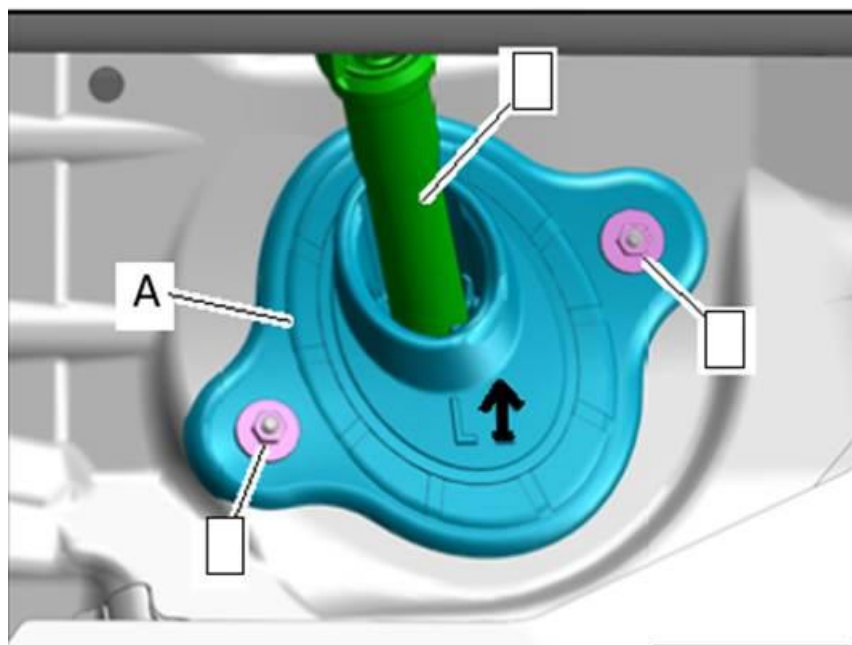
Figure 2. Sealing sleeve (also known as sealing lip).

1. Disconnect the intermediate steering shaft from the steering column.
2. Loosen the rubber sealing sleeve (A) and push it upwards as far as possible and retighten (Figure 2).

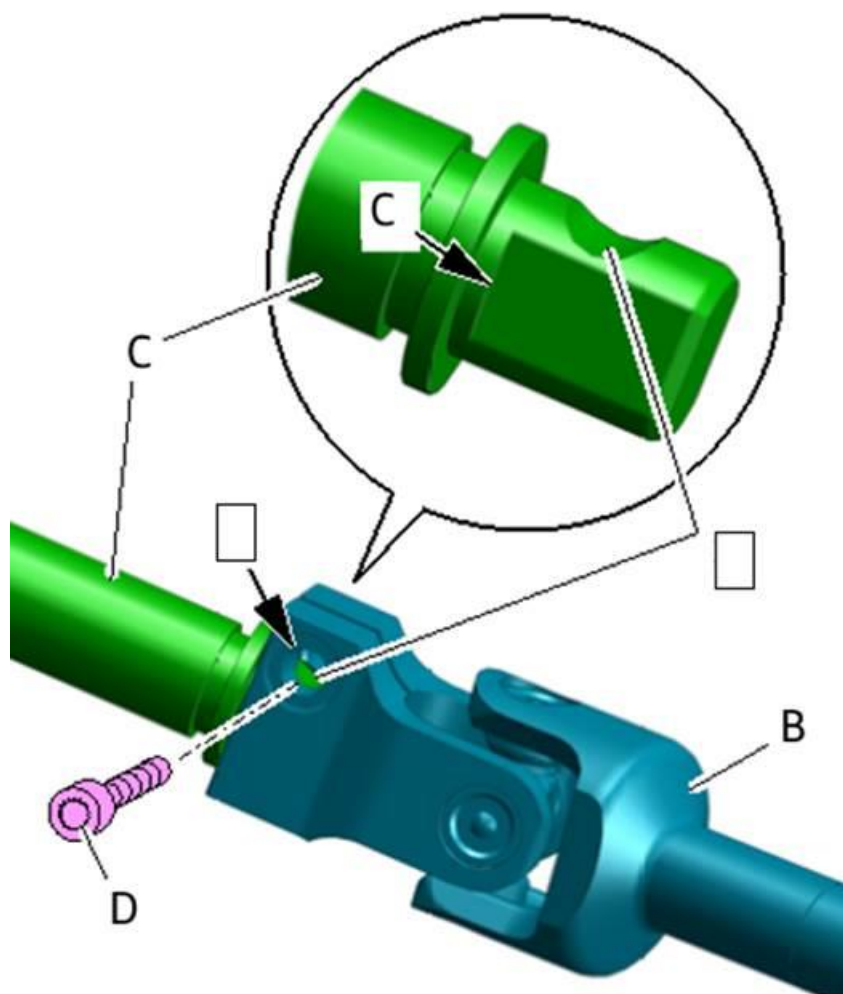
Figure 3. Steering column shaft and intermediate shaft connection.

3. Reinstall the steering intermediate shaft (B) to the steering column (C) and tighten with new bolts (D) (Figure 3).
