Technical Service Bulletin

60 Seal for Panoramic sun roof has changed

60 19 33 2055582/1 July 17, 2019.

Model(s)	Year	VIN Range	Vehicle-Specific Equipment
A7	2019	00001 – 032040	Panoramic sunroof

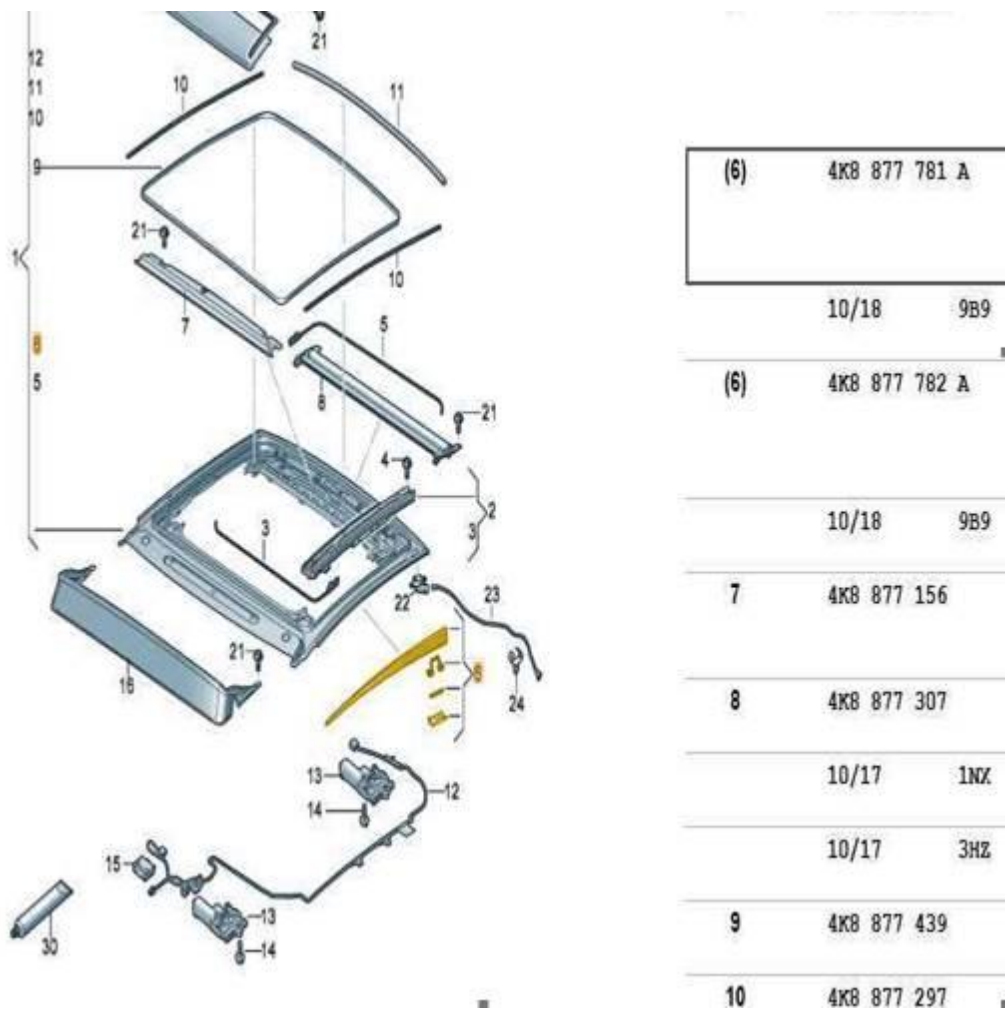
The pop-up panels on the Panoramic sunroof have changed (Figure 1).

Figure 1. The part number has been updated to 4K8 877 781 A or higher.

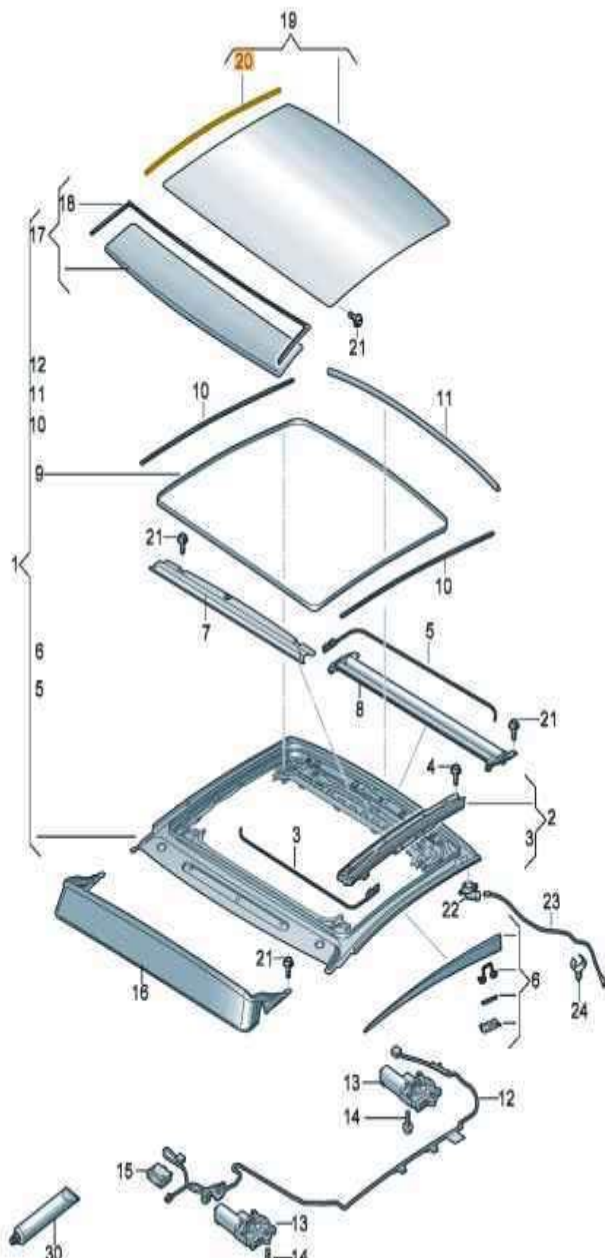
This requires a change in the installation position of the seal in position 20 (Figure 2).

Figure 2. Position change for the seal/bellows.

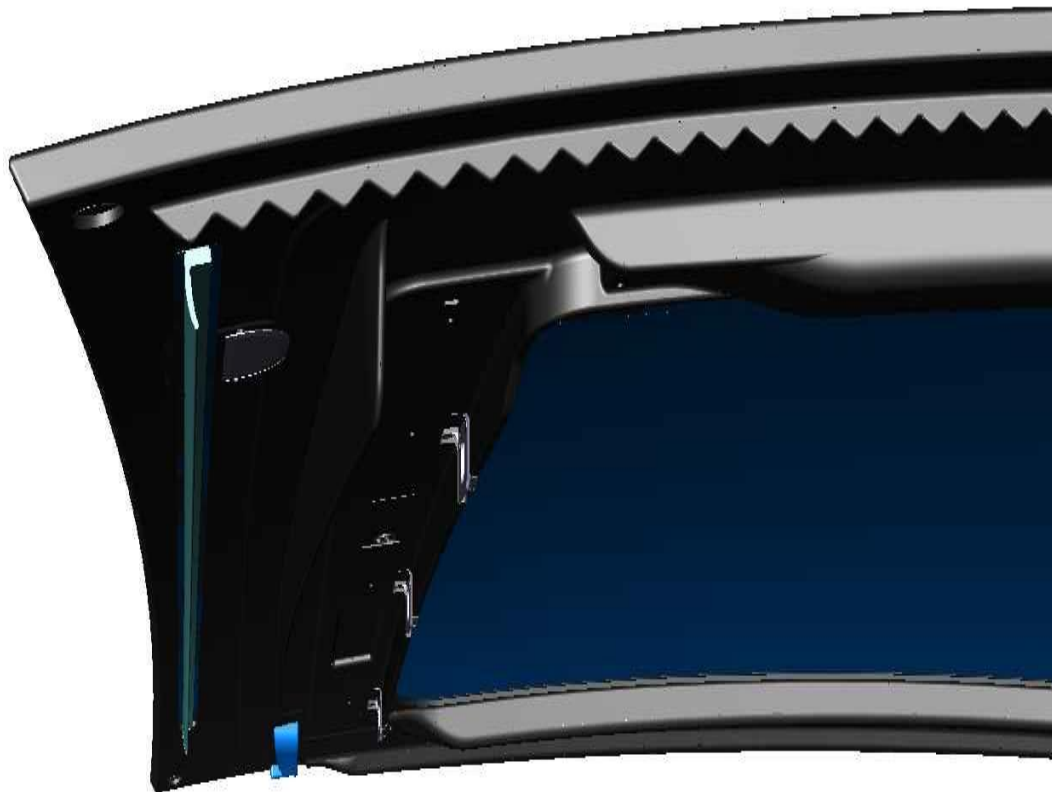
Figure 3. *New positioning.*

If a panel with index A is then installed, the two seals under the glass panel must be replaced and positioned (Figure 3).

The sealing lip must face outwards.

If a new glass panel is installed on the vehicle, then the pop-up panels must also be replaced. Install pop-up panels with Figure 3.
