69 Airbag warning light on, DTC B1225F1 stored in the airbag control module

69 19 41 2051242/5 July 24, 2019. Supersedes Technical Service Bulletin Group 69 number 19-40 dated June 26, 2019 for reasons listed below.

Model(s)	Year	VIN Range	Vehicle-Specific Equipment	
A5, Q5	2018 - 2019	All	Not Applicable	
A4, Q7	2017 - 2019	All	Not Applicable

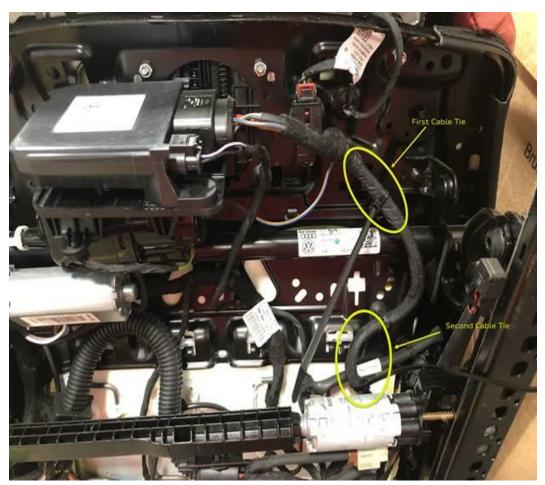
Figure 1. Positions of the cable ties.

Once the seat is adjusted to the above-mentioned position, you will see the need to attach the cable ties at two points on the harness as shown (Figure 1).

You are not going to secure the harness to any part of the seat with the cable ties, you are only applying the cable ties to the harness to apply clamping force to the harness and shielding. DO NOT ATTACH THE HARNESS TO THE SEAT FRAME.

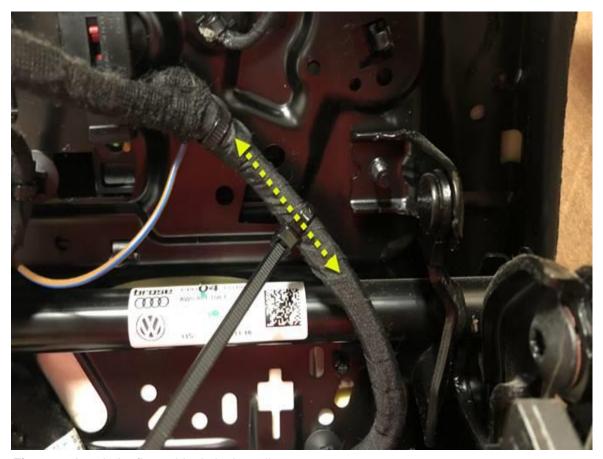
Figure 2. Attach the first cable tie in the yellow area.

2. You will attach the first cable tie in the yellow marked area on the harness between the cable tie clip and the crossbar tube as shown below (Figure 2).

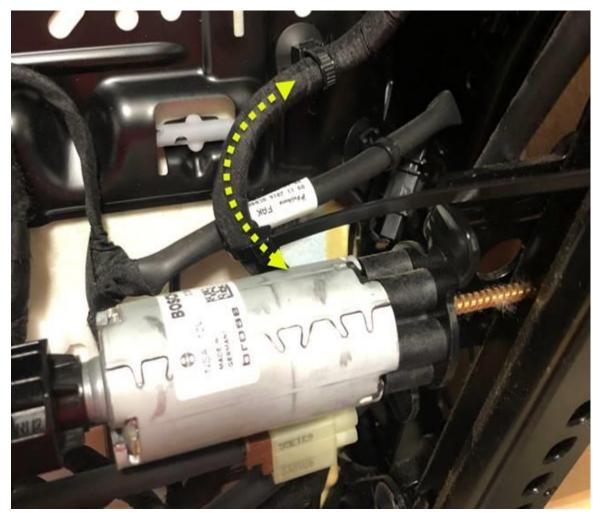
Figure 3. Attach the second cable tie to the yellow marked area.

3. The second cable tie position is to the rear of the crossbar tube where the harness drops down from the frame. Place the cable tie in the yellow marked area shown below (Figure 3).

When tightening the cable ties, only tighten them with your hands, do not use any tools to tighten the cable tie as this can damage the harness. Check that the cable ties cannot be rotated on the harness by hand, to ensure that proper tension is achieved. Then cut off the excess length from the tie wrap.

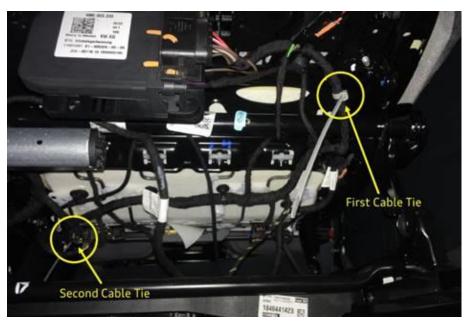
Figure 4. Positions of the cable ties (front to back).

Once the seat is adjusted to the above-mentioned position, you will see the need to attach the cable tie at two points on the harness as shown (Figure 4-6).

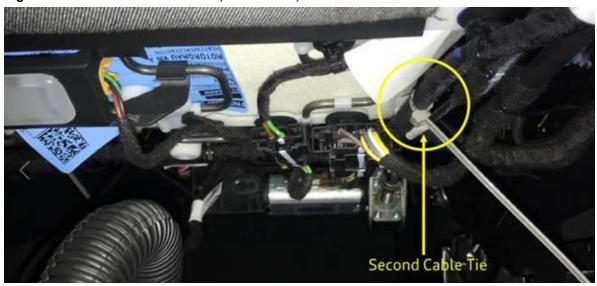
Figure 5. Positions of the cable ties (back to front).

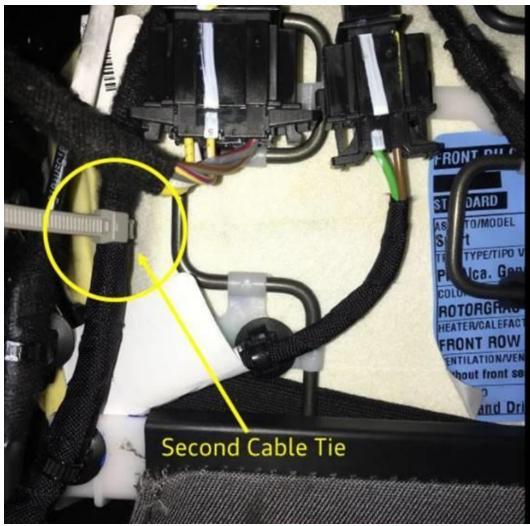
Figure 6. Position of second cable tie behind the 8-pin connector.

- 2. You will attach the first cable tie in the yellow marked area on the harness between the cable tie clip and the crossbar tube (Figure 2).
- 3. The second cable tie position is to the rear of the black 8-pin connector (T8m) for the backrest and lumbar adjustment and in front of the harness push pin (Figure 6).

When tightening the cable ties, only tighten them with your hands, do not use any tools to tighten the cable tie as this can damage the harness. Check that the cable ties cannot be rotated on the harness by hand, to ensure that proper tension is achieved. Then cut off the excess length from the tie wrap.
