GROUP <b>CHA</b>	MODEL <b>2012-2014MY Optima (QF) 2016-2018MY Sorento (UMa)</b>
	NUMBER <b>060 (Rev 5, 07/05/2019)</b>	DATE <b>January 2016</b>
<b>TECHNICAL SERVICE BULLETIN</b>		
<b>SUBJECT: ECU UPGRADE – STEERING LOGIC IMPROVEMENT</b>

This bulletin provides information related to the MDPS ECU software upgrade for some 2012-2014MY Optima (QF), produced from August 2, 2010 through July 27, 2014, and 2016-2018MY Sorento (UMa) vehicles, produced from October 27, 2014 through August 22, 2017, which may experience a notchy feel in the steering wheel. To correct this condition, the vehicle should be evaluated using the MDPS Effort Measurement Software detailed in the repair procedure starting on page 2 to determine whether an improved steering logic should be installed in the MDPS ECU, or if the Steering Column and Housing Assembly replacement is required. To determine whether the updated MDPS ECU reflash applies to a vehicle you are working on, or whether it has already been performed, verify ROM ID using the tables in this TSB.

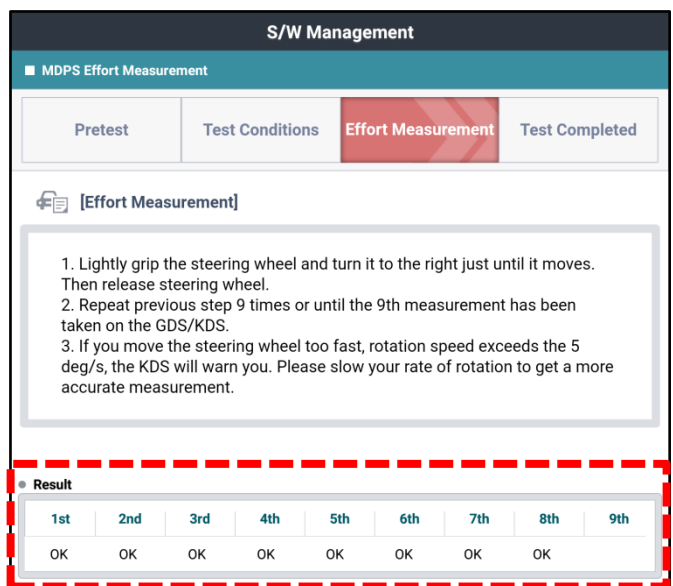
**If the five (5) Deg/Sec. rotation speed is exceeded, a message, as shown below, will display.**

Steering wheel rotation speed is fast.
