GROUP	MODEL
CLI	2017-2019MY Sportage (QL)
NUMBER	DATE
046	July 2019

TECHNICAL SERVICE BULLETIN

REDUCED PERFORMANCE OR INOPERATIVE AIR CONDITIONING

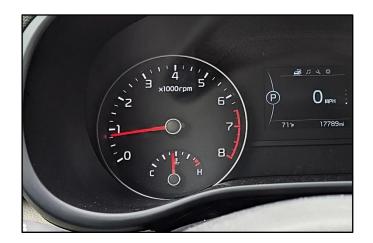
1. Start the engine and let it idle.

2. Turn the A/C temperature to the lowest temperature, set the fan speed to high, and vent mode to "face".

3. Wait five (5) minutes and then measure the air temperature at <u>a center vent</u> using a temperature gauge.

Abnormal Temperature: 50°F (10°C) and higher.

Normal Temperature: 41-50°F (5-10°C)

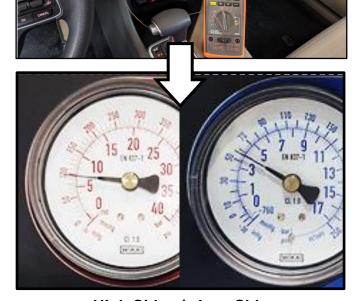
High Side / Low Side

Note: When connecting gauges, if the compressor is inoperative, there will be no significant difference between high and low pressure reading (as shown). Pressure difference will be within 2-3 bar (29-44 psi).

If the A/C compressor operates normally during engine idle, replace the ETS and if applicable, replace the ECV (pages 5 and 6).

If the A/C compressor is not operating normally during engine idle, replace the compressor **and** if applicable, replace the ETS (page 6).
