GROUP ELE	MODEL 2019MY Sportage (QL)
NUMBER 184	DATE July 2019

TECHNICAL SERVICE BULLETIN

SUBJECT: SERVICE ACTION: QL BLUETOOTH AUDIO UPDATE (SA392)

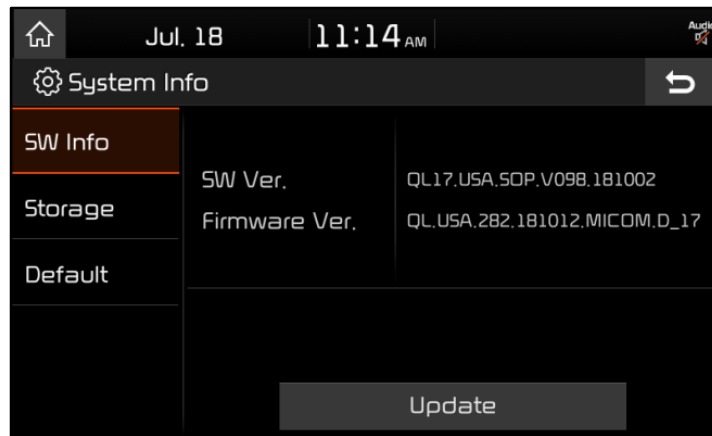
This bulletin provides the procedure for updating the UVO 3.0 software on some 2019MY Sportage (QL) vehicles produced from July 19, 2018 through Jan. 03, 2019 which may experience Bluetooth skipping/intermittent muting. To correct this concern, perform the head unit software update procedure outlined in this bulletin. Before conducting the procedure, verify that the vehicle is included in the list of affected VINs.
