# Allison Transmission Cooler Quick-Connect Fittings

## 20-018

Freightliner Custom  
Chassis Service Bulletin

> S2

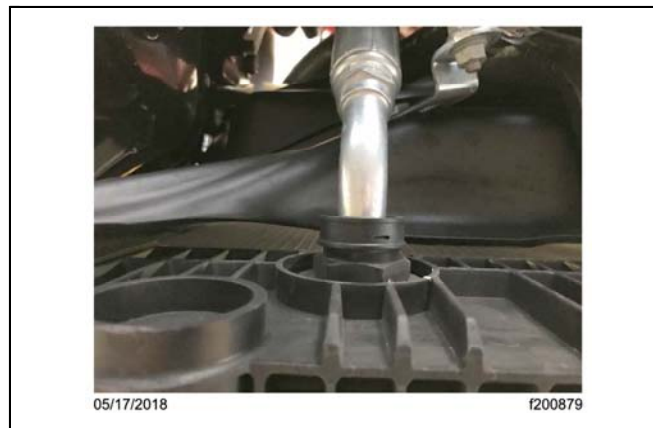
**Fig. 2, Cooler Line Connection with Original Plastic Cap and Spring Clip**

1. Park the vehicle on a level surface, shut down the engine, and set the parking brake. Chock the tires.
2. Inspect the transmission cooler lines where they connect to the radiator and determine if they have the original plastic cap and spring clip as installed from the factory (see Fig. 2 ) or if a hose clamp has been installed as a temporary containment (see Fig. 3 ).
