HDEP MCM 21 Pin Service Jumper Replacement

54-072

<p>Constellation 4900 Models 4700 Models 6900 Models</p>	<p>4800 Models > 5700 Models 5900 Models Heritage</p>	<p>Western Star Service Bulletin</p>
---	---	---

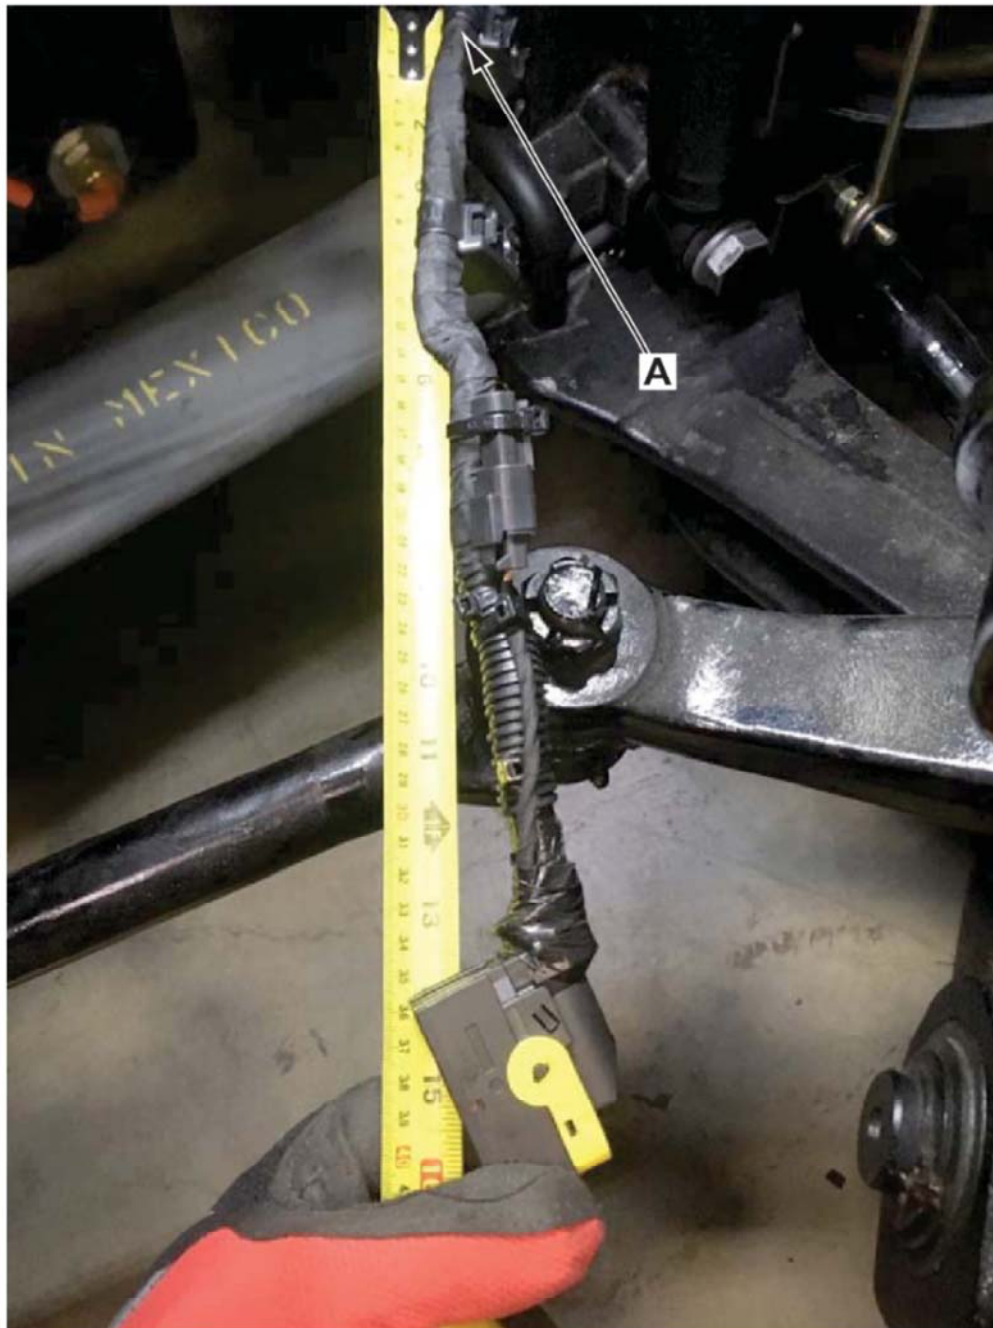
Fig. 1, Splicing Point on the MCM 21 Pin Jumper Harness

Jumper harness is available for repairing the damaged MCM 21 pin connector, terminals, and minor wiring. The MCM 21 pin jumper harness provides an alternative to replace the entire harness when damage is contained within the MCM 21 pin connector, terminals, seals, and minor harness wiring damage near the MCM 21 pin connector.

1. Park the vehicle on a level surface, shut down the engine, and set the parking brake. Chock the tires.
2. Disconnect the batteries.
3. Remove the 21 pin connector from the MCM.
4. Remove the clamps/tie straps. As required, unclip the harness to access the harness from the MCM 21 pin connector up to the splicing point (about 15 inches). See Fig. 1 .

NOTE: 35 inch jumpers have the splicing point location at the harness fore/after split and at the main harness mounting bracket.

5. Unwrap the harness and separate wiring in order to identify circuits, then cut, strip, and inspect the wires for splicing.
6. Install new jumper harness. Crimp and heat shrink the splices as needed.
7. Wrap the harness with a fiber wrap, route the harness along the clipping points, connect the 21 pin connector to the MCM, and secure the harness as needed.
