June 2019  
SF578AB  
REVISED NOTICE

## Subject: Forward Chassis Wiring Harness

**Models Affected:** Specific Freightliner Cascadia model vehicles,  
manufactured June 13, 2016, through April 6, 2018.

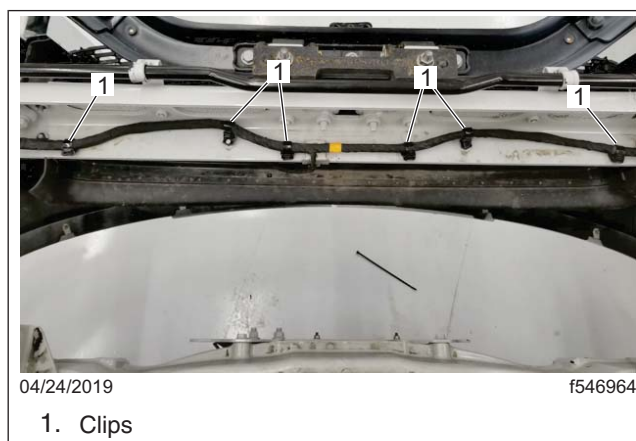
**Fig. 1, Clipping Points**

6. Inspect the forward harness at both sides of the radiator area, and the forward harness routing along the entire front cross member, including to the forward radar, if equipped. Verify that the harness is secured and protected, per installation drawing D66-15080, and is not chafing on baffles, tubing, crossmember, brackets, or the oil cooler. When correctly secured, the forward harness should be secured twice at each side of the brackets near the bottom edge of the baffle, and the forward harness should be secured with 6 clipping points along the entire lower web of front cross member. See [Fig. 1](#). On vehicles with forward radar, the radar harness should have a caddy clamp on the edge of the crossmember, and an edge clip under the rock guard to protect the radar harness from chafing. If any of the clipping points or clips are missing, or if the forward harness is chafing or unsecured, the harness will need further repairs as directed in these work instructions.

11. Secure the forward harness across the entire front crossmember as needed using drawing D66-15080-000 for reference. The forward harness should have 6 clipping points along the lower web of front cross member, 4 fir tree and 2 stud mount tie straps. See [Fig. 1](#). Vehicles with forward radar will have an additional retainer clip, tie strap, and edge clip to secure and protect the forward radar harness. Any chafing damage found on the forward harness should be repaired using the instructions in **SB 54-290, Guidelines for Repairing or Replacing an Electrical Harness**.
