Business Class M2  
Cascadia  
108SD/114SD  
> New Cascadia

**Freightliner  
Service Bulletin**

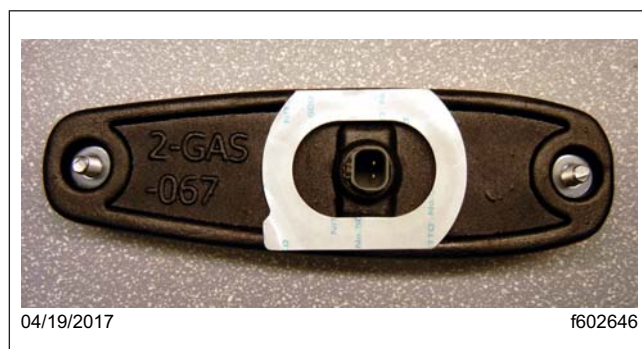
On November 14, 2016, the New Cascadia marker light was changed in production to include an adhesive gasket. On some New Cascadia vehicles built before November 14, 2016, water may intrude into the cab through a marker light gasket. If a leak is detected in a vehicle built before that date, install new peel-and-stick adhesive gaskets on all five marker lights; see [Fig. 1](#).

**Fig. 1, Marker Light with Peel-and-Stick Adhesive Gasket**

1. Park the vehicle on a level surface, shut down the engine, and set the parking brake. Chock the tires.
2. Remove the two screws that attach the marker light to the cab roof. The marker light will be reused.
3. Remove the old gasket. Retain the old gasket if filing a claim for warranty.

4. Peel the paper from the film adhesive on the lamp-facing side of the new gasket.
5. Install the new gasket on the original marker light.

6. Scrape any remaining sealant or gasket material from the cab surface, then using soapy water, clean the cab roof where the marker light will be installed.
7. Make sure the cleaned surfaces are dry, then peel the backing off the roof side of the marker light gasket.

8. Install the marker light, using two screws to fasten it securely. Tighten the screws 31 lbf·in ± 4.4 lbf·in (350 N·cm ± 50 N·cm).

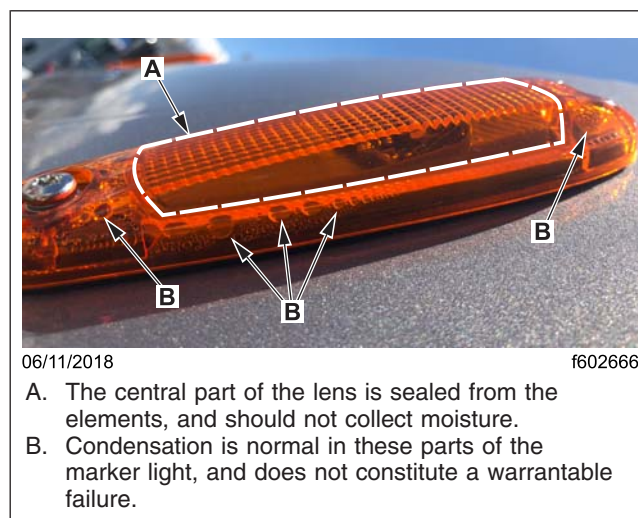
NOTE: The roof marker lights may collect moisture between certain portions of the lens and the gasket. This is completely normal and does not constitute a warrantable failure. Only the part of the lens which contains the electronics, in the center of the marker light, is sealed from the elements. See [Fig. 2](#).

**Fig. 2, Condensation in Marker Light**
