June 2019  
FL806AB  
NHTSA #19V-066  
Transport Canada #19-054

## **Subject: Freightliner Cascadia Steering Wheel Airbags**

**Models Affected: Specific Freightliner Cascadia vehicles manufactured August 3, 2017, through January 30, 2019.**

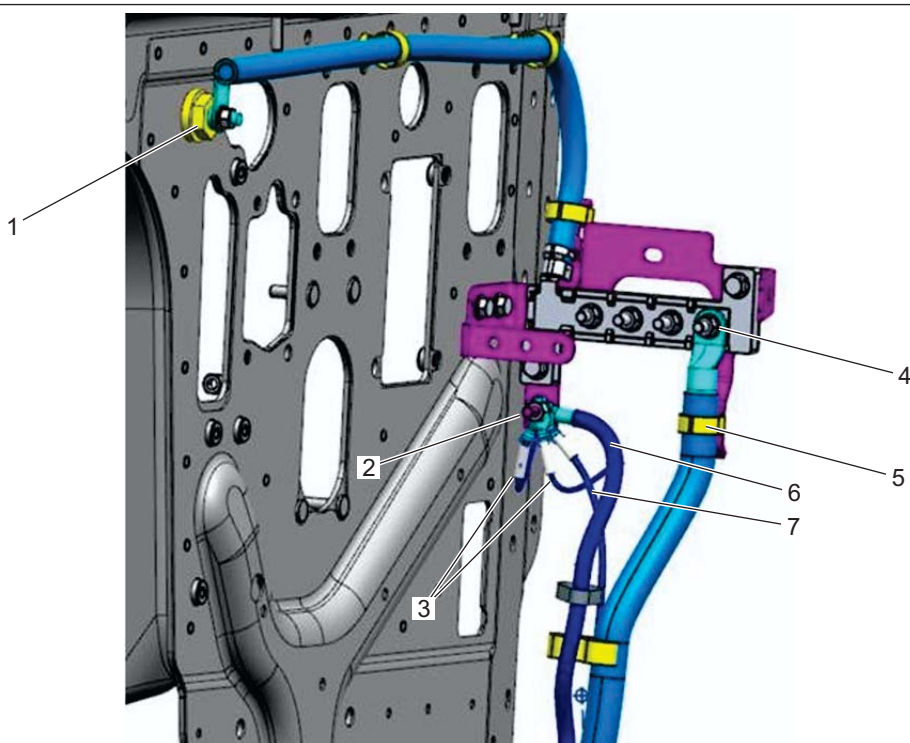
**Fig. 6, MGJB and Frontwall Grounds**

NOTE: There should always be FOUR ring eyes attached to the GNDP non-isolated stud. **The non-isolated stud itself is NOT a return path to ground through the bracket and relies on the grounding cable returning to the frame for ground;** confirm the 2YU GNDP cable is connected from the stud to the frame rail GNDP stud. The GNDP cab skin cable is oversized, and larger than the return to frame cable.

- 10.5 Use a cutoff wheel or suitable tool to cut the damaged stud off flush with lower floor skin.
- 10.6 Using a 5/16 x 1.25 bolt, install the A/C line support Z bracket, and secure it with a washer and nut. Torque to 14 lbf-ft (18 N·m).
- 10.7 Position the driver's-side floor mat in the vehicle and install the driver's side lower steering cover, the lower A-pillar cover, and the sill cover.
11. Inspect the GNDE pass-through stud on the engine side of the frontwall. See [Fig. 6](#) and [Fig. 8](#). Verify that the GNDE pass-through stud on the engine side frontwall is clean and torqued correctly. Disassemble and inspect the stud for overspray on the flat surfaces. Torque the stud 7 lbf-ft (9.5 N·m). Repaint the connection as necessary.
12. Inspect the GNDP non-isolated stud, located on the lower aft portion of the MGJB bracket. See [Fig. 6](#), ref. 2.

13. Inspect the GNDE ring terminals on the isolated studs on the Main Ground Junction Block (MGJB). See [Fig. 6](#), ref. 4. Verify that the GNDE connections to the MGJB are clean, configured properly, and torqued correctly.

Disassemble and inspect the studs for overspray on the flat surfaces, and in between the ring eyes, then fan the ring eyes properly and torque the studs 14 lbf·ft (18 N·m). Repaint the connection as necessary.

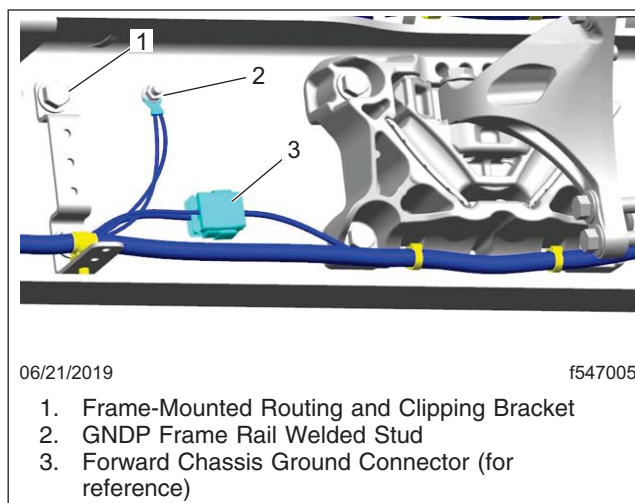
**Fig. 9, GNDP Frame Rail Stud**

8. Verify that the Electrical Ground (GNDE) and the Power Ground (GNDP) frame rail studs are clean and torqued correctly. Disassemble and inspect the studs for overspray on the flat surfaces, and in between the ring eyes. Torque these frame rail ground studs 14 lbf-ft (19 N·m). Repaint the connection as necessary. See [Fig. 9](#) on page 10.
