June 2019  
SF587A

## Subject: Freightliner Cascadia Pre-Wired Airbags

**Models Affected:** Specific Freightliner Cascadia vehicles manufactured October 24, 2018, through May 23, 2019 and pre-wired for a steering wheel airbag.

Daimler Trucks North America LLC, on behalf of its Freightliner Trucks Division, is initiating Field Service Campaign SF587A to modify the vehicles mentioned above.

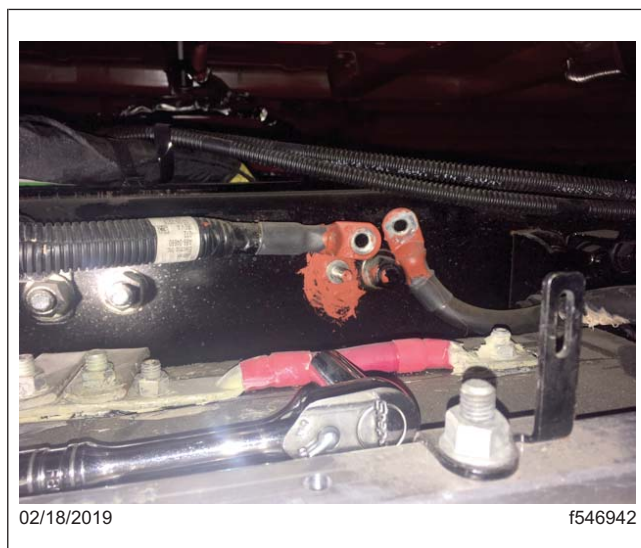
Fig. 1, GNDE Frame Rail Stud

6. Open the hood.
7. Inspect the vehicle frame rail GNDE and GNDP studs. See [Fig. 1](#) and [Fig. 2](#). Use lacquer thinner, as needed, to clean off any excess paint on electrical connections throughout these instructions.

8. Verify that the Electrical Ground (GNDE) and the Power Ground (GNDP) frame rail studs are clean and torqued correctly. Disassemble and inspect the studs for overspray on the flat surfaces, and in between the ring eyes. Torque these frame rail ground studs 14 lbf-ft (19 N·m). Repaint the connection as necessary. See [Fig. 9](#) on page 8.

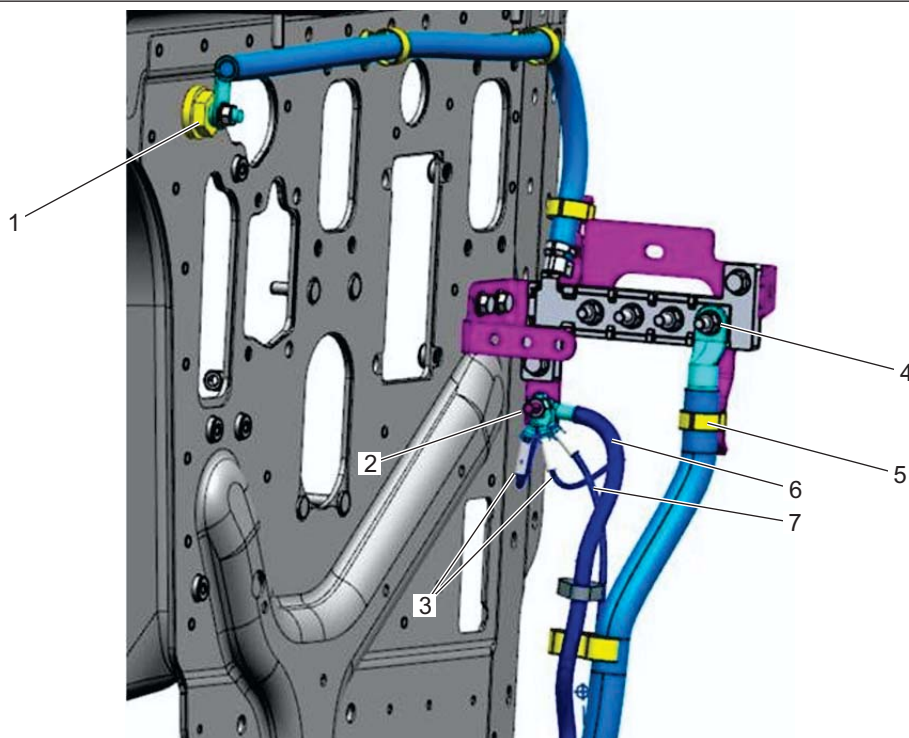
**Fig. 6, MGJB and Frontwall Grounds**

12. Inspect the GNDP non-isolated stud, located on the lower aft portion of the MGJB bracket. See [Fig. 6](#), ref. 2.

13. Inspect the GNDE ring terminals on the isolated studs on the Main Ground Junction Block (MGJB). See [Fig. 6](#), ref. 4. Verify that the GNDE connections to the MGJB are clean, configured properly, and torqued correctly.

Disassemble and inspect the studs for overspray on the flat surfaces, and in between the ring eyes, then fan the ring eyes properly and torque the studs 14 lbf-ft (18 N-m). Repaint the connection as necessary.

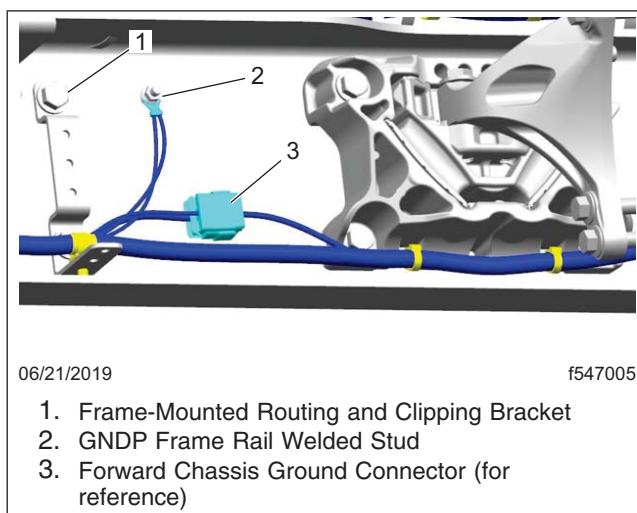
**Fig. 9, GNDP Frame Rail Stud**

NOTE: There should always be FOUR ring eyes attached to the GNDP non-isolated stud. **The non-isolated stud itself is NOT a return path to ground through the bracket and relies on the grounding cable returning to the frame for ground**; confirm the 2YU GNDP cable is connected from the stud to the frame rail GNDP stud. The GNDP cab skin cable is oversized, and larger than the return to frame cable.

Verify that the GNDP non-isolated stud is clean, configured properly, and torqued correctly. See [Fig. 9](#). Disassemble and inspect the stud for overspray on the flat surfaces, and in between the ring eyes. Verify there are exactly four (4) circuits on ring eye terminals that attach to the GNDP non-isolated stud on every vehicle. If more or less are found on this stud, combine this inspection step with the next one for GNDE MGJB, separate and group the cables until four GNDP connections are confirmed. Fan these GNDP ring eyes properly on the non-isolated stud and then torque the stud to 14 lbf-ft (18 N-m). Repaint the connection as necessary.
