Instance Number	Published Date	Version Number	Reason For Update
2055763/1	7/26/2019	87-19-02TT	Original publication.

## Technical Background

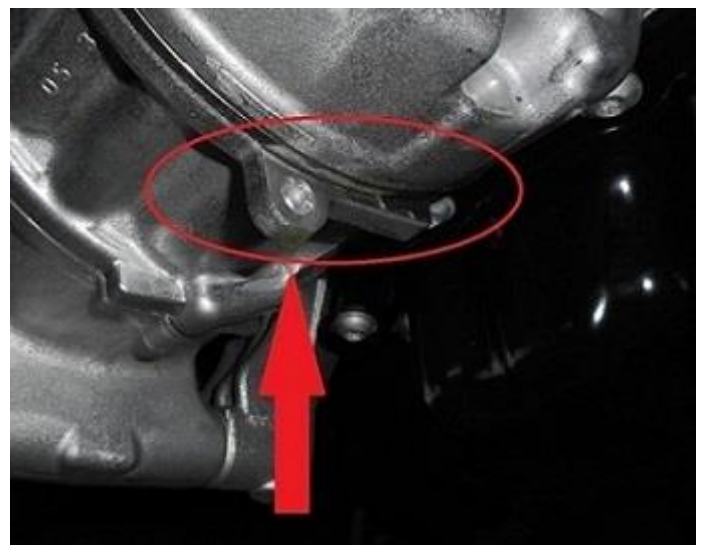
Figure 1

While verifying a low refrigerant condition the -**V454**- Air Conditioning Compressor sometimes appears to be leaking at the case seals (Figure 1).

The oil found at the bottom of the compressor (Figure 1) can be caused by a leaking low pressure compressor O-ring. (Figure 2-3).

Oil found at bottom of compressor.

Before the replacement of any compressor for a possible leak the leak must first be verified by injecting dye into the Air Conditioning system after refrigerant recovery to verify the refrigerant level.

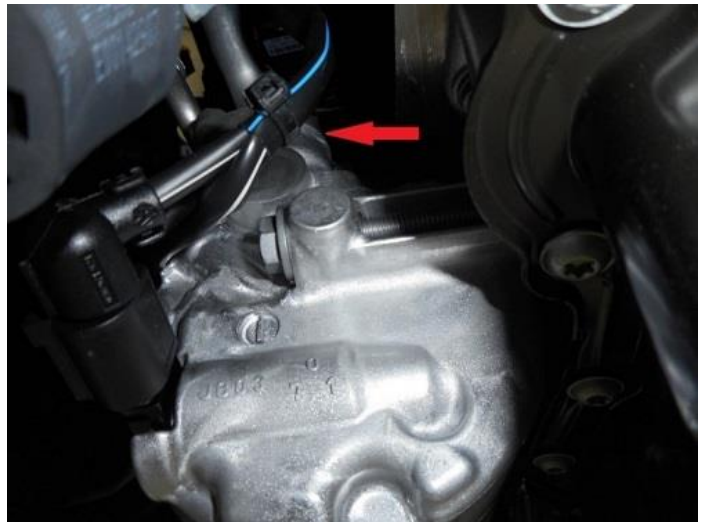
Figure 2

Leak found at low pressure compressor connection.

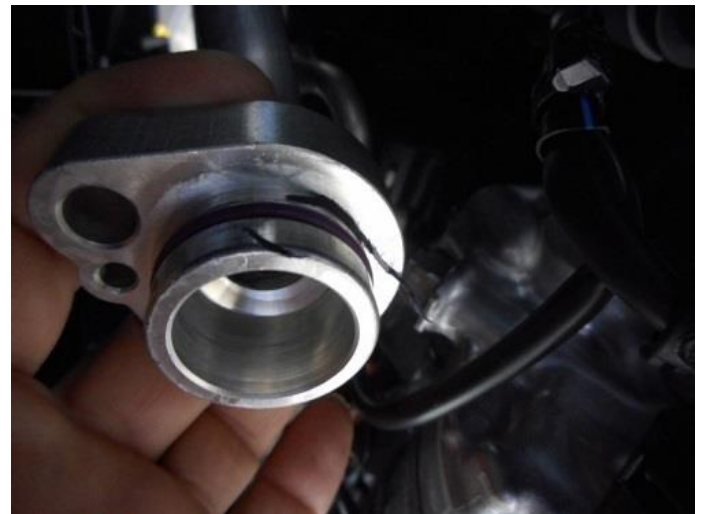
Figure 3

**Cause:** O-ring torn on low pressure AC hose connection to compressor.
