SERVICE BULLETIN

APPLICABILITY: 2017-19MY Impreza
2017-19MY Crosstrek

NUMBER: 16-121-19R

SUBJECT: "Tapping" -Type Sound Coming from Engine to CVT Connection

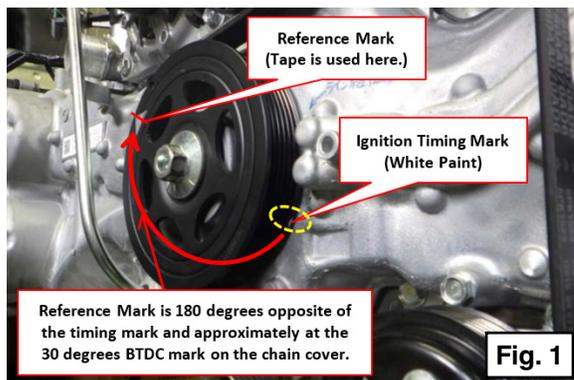
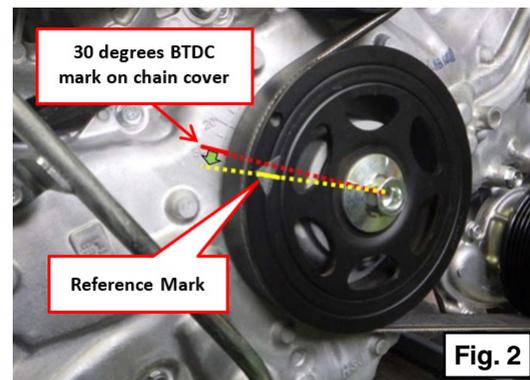
Step 5: Locate the small ignition timing mark on the back edge of the crankshaft pulley as shown below (**Fig. 1**). Put a mark with a grease pencil or use a small piece of tape **180 degrees opposite** of the timing mark for reference. As a general guideline, this mark should approximately align with the 30 degrees before TDC mark on the timing chain cover (**Fig. 2**) and will be much easier to see and refer to than the timing mark.
