2045672/5

60-18-03 Water Leak From Rear Of Panoramic Sunroof

Release date: 7/18/2019

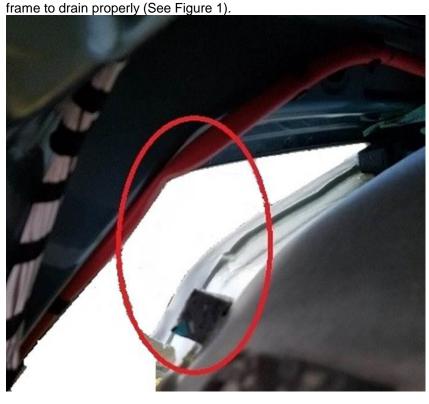
The rear sunroof drains may be pinched shut by foam blocks on the headliner, not allowing the sunroof frame to drain properly (See Figure 1)

Incorrect assembly in production allows too much length in the sunroof drain between the second and third securing clips. This causes excess slack in the drain hose allowing the foam block to contact the hose.

The new hoses (longer than original) should be cut to match the length of the original hoses prior to the installation. During installation of the new drain hoses, ensure the hoses are pulled taught between the 2nd and 3rd mounting clips with no excess slack in the hoses (See Figures 4 and 5).

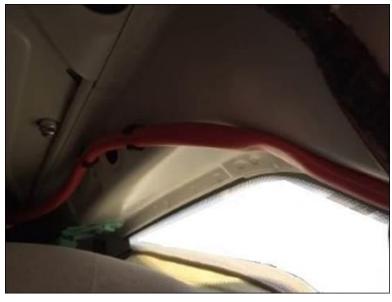
- 5. Remove the C-Pillar trim panels. See repair manual group 70 in ELSA.
- 6. Remove the D-Pillar trim panels. See repair manual group 70 in ELSA.
- 7. Loosen the rear roof grab handles from the mounts in the grab handle brackets. DO NOT completely remove. See repair manual group 68 in ELSA.
- 8. Remove the luggage compartment lamp. See repair group 96 in ELSA.
- 9. Carefully lower the rear of the headliner and inspect the rear sunroof drain hoses. The drain hoses should be replaced if they show signs of being pinched by the foam blocks on the headliner (Figure 3).

Figure 3: Impression on rear sunroof drain from contact with headliner foam block.

If the sunroof drains are pinched continue to next step. If the sunroof drains are not pinched, this bulletin does not apply and further diagnosis is required.

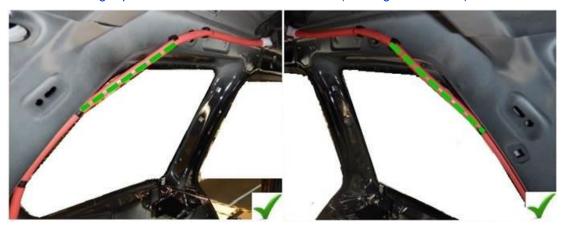
Figures 4 and 5: Correct routing of left and right rear drain hoses with no slack between the 2nd and 3rd mounting clips.

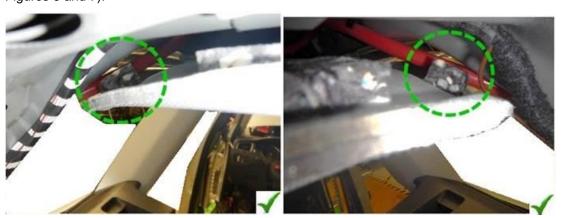
Figures 6 and 7, Rear drain hoses routed behind foam blocks on headliner.

3. Reinstall the headliner ensuring the foam blocks do not contact either of the sunroof drain hoses (See Figures 6 and 7).
