SERVICE BULLETIN

APPLICABILITY: All 2015-17MY Vehicles with Fujitsu TEN (F10) 7in. Multimedia Navigation (AVN) & Display Audio Units
NUMBER: 15-177-14R
DATE: 10/16/14
SUBJECT: “Gen 2” & “Gen 2.1” Operating Tips
REVISED: 07/26/17

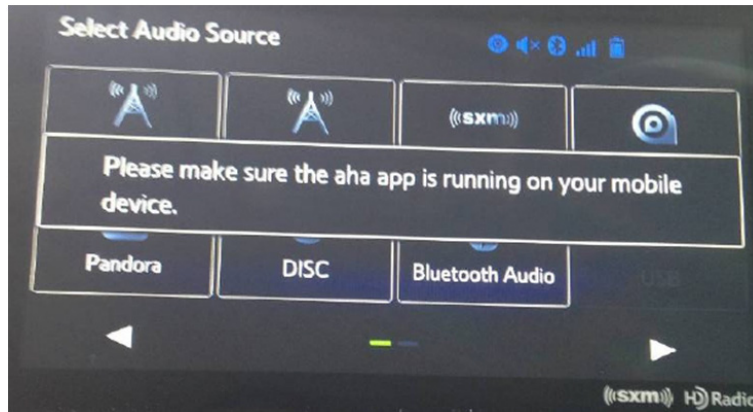
aha Message

CONDITION #10: When selecting aha or Pandora on the head unit with a Smartphone (iPhone or Android) connected, the head unit displays a message informing the user to check the app on their Smartphone (see below).

- Pandora or aha App is not installed on the Smartphone.
- Pandora or aha App is not launched on the Smartphone.
- The iPhone is not connected to the system to the head unit with a USB Cable or in the case of an Android Smartphone, the Smartphone is not paired to the head unit using Bluetooth or launched.

- Download the Pandora or aha app to the Smartphone.
- Launch the Pandora or aha app on the Smartphone.
- Connect the iPhone to the head unit using a USB cable.
- Pair the Android phone to head unit using Bluetooth.
- Select Pandora or aha on the head unit from Audio Source

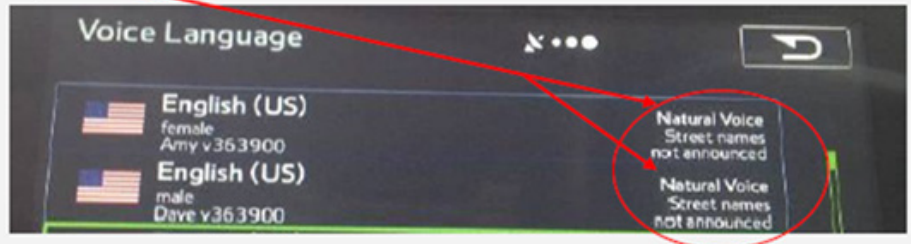
Figure 1

CONDITION #12: When using the voice command to operate navigation system functions, the following message is displayed: “This feature cannot be used with the selected guidance voice profile”.

“Natural Voice” (Figure 1) is selected from the Voice Language menu when “Text To Speech” (TTS) is required (Figure 2) for proper voice command operation.

- Follow the steps below to change from Natural Voice to TTS:
 1. Select “Home”.
 2. Select “Settings”.
 3. Select “General”.
 4. Select “Language”.
 5. Select “English (US) TTS Voice”.

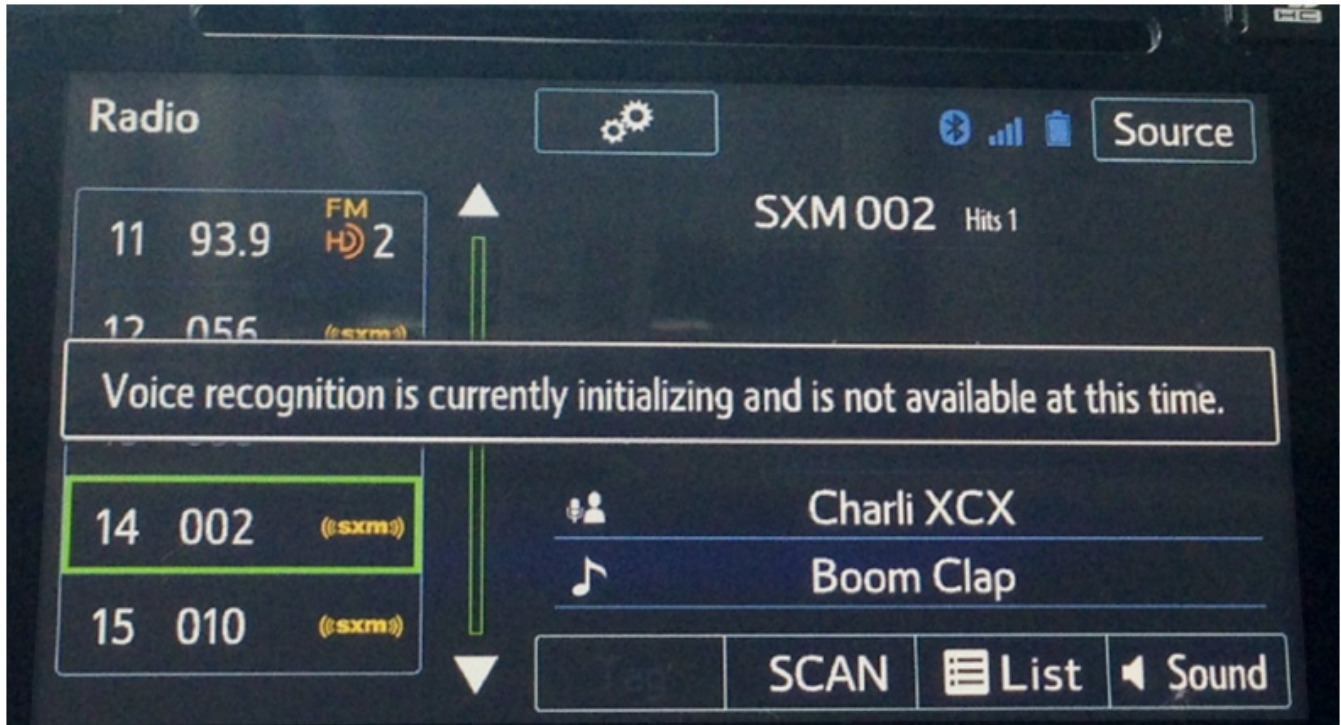
CONDITION #15: The message “Voice recognition is currently initializing and is not available at this time” appears on the screen.

When the head unit is turned on, the system scans XM stations along with every song (digital file) on the currently loaded CD, connected USB device and / or Bluetooth Audio player. It also scans the phone contacts stored on all Bluetooth-connected Smartphones. The system then creates voice tags for all the XM station names, artists, songs, albums, playlists, podcasts, genres, and contacts. During this process, the head unit will also display “Voice Recognition is currently initializing and is not available at this time” (see picture below).

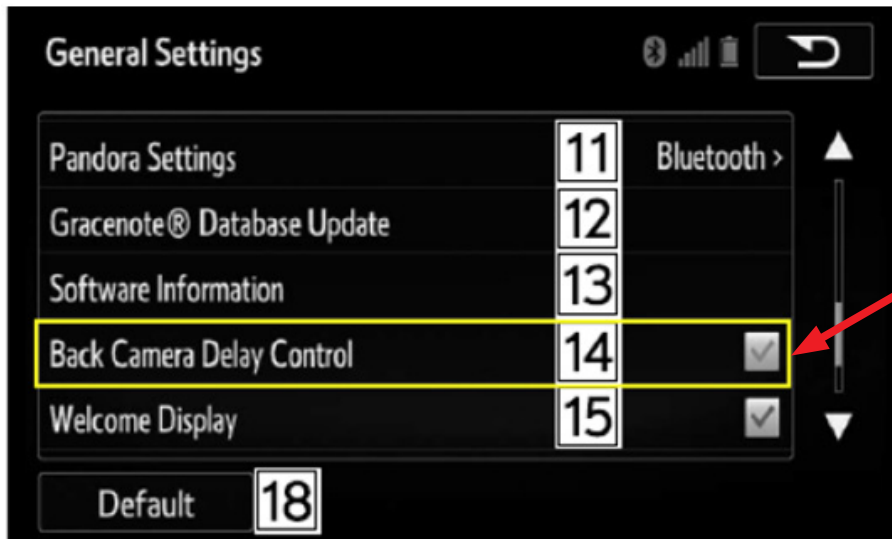
CONDITION #17: Back-up camera image remains displayed after shifting out of Reverse

“Back Camera Delay Control” setting is set to “ON”

When set to “ON”, the back-up camera image will remain displayed for about 7 seconds after moving the shifter out of Reverse. The image will turn off when shifting into Park or when vehicle speed exceeds 5 mph.

1. Touch “HOME” button.
2. Touch “SETTINGS” button.
3. Touch “General”.
4. Unselect the “Back Camera Delay Control”.

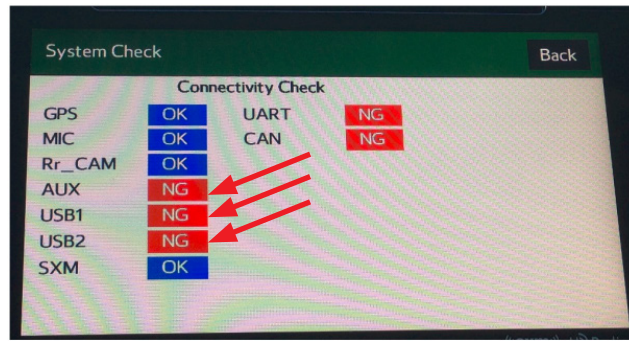
CONDITION #18: When in Diagnostic Mode, AUX, USB1 and USB2 all show as being NG

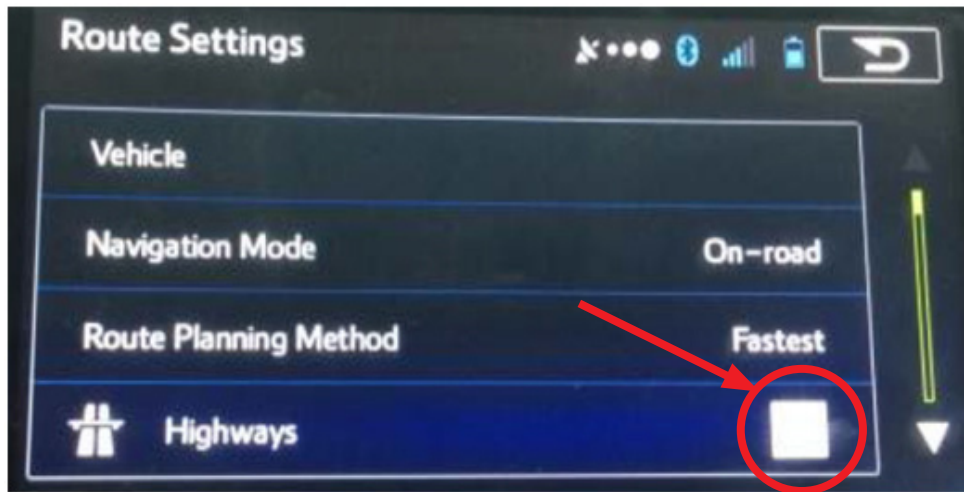
CONDITION #20: The Navigation system often routes the user off the highway, and onto rough surface (dirt / gravel) roads.

In the Route Settings menu, the “Highways” selection box is unchecked.

- Select “**Menu**” on the Map Screen
- Select “**More**”
- Select “**Settings**”
- Select “**Route Settings**”
- When “**Highways**” is checked the navigation system will always consider using highways first when planning routes.

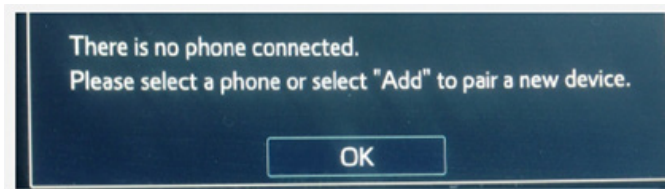
Pic 1

1. The message shown in (Pic 1) will display when there is no phone paired with the unit.

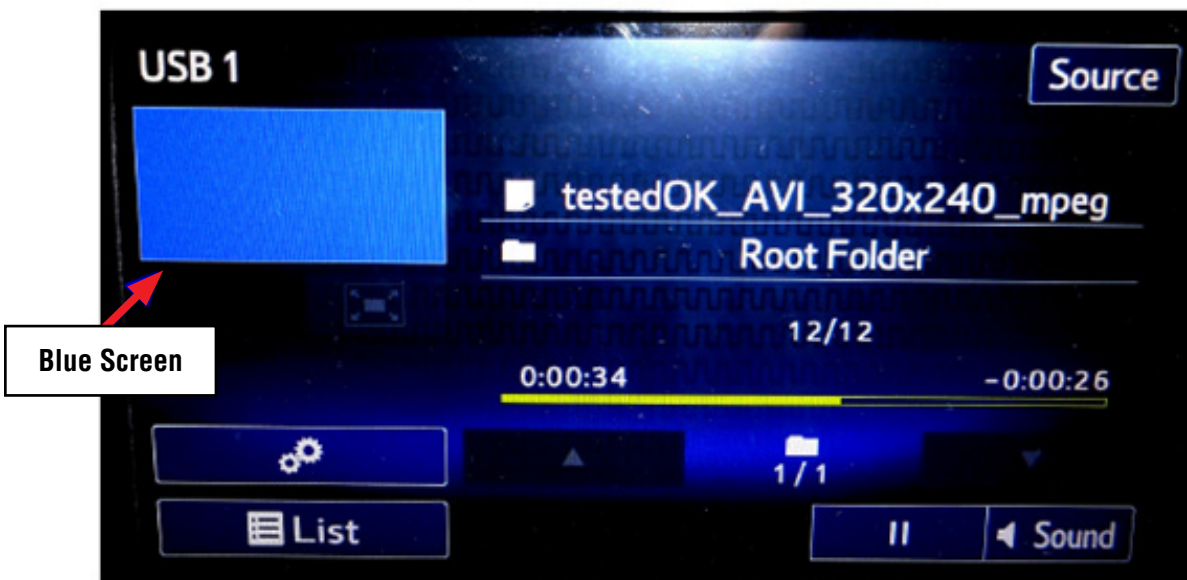
REMINDER: The parking brake must be engaged in order to watch videos. If not, the unit will display the blue screen as shown below but audio will be heard normally.

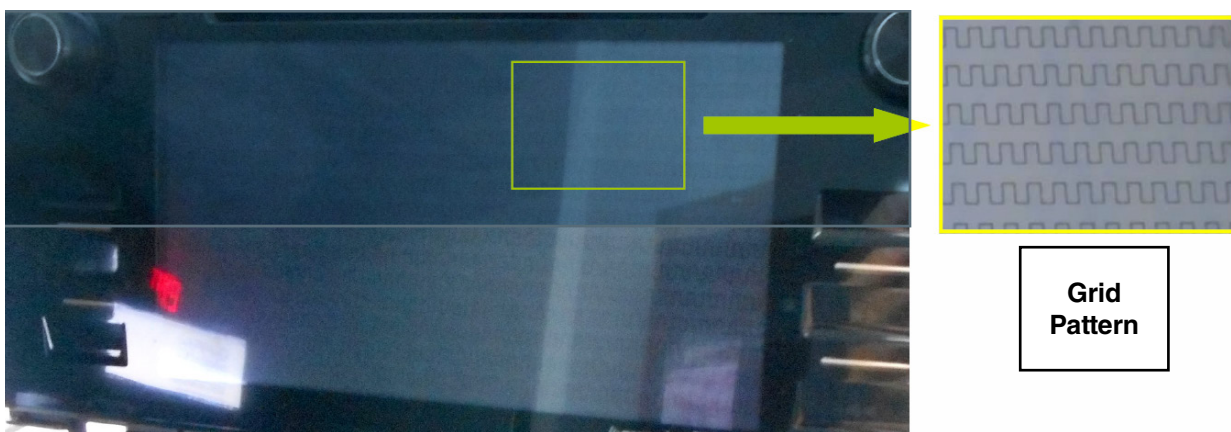
CONDITION #37: Grid pattern visible on the entire display area, all the time.

Defective Display unit.

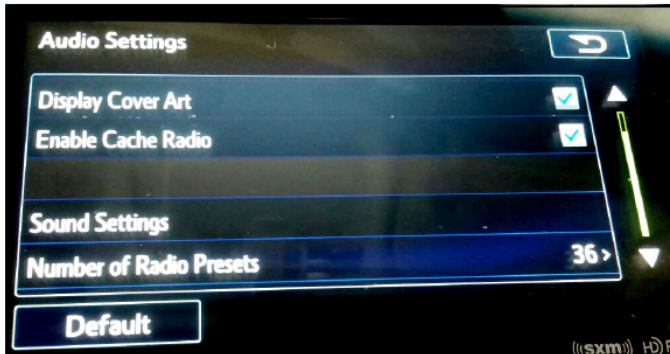
CONDITION #38: ASL (Automatic Sound Levelizer) function does not appear in Audio Settings as indicated in the Owner’s Manual.

ASL function not displayed in vehicle.

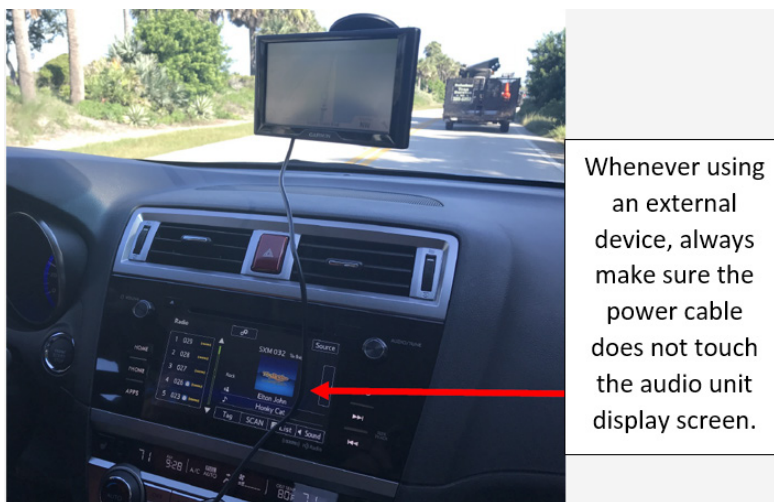
CONDITION #39: Unit freezes or locks up with no response to touch screen inputs.

A power cord from an auxiliary device (e.g. GPS or cell phone cord) placed on the dash or attached to the windshield may be coming in contact with the display screen and inadvertently be causing a touch button to be continually “pressed”. When this condition occurs, the result is that none of the other buttons will respond to any user touch inputs.
