SERVICE BULLETIN

APPLICABILITY: 2017-18MY Impreza
 2018MY Crosstrek
 2018MY Legacy and Outback
 2018MY BRZ*

NUMBER: 15-211-17R

SUBJECT: Reprogramming File Availability for Additional Optimization of Harman Gen 3 Audio and Navigation Head Units

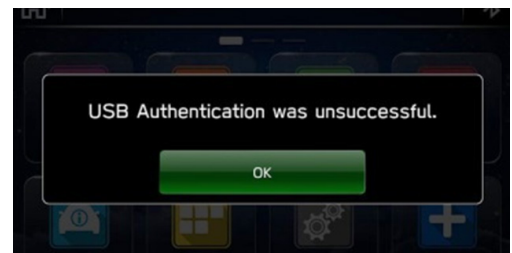
CAUTION: NEVER attempt to install this software on any 2019 MY vehicles as they are equipped with Gen 3.1 Audio/Navigation systems. This update is ONLY for models equipped with Gen 3.0 Audio/Navigation systems. Should an attempt be made to install any of these files into a Gen 3.1 head unit, the authentication error screen to the right will be displayed.

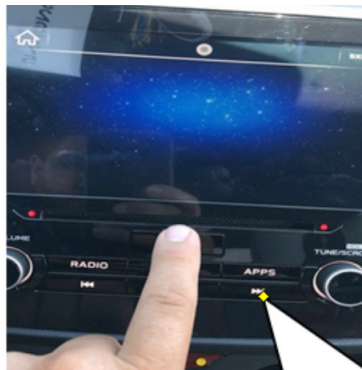
Background shown, but no icons

- Update for condition where only the star field background is displayed (without icons) after the HOME button is pressed.

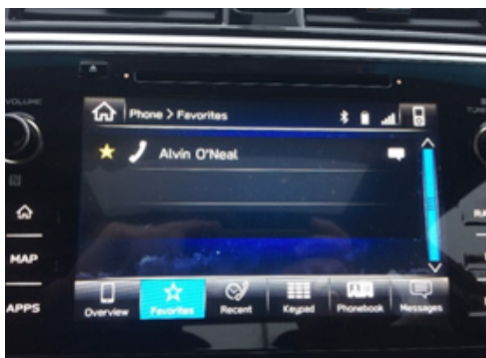
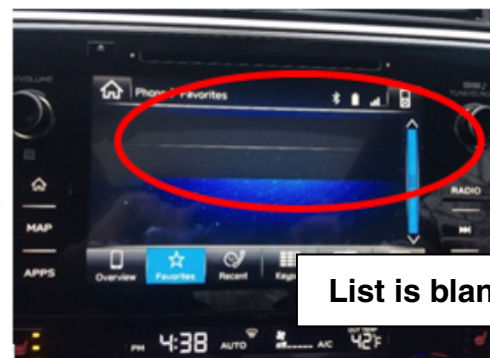
List is blank

- Update for a “Pop” or “Crackling“ sound concern when listening to AM radio.
- Update for a concern of the head unit continually resetting itself.
- Update for a concern of after selecting a contact to be a “Favorite” and the “Favorite” list display is blank.

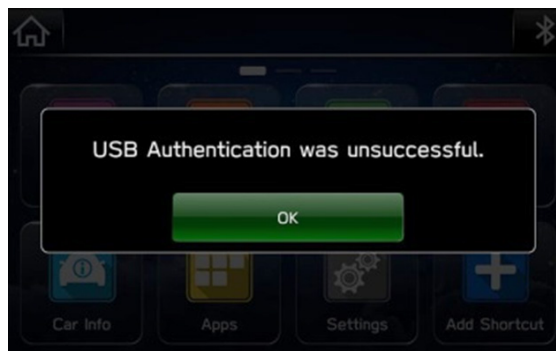
NOTE: If an attempt is made to install the wrong “grade” file into the wrong grade head unit (EXAMPLE: “Base” update file into a “Mid” or “High” head unit), the USB Authentication error screen below will be displayed:
