Constellation  
Heritage  
4700 Models  
4800 Models

4900 Models  
> 5700 Models  
5900 Models  
6900 Models

Western Star  
Service Bulletin

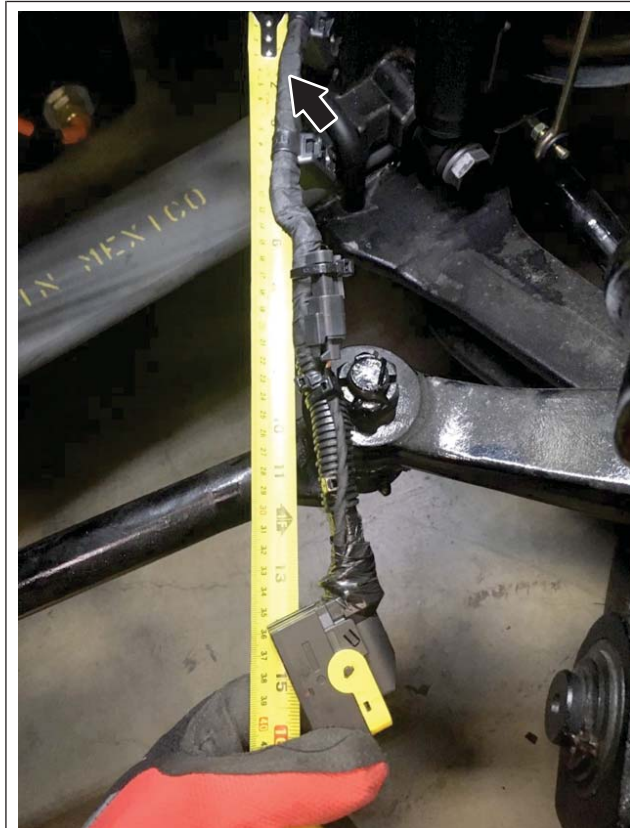
**Fig. 3, Splicing Point on the MCM 21-Pin Jumper Harness**

NOTE: The splicing point should be about 15 inches from the MCM 21-pin connector.

4. Remove the clamps and tie straps. As required, unclip the harness to access the harness from the MCM 21-pin connector up to the splicing point (about 15 inches). See [Fig. 3](#).
