TECHNICAL SERVICE BULLETIN

8F35 Transmission - Illuminated MIL With DTC P0766

19-2213

08 July 2019

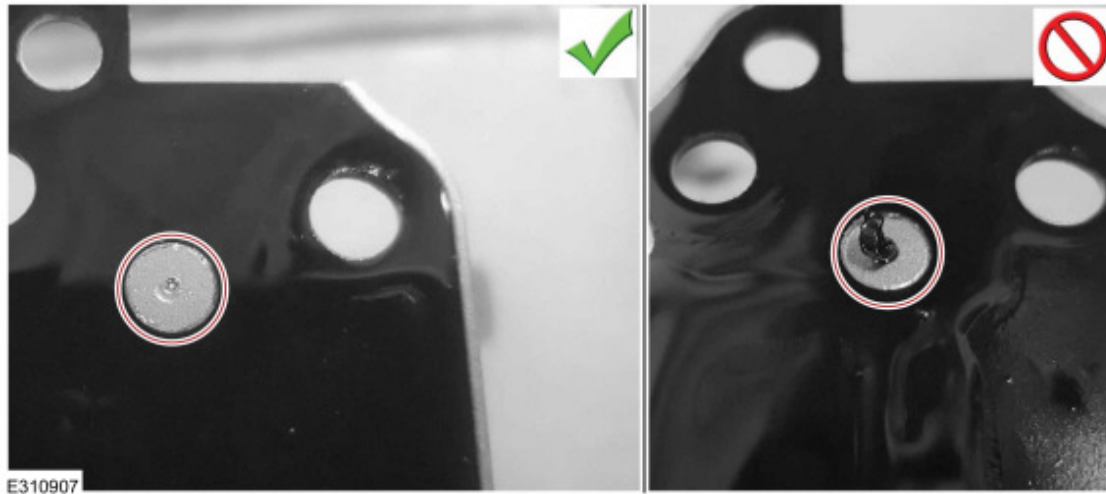
Figure 1

Issue: Some 2019 Edge/Nautilus/Transit Connect vehicles equipped with a 8F35 transmission may exhibit an illuminated malfunction indicator lamp (MIL) with diagnostic trouble code (DTC) P0766 stored in the powertrain control module (PCM) and/or intermittent or delayed reverse engagement concerns. This may be due to contamination in the main control valve body separator plate orifice. To correct the condition, follow the Service Procedure steps to clean the contamination from the main control separator plate.

1. Remove the main control valve body. Refer to Workshop Manual (WSM), Section 307-01.
2. Remove the main control separator plate. Refer to WSM, Section 307-01.
3. Clean and remove any debris from the separator plate orifice. (Figure 1)
