Constellation
Heritage
4700 Models
4800 Models

Western Star
Service Bulletin

ABS Light Illuminating in the ICU, ABS Solenoids Not Self Checking

54-067

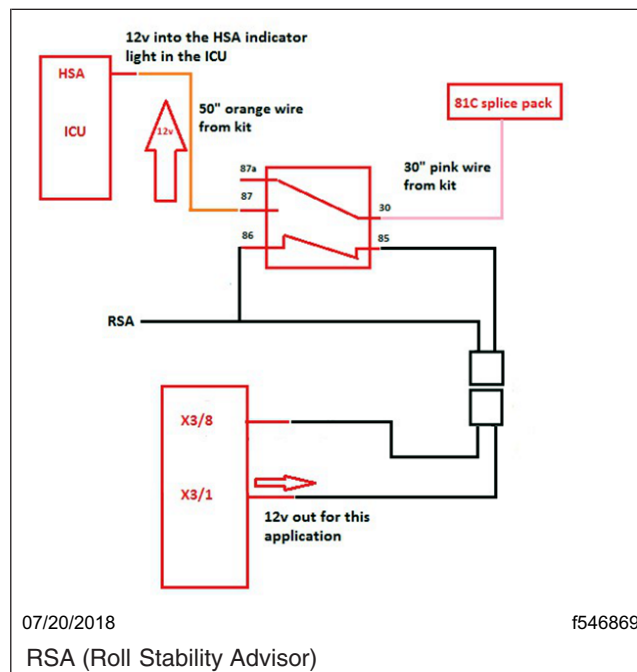
Fig. 1, Correct Wiring After the Procedure

The Hill Start Aid (HSA) telltale is driven by ABS ECU connector 3, pin 1, which is wired to a 120 ohm resistor, circuit 376N. This circuit seeks a grounding path through a splice to circuit 378RS-, which keeps the indicator from flickering during normal operation. Circuit 378RS- terminates at ABS ECU connector 3, pin 8. This input to ABS connector X3, pin 8 through the 120 ohm resistor causes the pin to degrade prematurely, causing the ABS light to self check when the key is turned to the ON position while the ABS solenoids do not self check. When this condition occurs, the ABS and enhanced stability control (ESC) systems continue to operate normally.

Correction of this failure involves installing a relay jumper assembly part number A66-12083-000 in place of the resistor. Use the instructions in this bulletin to install the relay jumper.

See [Fig. 1](#) for a basic schematic of the retrofit with a relay.

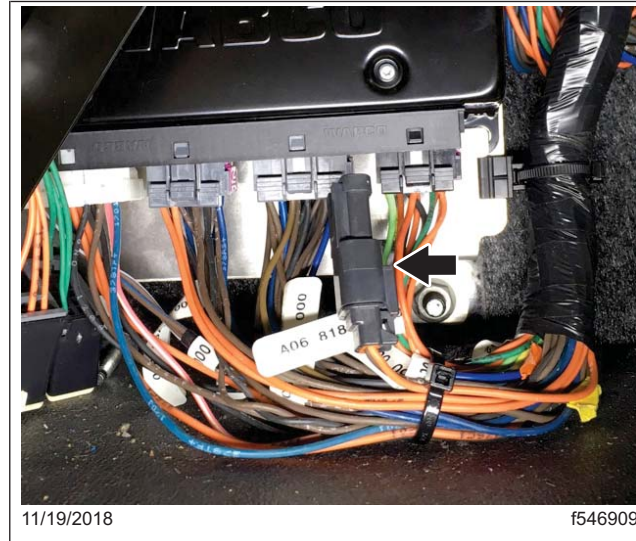
Fig. 4, Resistor Location

NOTE: The resistor will be located near the ABS ECU and is connected to the ABS harness circuit numbers 376N and 378RS.

3. Locate the resistor, remove it from the connector . See [Fig. 4](#).

4. Connect the 2-pin connector of the harness supplied in the kit to the ABS harness where the resistor was just removed.
5. Secure the relay to existing harnesses using tie straps.
