No.: 19 TS-6  
July 15, 2019

FROM: Detroit - Customer Support Center

SUBJECT: **Modified Parked Regeneration Concerns**

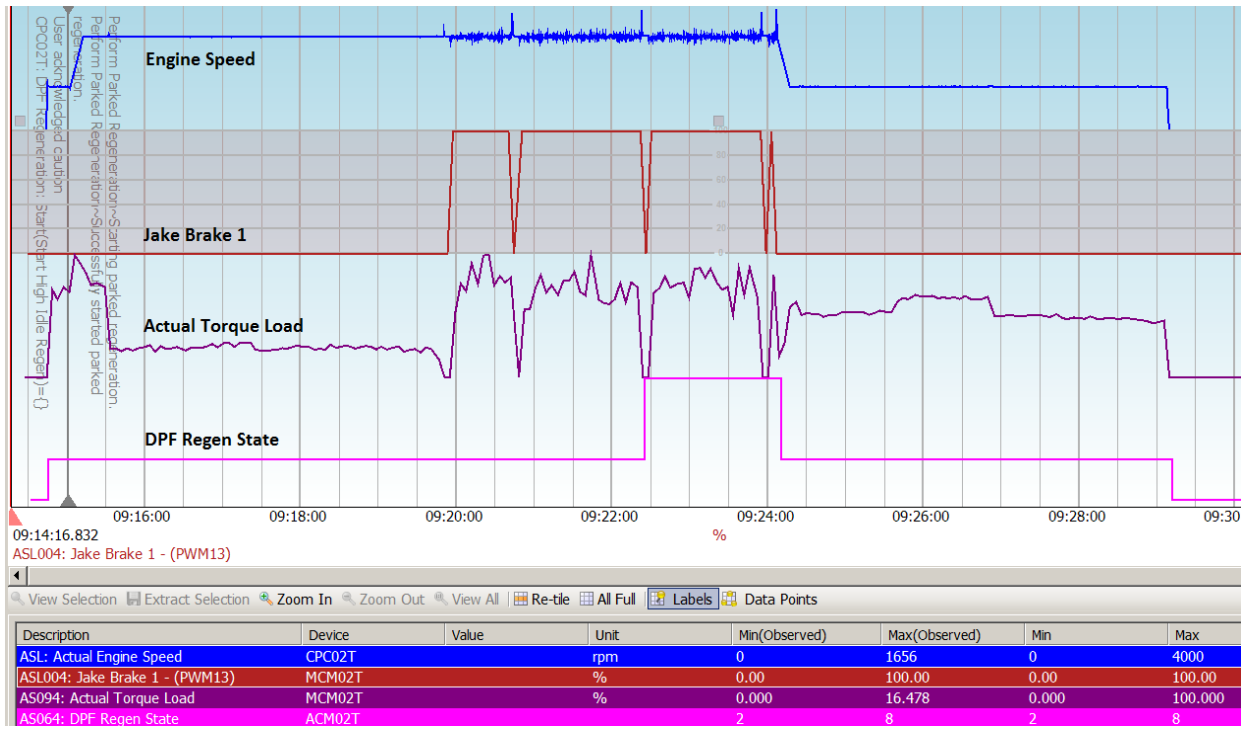
Figure 1

- The engine speed was increased from 1100 rpm and may fluctuate/surge between 1100 and 1300 rpm.
- The front jakes may cycle on and off. See Figure 1.
- Increased exhaust temperature may lead to visible changes in the exhaust manifold. See Figure 2.
- The intake throttle valve, SCR inlet NOx, rail pressure, and several other parameter values may fluctuate. See Figure 3.
- Higher engine speed and increased torque load may cause inlet manifold pressure, EGR flow, and DOC inlet pressure to be slightly higher than previously acceptable values.  
Note: DOC inlet pressure will also be affected by other factors such as Jake brake status, intake throttle valve position, and fan status.
