# Preliminary Information

## PIT4713B (Hybrid) Itch Or Rattle Noise From Center Of Instrument Panel

### Models

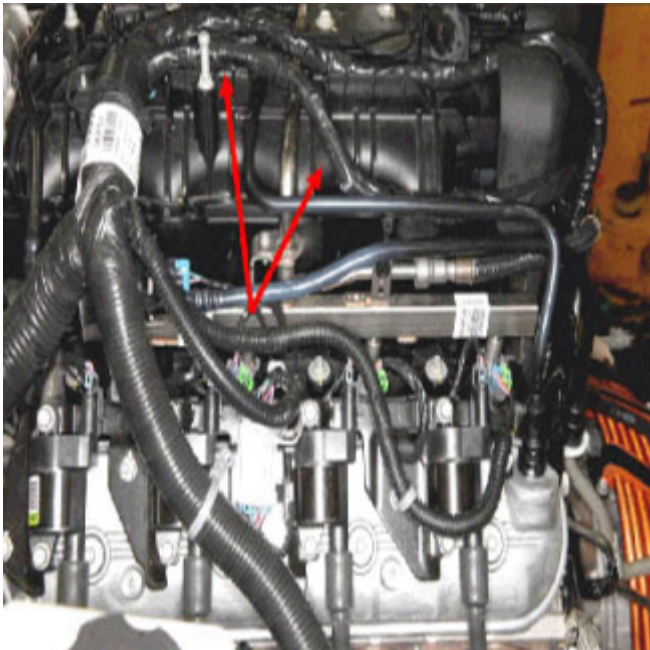
A customer may comment about a rattle, Itch, or tapping type noise from the center of the instrument panel area while driving. The cause may be an engine wiring harness making contact with a dowl pin on the forward bulkhead (Back side of the engine compartment)

If you experience this concern, Please remove the engine cover and locate the engine harness as shown in the photo below.

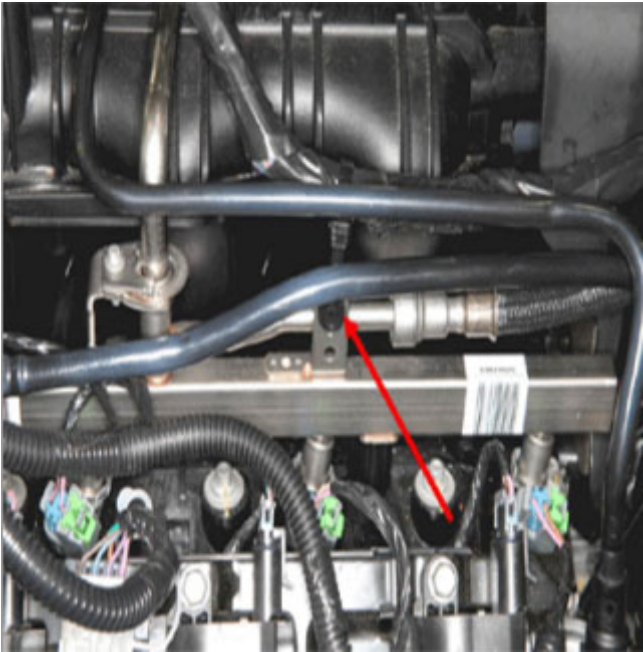
Inspect for a holding clip that secures the engine harness to the fuel line bracket. See Photo Below.

If the holding clip is missing, you will need to get a retaining clip to install.
