PIT5626A Intermittent Communications Concerns - Possible Multiple MIL's on U0073 or Multiple U-Codes Stored

Brand:	Model:	Model Years:	VIN:		Engine:	Transmissions:
			from	to		
Chevrolet	Colorado	2016 - 2019	All	All	LCV	All
GMC	Canyon	2016 - 2019	All	All	LCV	All

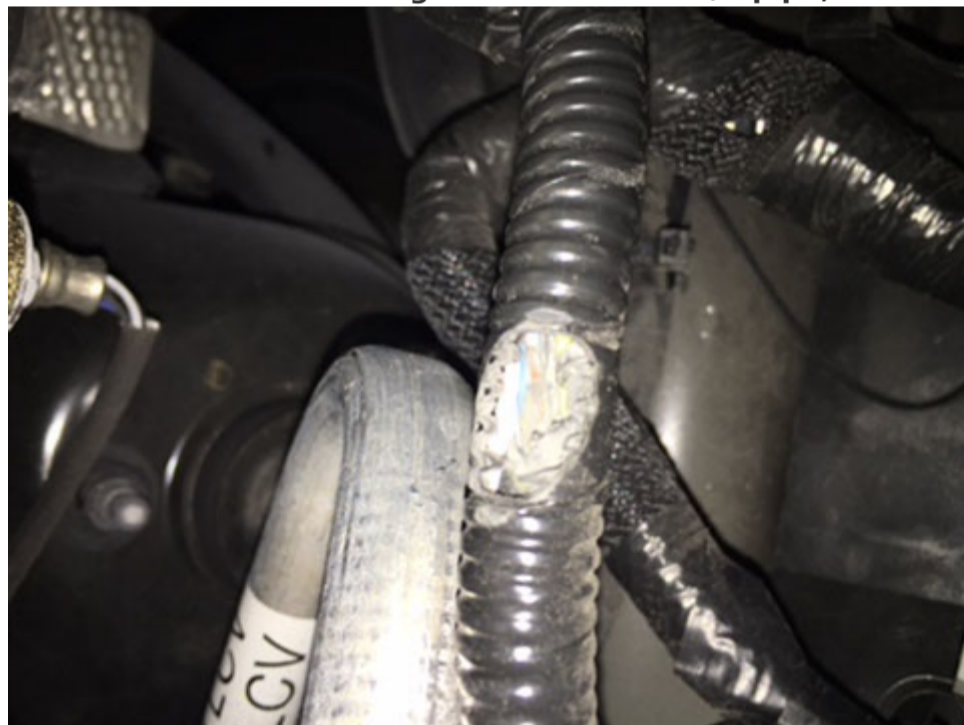
Involved Region or Country:	North America
Additional RPO/s:	LCV
Condition:	Intermittent multiple MIL's or messages, loss of communication, potential U-codes.
Cause:	Main harness chaffed under hood.

Check for harness chaffing on the low side A/C pipe, left side below the exhaust manifold .

Repair per instructions in SI and secure harness away from the pipe.
