# Preliminary Information

## PIT5535D Service Front Camera / Service Lane Departure Warning / Service Lane Keep Assist Message with DTC B1008 SYM4B / IntelliBeam Headlight / Windshield Wind Rush Noise

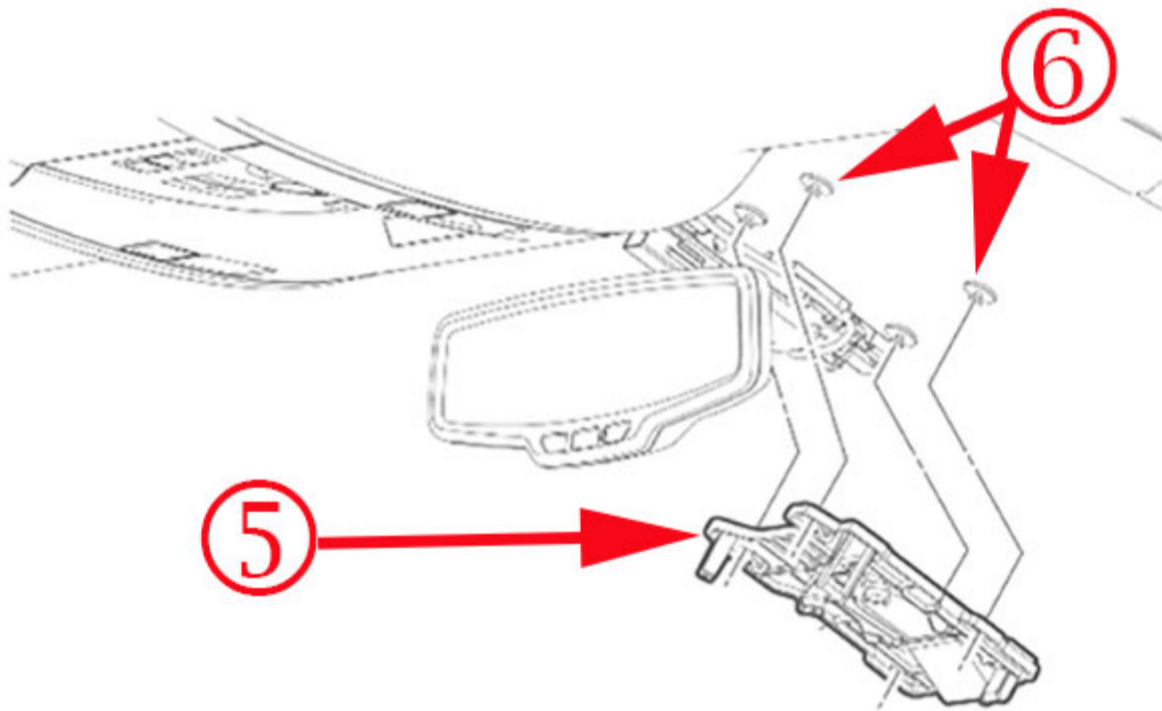
- Verify the front view camera module bracket (5) is fully seated down and secured on the windshield pins (6), shown below.

**Do NOT** replace the Front View Camera Module if it is only setting DTC B1008 SYM4B. Perform the following checks and repair as necessary:

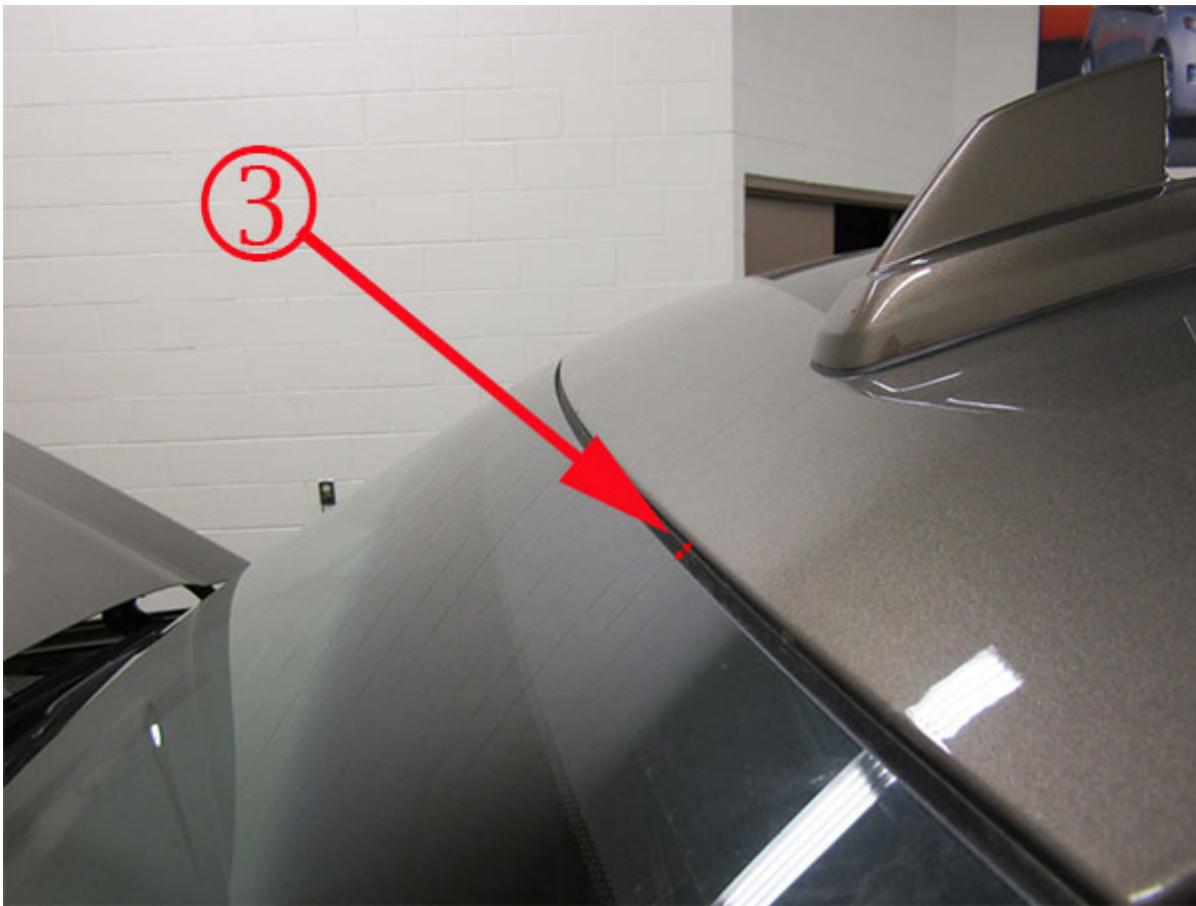
Inspect the gap between the top of the windshield and roof sheet metal (3), shown below. This gap should be 3.6 mm (+/- 1 mm).

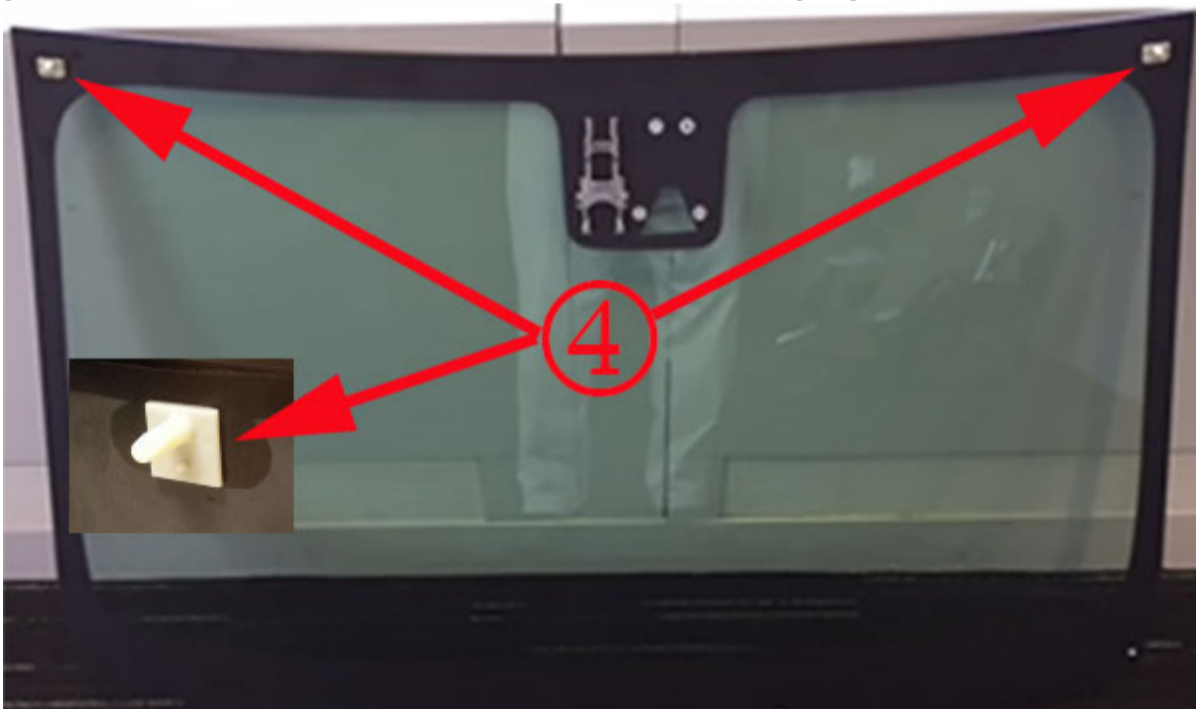
Factory GM windshields use alignment/locating pins (4) in the upper corners of the windshield, which makes it much easier to properly align the windshield to the body opening, shown below. Most aftermarket windshields do not use these alignment/locating pins, which can make it more difficult to ensure a proper installation.

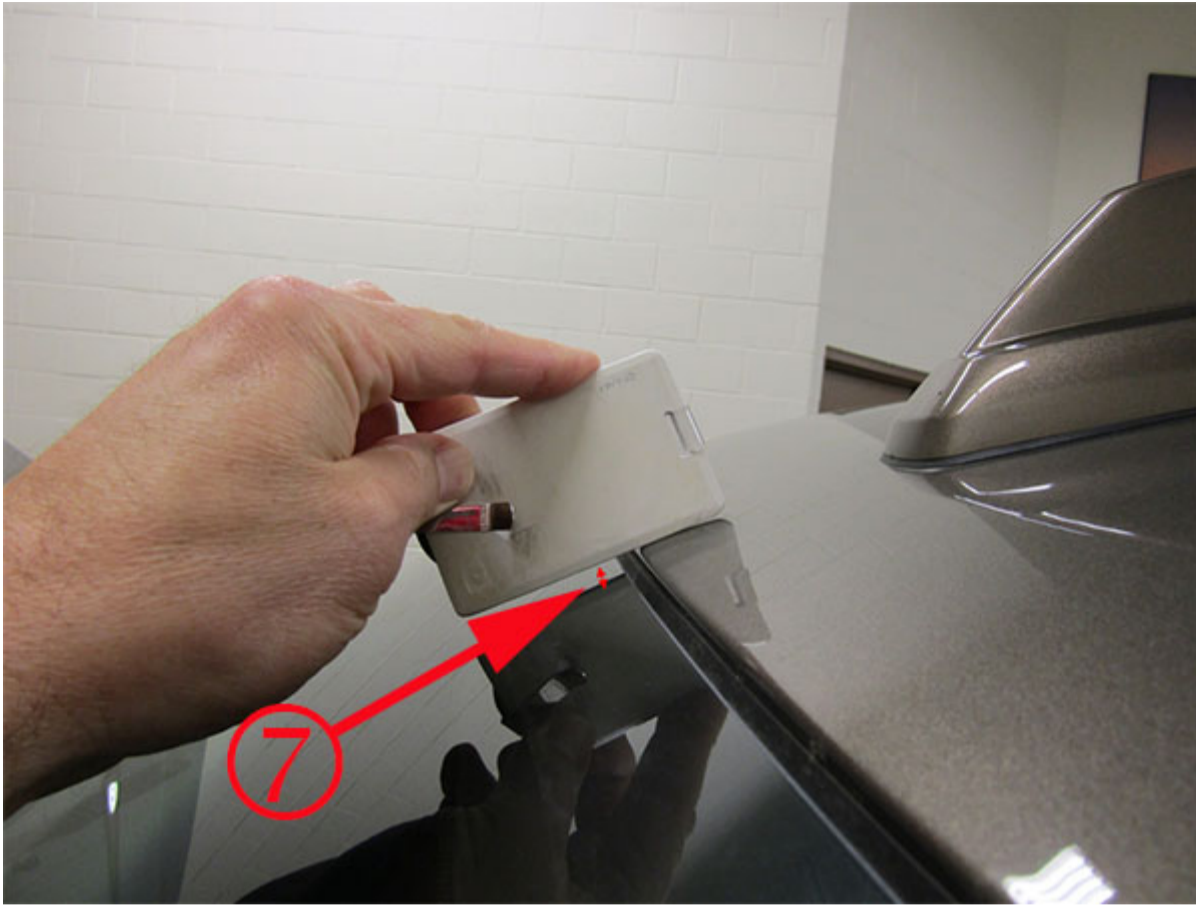
Also, inspect to make sure the windshield is sub-flush to the roof sheet metal (7), as shown below. If the windshield is proud of the roof sheet it could indicate:

- The old urethane adhesive bead was not cut low enough and left excessively thick.
- Windshield alignment/locating pin(s) are not fully in the alignment hole(s).
- During windshield installation it was not firmly pressed around the entire outside edge in order to wet-out the urethane adhesive bead.
- The urethane adhesive bead dried before the windshield was installed.

**NOTE: A windshield proud of the roof sheet metal could cause excessive wind noise.**

Either of these windshield mounting issues could cause the camera to be misaligned and

unable to complete the learn.

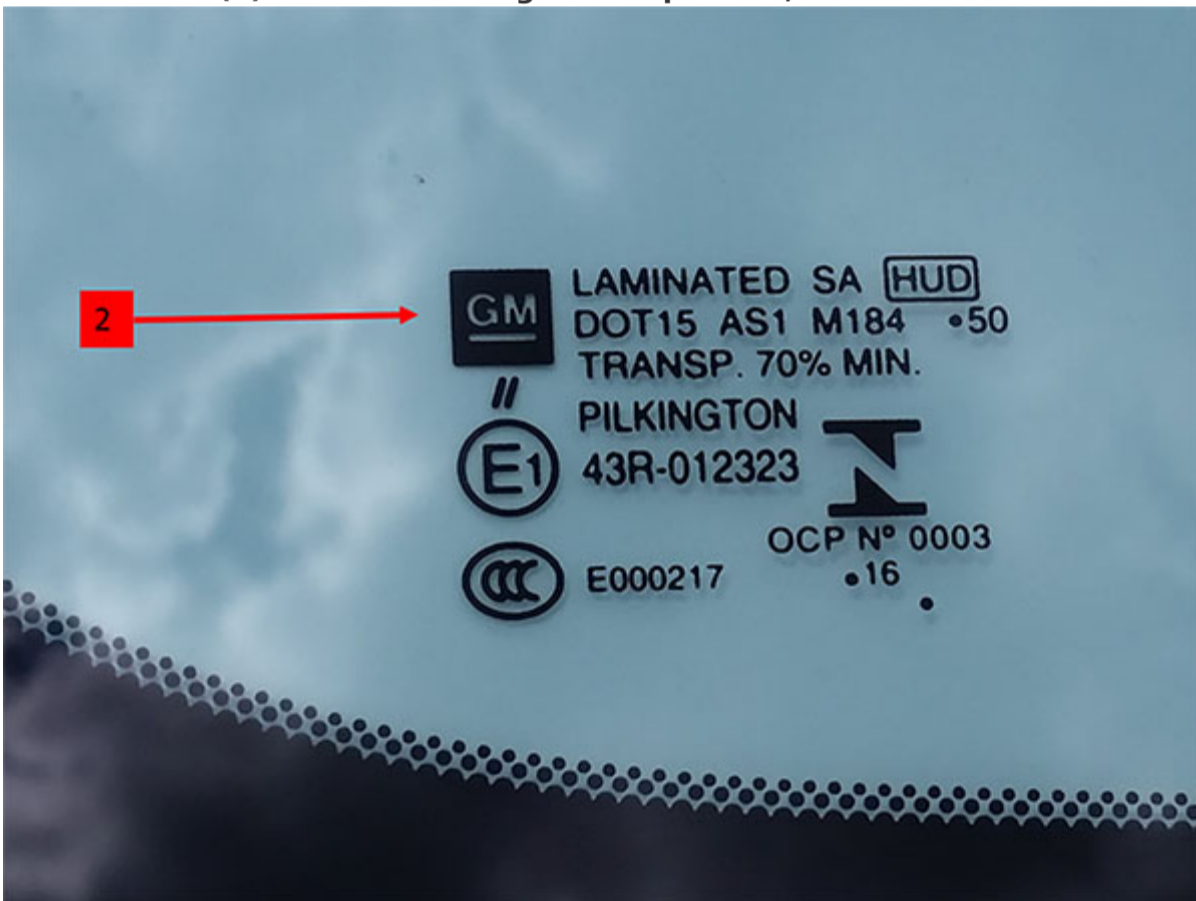
- If, after performing the checks listed above and the root cause of the camera not completing the calibration/learn is still not found, inspect for an aftermarket windshield being installed in the vehicle. To determine whether or not the windshield is an aftermarket or factory windshield, inspect for the "GM" Logo in the lower right corner of windshield, as shown below (2). If the "GM" Logo is not present, then the windshield is aftermarket.

**NOTE: If the windshield has to be removed/replaced for any of the above reasons, it is suggested that a factory GM windshield be installed.**

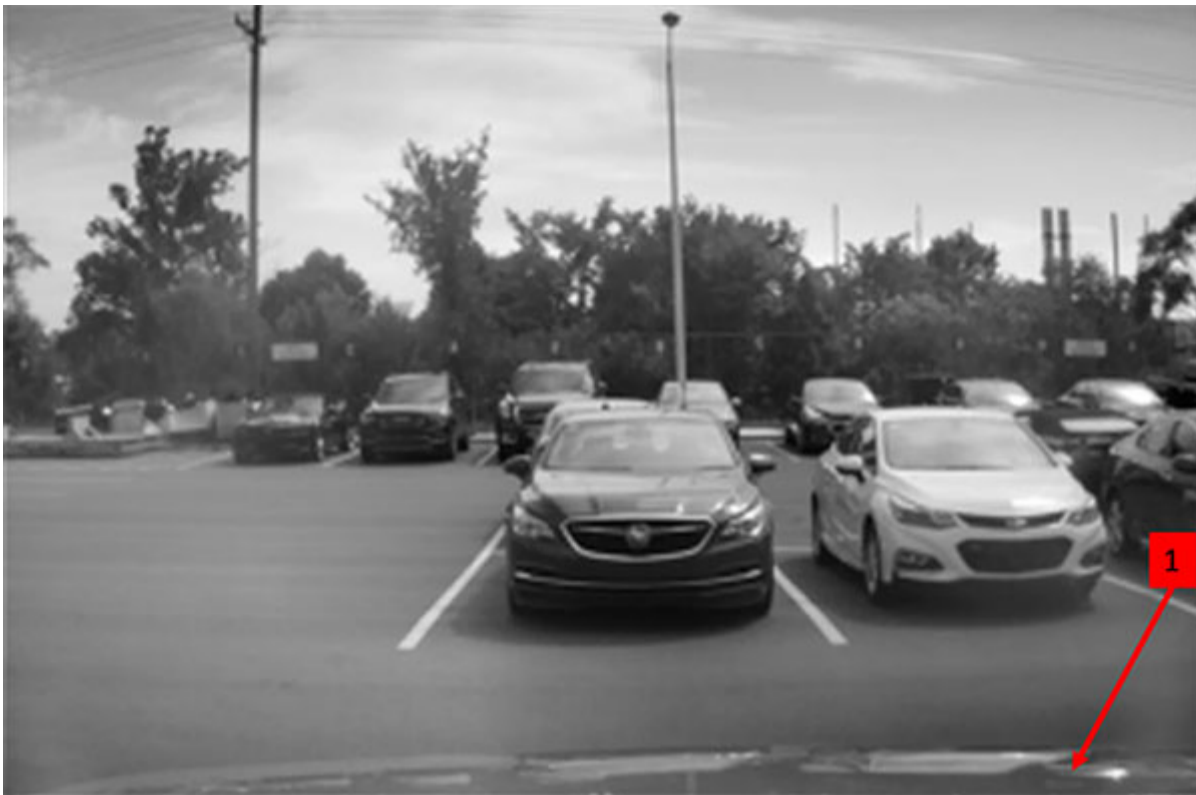
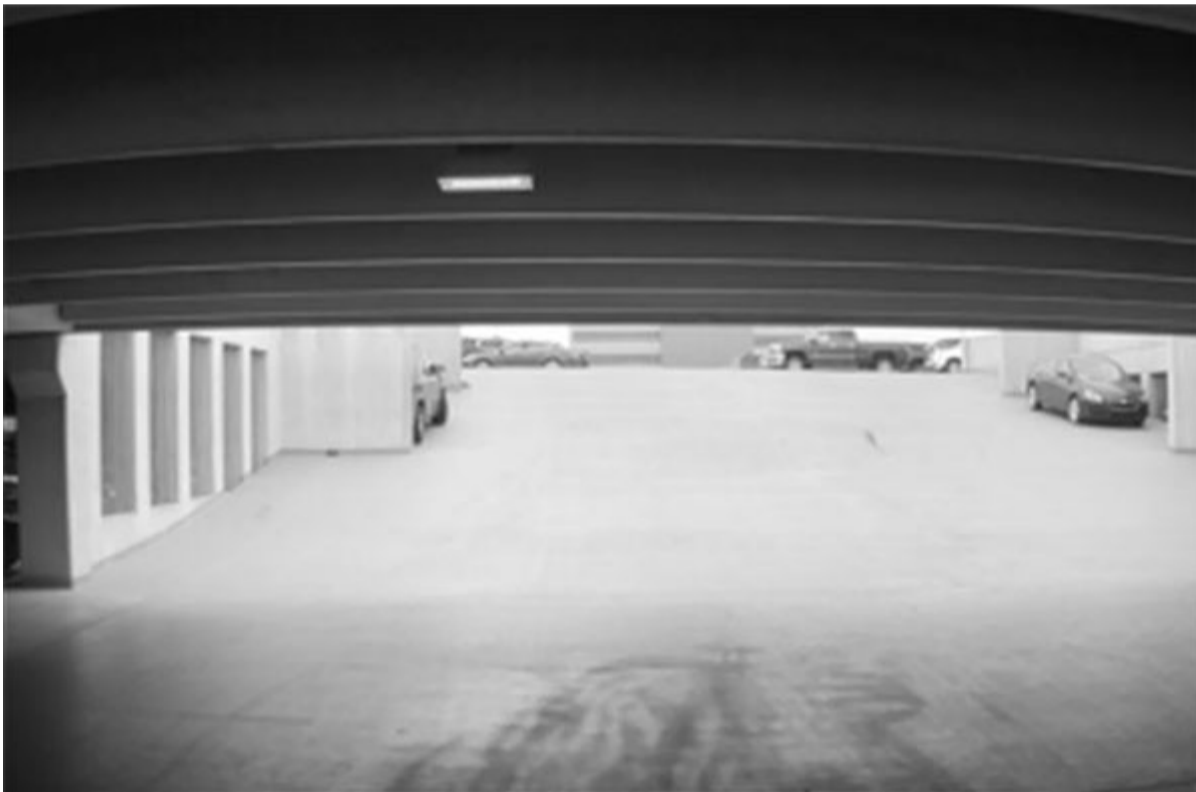
It has been found that some aftermarket windshields do not properly mount/position the front view camera. Shown below are some images, taken with engineering tools (see note below), of what the front view camera is actually seeing. The first image is taken from a truck with an aftermarket windshield. As shown below, the camera is seeing part of the hood (1). Because of this, the camera is not seeing movement in the area of the hood and can not complete the learn. The second image below is from a truck with a factory windshield and there is no hood seen by the front view camera.
