Preliminary Information

PIP5661 2019 2.0 LTG Engine Runs Rough with Malfunction Indicator Lamp (MIL) ON, Low Compression on Cylinder with Misfire, DTC P0300 Set

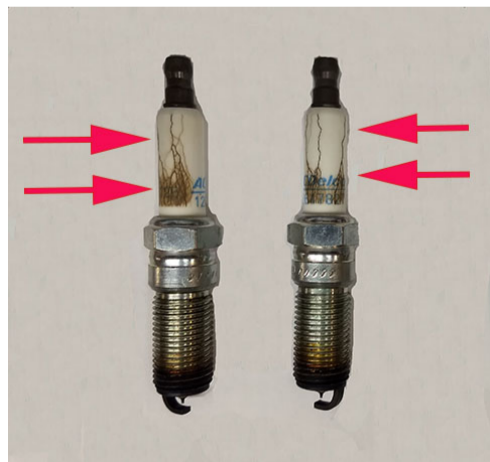
Involved Region or Country	North America
Condition	Some customers may comment on a rough running engine with the Malfunction Indicator Lamp (MIL) ON. Upon inspection, a technician may find DTC P0300 misfire set and may find low compression in one or more cylinders. This condition may be caused by spark plug carbon tracking and/or a crack in a piston located between the piston compression rings.
Cause	The cause of this concern is currently under engineering investigation. This document will be updated as more information becomes available.

Visually inspect all the spark plugs for signs of carbon tracking on the portion of the spark plug being covered by the coil boot.

If any carbon tracking is seen replace all four spark plugs and ignition coils.

Important: Be sure to apply dielectric grease to the spark plug boot as directed in SI for ignition coil replacement.

Apply a thin coating of dielectric grease to the inside of the ignition coil rubber boot, up to a depth of 15 mm from the end of the boot. Refer to Adhesives, Fluids, Lubricants, and Sealers.

Remove any excess grease from around the end of the boot, and ensure there is not an excessive amount within the boot.

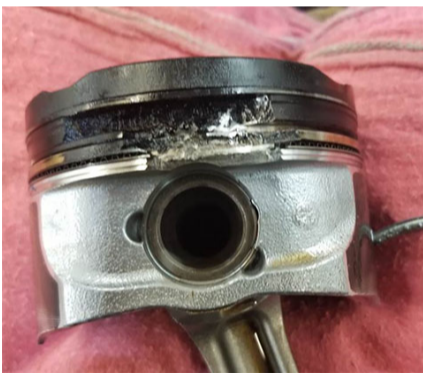
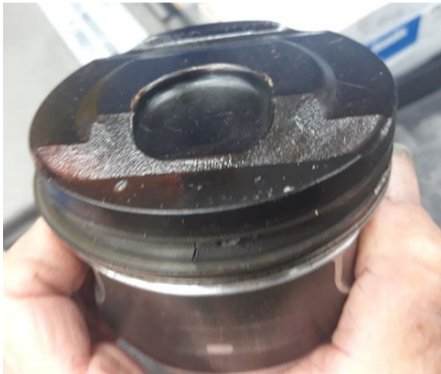
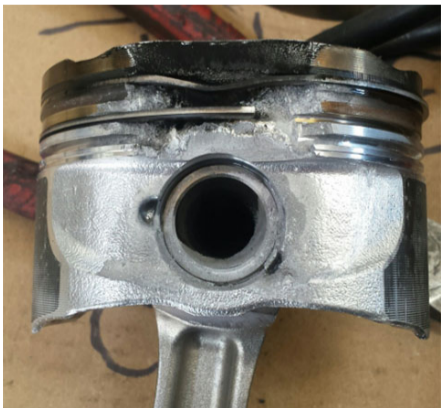
If the cylinder walls are not damaged, remove the pistons and inspect for a fractured piston between the top and second rings.

The pictures below are some examples of what might be found.

If cylinder walls are not damaged and one or more of the pistons are found fractured, replace all four spark plugs, all four ignition coils (apply dielectric grease to the spark plug boots), the fuel injector of the cylinder(s) that had damaged pistons, all four piston kits, all ring sets for all four pistons, all rod bearings, all four connecting rod assemblies and other components necessary when pistons are replaced.

Note: When installing pistons, make sure to use the tapered ring compressor J-43953 special tool. Use care when installing the piston assemblies into the cylinder so the rings are not damaged.
