# Preliminary Information

## PIP4905E Vehicle Will Not Charge DTC P0D26

### Condition / Concern

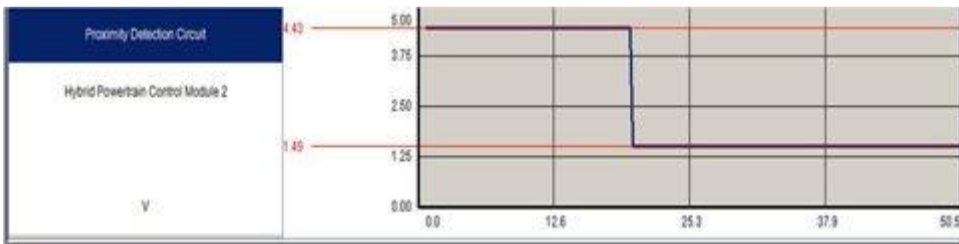
#### Good Signal

- 5) Review the two pictures below. One shows a Proximity signal that is good and the other shows a proximity signal that is erratic.

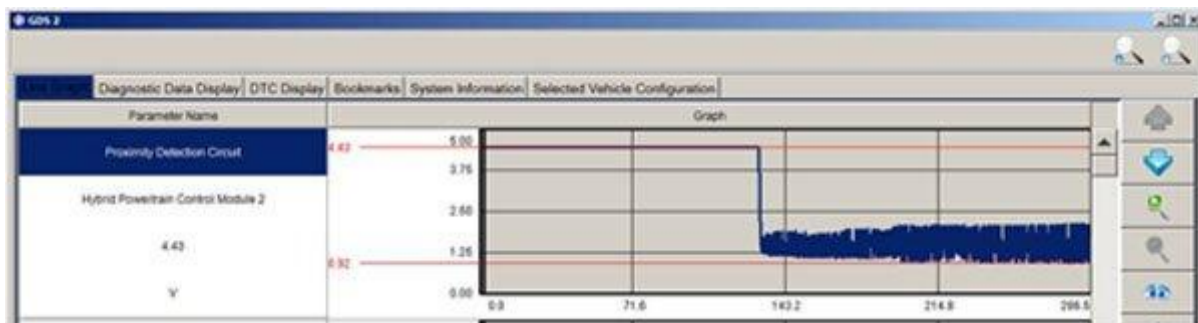
#### Erratic Signal

6) If your snapshot shows the erratic signal above, and/or the condition changes with charge cord coupler ( handle ) manipulation, or the proximity signal does not drop to a steady 1.49 volts it will be necessary to inspect the charge port receptacle and wiring.

7) Inspect the charge port receptacle connector for signs of water intrusion or corrosion in both the vehicle harness side and charge port side. If a concern is found it will be necessary to replace the receptacle and repair the harness as needed.

8) If no water or corrosion is found, test the resistance of all the charge port receptacle circuits to each other while disconnected from the OBCM, the HPCM 2 and the charge port receptacle. All circuits should read open, if they do not inspect the harness or connector for a short.
