SERVICE CAMPAIGN BULLETIN

Classification: EL19-014a	Reference: NTB19-055a	Date: July 23, 2019
------------------------------	--------------------------	------------------------

VOLUNTARY SERVICE CAMPAIGN 2011-2019 LEAF; LITHIUM-ION BATTERY BONDING PLATES

CAMPAIGN ID #: P9312
APPLIED VEHICLES: 2011-2017 LEAF (ZE0)
2018-2019 LEAF (ZE1) with 40 kWh battery only

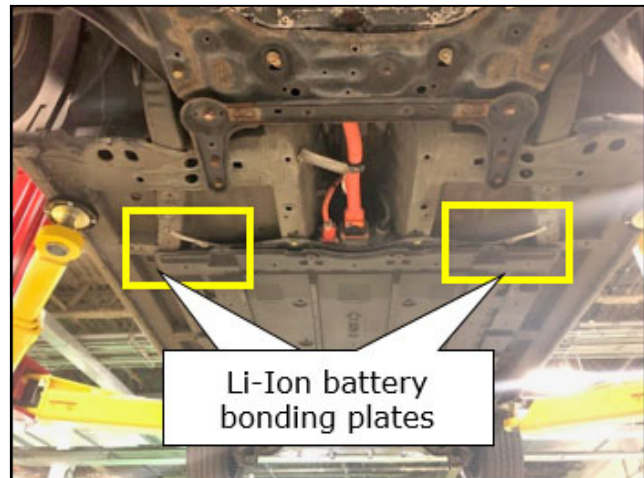
Figure 5

5. Locate the two (2) Li-Ion battery bonding plates connecting the HV battery case to the vehicle body (see Figure 5).
6. Apply rust penetrant to the four (4) bolts of the bonding plates.
 - Allow rust penetrant to set for at least 10 minutes.

9. Install the new bonding plates. See **PARTS INFORMATION** on page 6.
 - Install the new bonding plates using new bolts.
 - Torque the bonding plate bolts to 11 N·m (1.1kg-m, 8 ft lb).

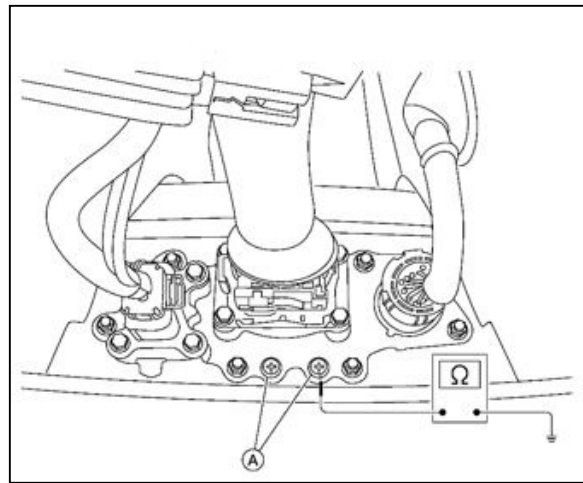
Figure 7

- If the resistance is less than 0.1 ohm, continue to step 11.
- If the resistance is 0.1 ohm or greater, check and correct the following:
 - Conditions of the bonding plate connection.
 - Corrosion on the bonding plate mounting surface.
 - Presence of paint, oil, dirt, or other substance on the bonding plate mounting surface.

For 2013-2019 LEAF, measure the resistance between the body of the battery pack and the vehicle body. See Figure 7.
