Engine Crankshaft Inspection

Reference: PC704

Date: July 17, 2019

PC704 - 2019 – FRONTIER/NV ENGINE CRANKSHAFT INSPECTION

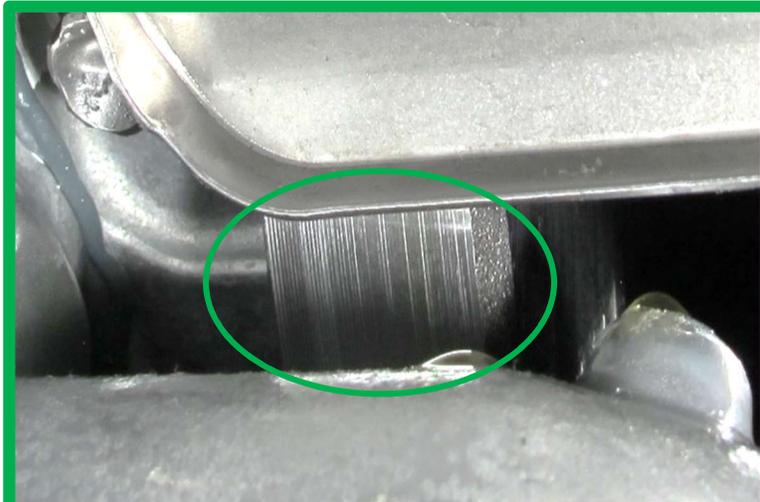
Figure 12 - **OK**

10. Rotate crankshaft pulley clockwise to inspect counterweight machined surface
- Verify the crankshaft pulley is at the 5 o' clock position and rotating to the 7 o' clock position (moving clockwise only) while inspecting the counterweight machined surface
 - **OK condition**-smooth machined surface with no impact marks (Figure 12) reassemble vehicle per the ESM and claim inspection operation code
 - **NG condition**- impact mark(s) located on machined surface area of counterweight when crankshaft pulley notches are between the 5 o' clock and 7 o' clock positions (Figure 13) **continue to step 11**

NOTE: Impact mark is generally within 2" of the end of the counterweight surface.

- Use the attached procedure to inspect the vehicle.
 - If an impact mark **is not** found on the counterweight machined surface, reassemble vehicle per the Electronic Service Manual (ESM).
