CAMPAIGN BULLETIN

VCR Engine Inspection

Reference: PC707

PC707 - 2019 ALTIMA VCR ENGINE INSPECTION

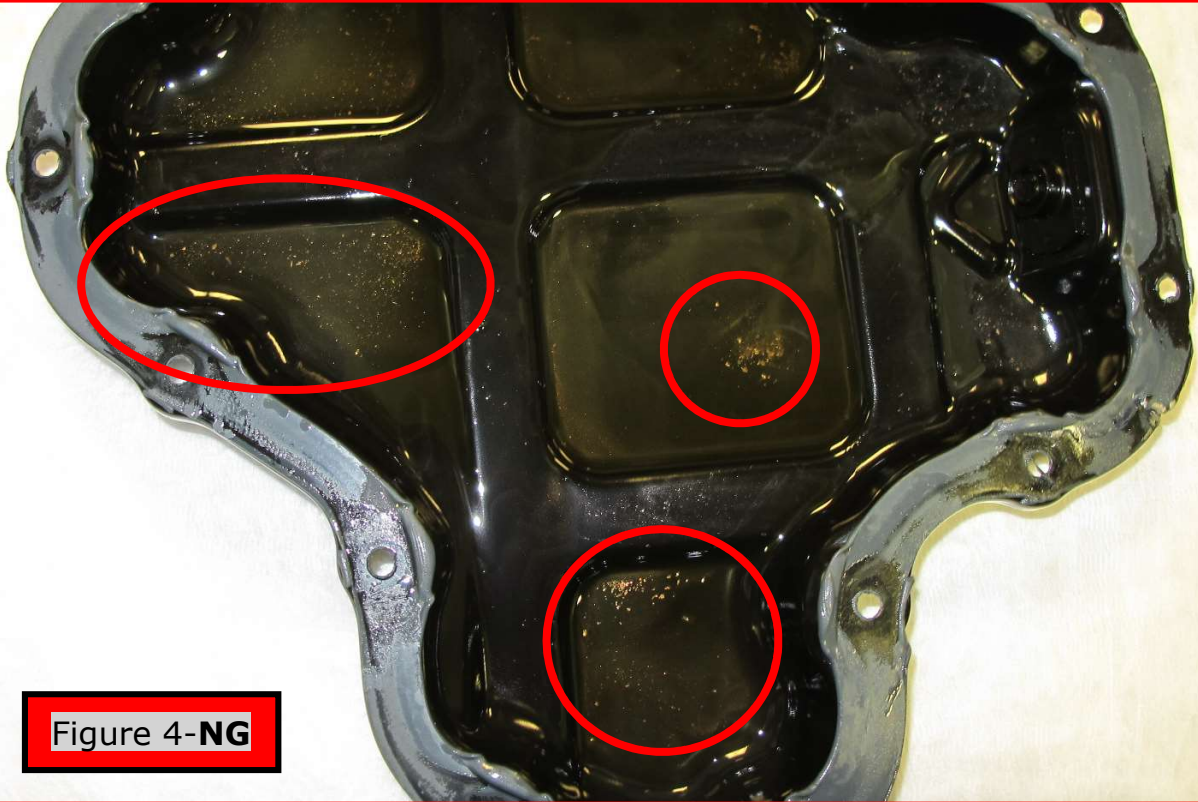
5. Inspect the lower engine oil pan for gold colored debris.
- Any amount of **gold** colored debris in engine oil pan is **NG (Figure 4)**
 - **No debris or black and silver debris** in the engine oil pan for this inspection is considered **OK (Figure 5)**

- If found to be NG continue to Step 7-

7. If **NG condition**, provide a video to FQA using the information below and **HOLD** the vehicle until further notice.

- Take a short video starting at the lower engine oil pan to show debris and move to the VIN certification label
- Video needs to be less than 8mb in size
- Email video to nnafqasupport@nissan-usa.com
 - Make sure to include the below information:
 - E-Mail Subject Line: PC707 Altima VCR Engine inspection
 - Dealer Name:
 - Dealer Code:
 - Dealer Address:
 - VIN:
 - Contact Person Name:
 - Contact Person Phone Number:
