# Replace 2<sup>nd</sup> Generation Front Junction Box to Front Drive Unit High Voltage Harness

<b>Classification</b>	Campaign Bulletin	<b>Section/Group</b>	44 - High Voltage System	<b>Country/Region</b>	All
<b>Year</b>	2019	<b>Model</b>	Model S, Model X	<b>Version</b>	All

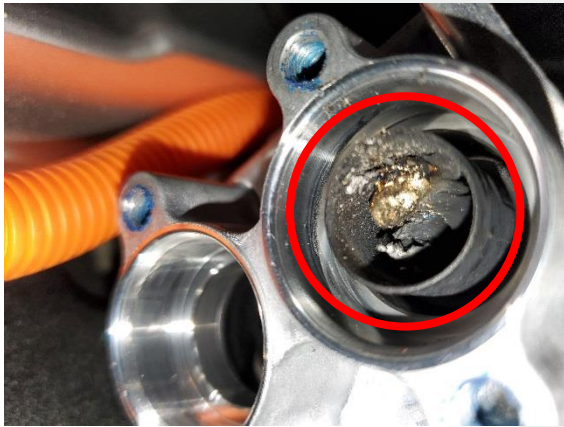
**✘ Figure 1 (Example of damage to the FDU HV connector terminal)**

Replace the 2<sup>nd</sup> generation FJB to front drive unit HV harness. In addition, inspect the connector terminals in the FJB for minor thermal or soot damage. If damage is found, replace the FJB.

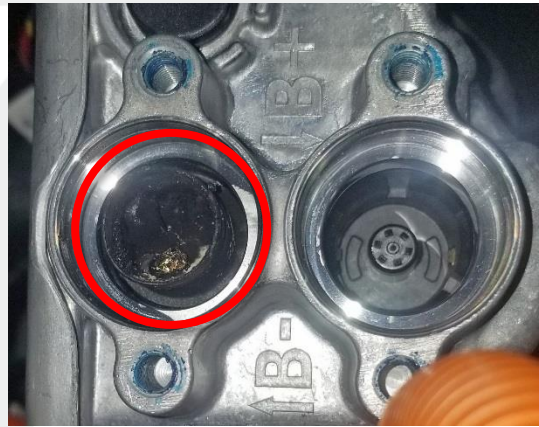
**✘ Figure 2 (Example of damage to the FDU HV connector terminal)**

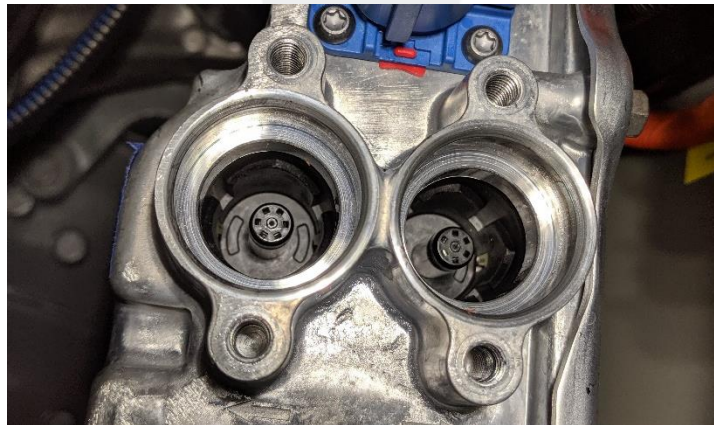
**✔ Figure 3 (Example of undamaged FDU connector terminals)**
