# Replace 1<sup>st</sup> Row Seat Lift Link Pivot Bolts

<b>Classification</b>	Repair Bulletin	<b>Section/Group</b>	13 - Seats	<b>Country/Region</b>	All
<b>Year</b>	2017-2019	<b>Model</b>	Model 3	<b>Version</b>	All

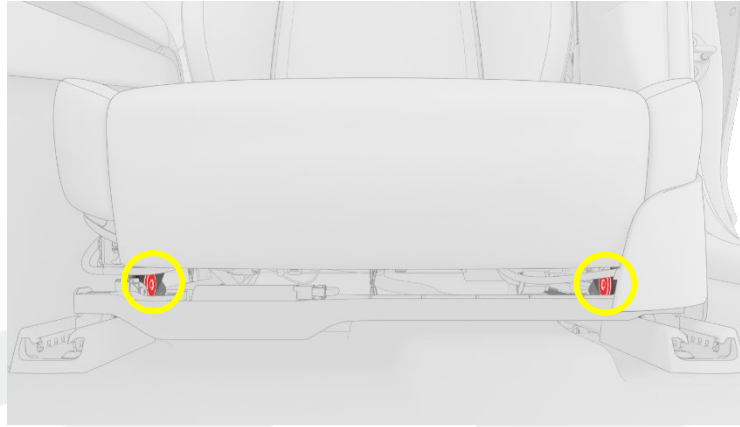
**Figure 1 (Inboard and outboard lift link pivot bolt areas)**

2. Use a flashlight to look from the 1<sup>st</sup> row footwell and visually inspect the outboard and inboard lift link pivot bolt areas under the LH 1<sup>st</sup> row seat (Figure 1).

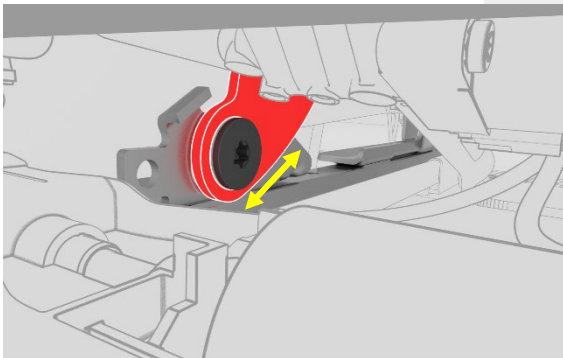
**Figure 2 (Inboard lift link movement)**

3. While an assistant manually rocks the seat back fore and aft, determine if there is movement in the outboard and inboard lift links (Figure 2, Figure 3, and Video 1).
  - If there is lift link movement, the pivot bolt for that link is affected and must be replaced.
  - If there is no lift link movement, the pivot bolt for that link does not need to be replaced.

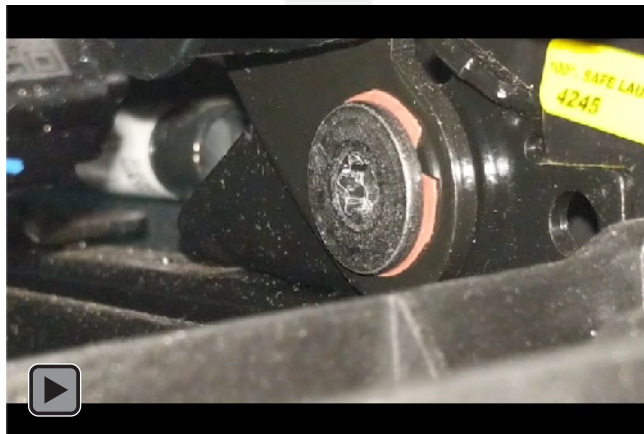
**Video 1 (Subtle lift link movement)**

**NOTE:** The lift link movement is subtle, and it might be necessary to raise or lower the seat cushion to amplify the movement (Video 1).
