# Technical Service Bulletin

**01 MIL on, DTC P20E8, P249C, and/or P218F are stored in the ECM or AdBlue residue is found on the injector**

01 19 20 2044927/2 August 7, 2019. Supersedes Technical Service Bulletin Group 01 number 16-70 dated July 27, 2016 for reasons listed below.

Model(s)	Year	VIN Range	Vehicle-Specific Equipment
A3	2015	All	TDI

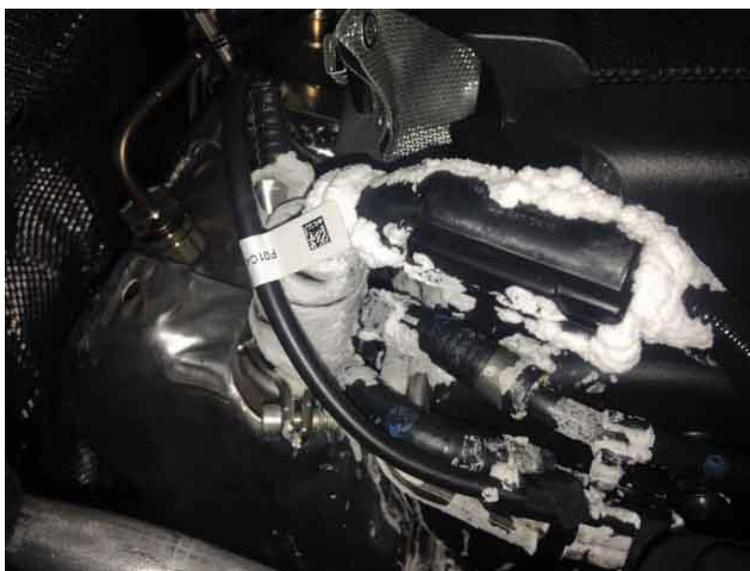
- Leaking AdBlue and/or dried residue may be noticeable under the hood near the AdBlue injector.

AdBlue supply lines may have a quality deviation that causes a leak near the AdBlue injector.

*Figure 1. Evidence of leak—AdBlue residue.*

1. Before replacing the pump or performing additional diagnosis for these faults, verify if any signs of leakage are found near the AdBlue injector.
2. If any leakage is found (Figure 1), replace the AdBlue supply line according to the Elsa Repair Manual and check system operation.

Dried AdBlue residue on any additional components can be cleaned off with warm water and a soft brush and allowed to air dry.
