Technical Service Bulletin

91 SOS warning displayed in instrument cluster, DTC B105313 stored in the data bus on board diagnostic interface

91 19 75 2048360/5 August 7, 2019. Supersedes Technical Service Bulletin Group 91 number 18-93 dated April 26, 2018 for reasons listed below.

Model(s)	Year	VIN Range	Vehicle-Specific Equipment
Q7	2017	037860 - 999999	With connected gateway
Q7	2018	All	With connected gateway

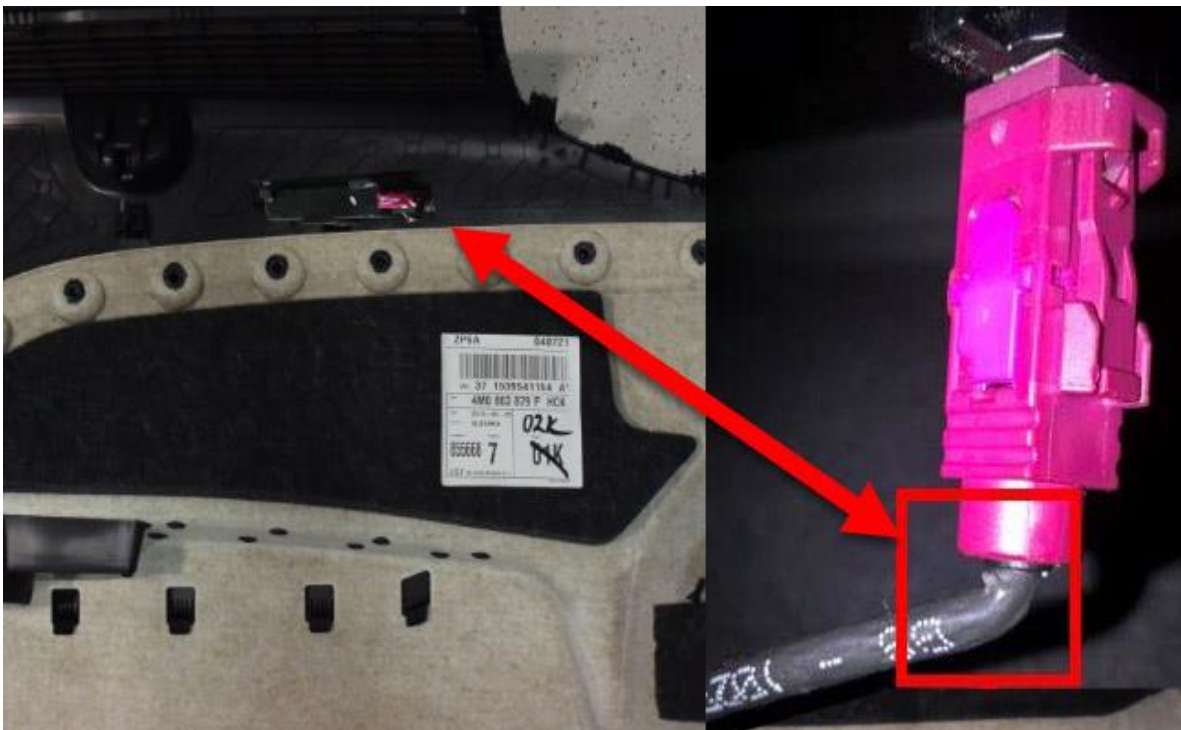
1. If **DTC B105313** (GSM antenna Open circuit) is **NOT** found in the data bus on board diagnostic interface, J533 (address word 0019), then this TSB does not apply.
2. Inspect the coaxial wiring at the SOS Antenna (R263):
 - Remove the left luggage compartment side trim panel. Refer to the repair manual.
 - Perform a visual inspection of coaxial wiring, if wiring is under tension or kinked (Figure 2), continue with TSB.

Figure 2. Coaxial wire kinked at R263 SOS Antenna.

3. Repair existing coaxial harness:
 - Unplug the FAKRA connector from the R263 SOS Antenna.
 - Remove 250mm (9 3/4 inches) of coax wire from the existing harness. Measure from the front of the FAKRA connector (Figure 3).

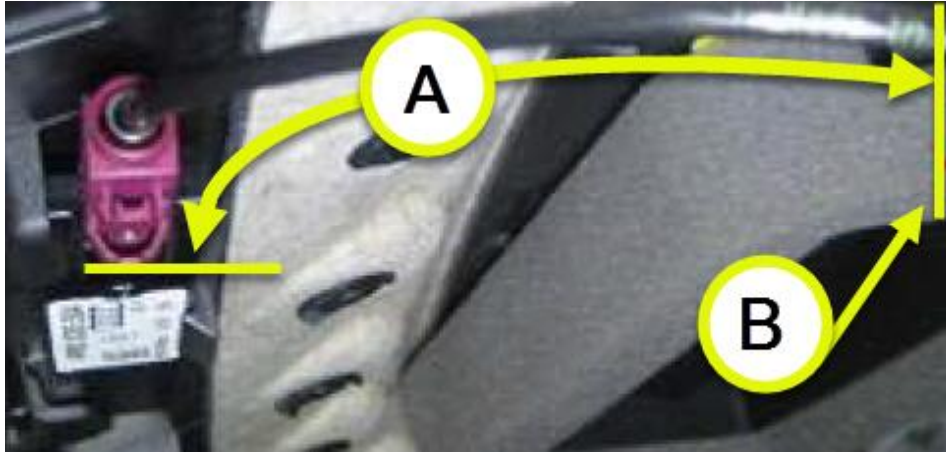
Figure 3. Cut the coaxial harness (B) 250mm (9 3/4 inches) (A) from the start of the Fakra connector.

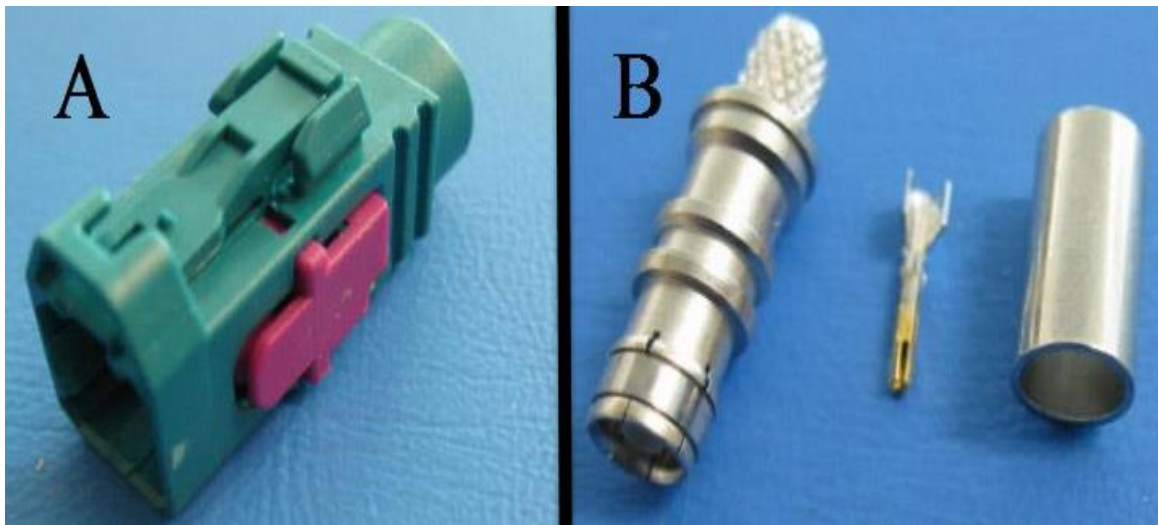
Figure 4. A: Fakra Housing 6Q0035576K, B: Fakra Terminal: 000979910.

- Using the VAS 6720, install a new female FAKRA Terminal (Figure 4B) onto the vehicle's coaxial harness. Install a new Fakra Housing (Figure 4A) onto the newly installed terminal.

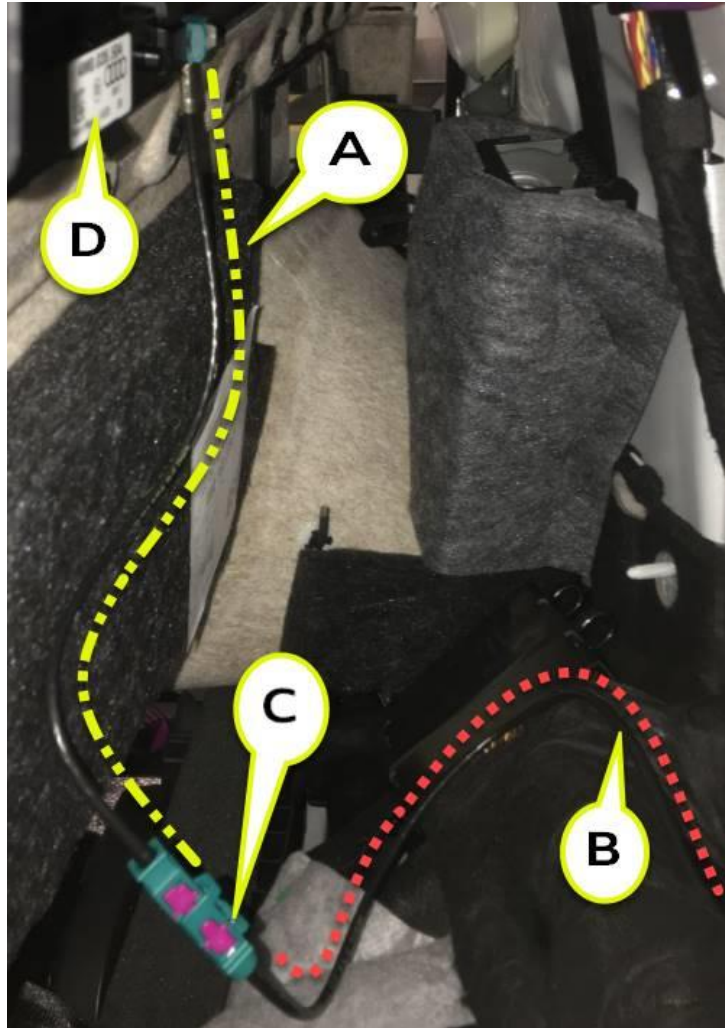
Figure 6. Modified R263 antenna wiring. A: Right Angle Adapter Antenna Cable 000098710A. B: Vehicle Coax Harness. C: New FAKRA connector. D: R263 SOS Antenna.

- Install the right angle adapter antenna cable (Figure 5) between the newly installed Fakra connector from step 3 and the SOS antenna. Re-install all components.
- See Figure 6 for optimal wire routing path.

Tip: The cable must be free of tension around the area of the connector.
