Technical Service Bulletin

96 Adaptive light, pre sense malfunction or unable to calibrate, DTC C12B3F0 is stored in the driver assist module

96 19 41 2054765/1 August 5, 2019.

Model(s)	Year	VIN Range	Vehicle-Specific Equipment
Audi e-tron quattro	2019 - 2020	All	With multifunction camera

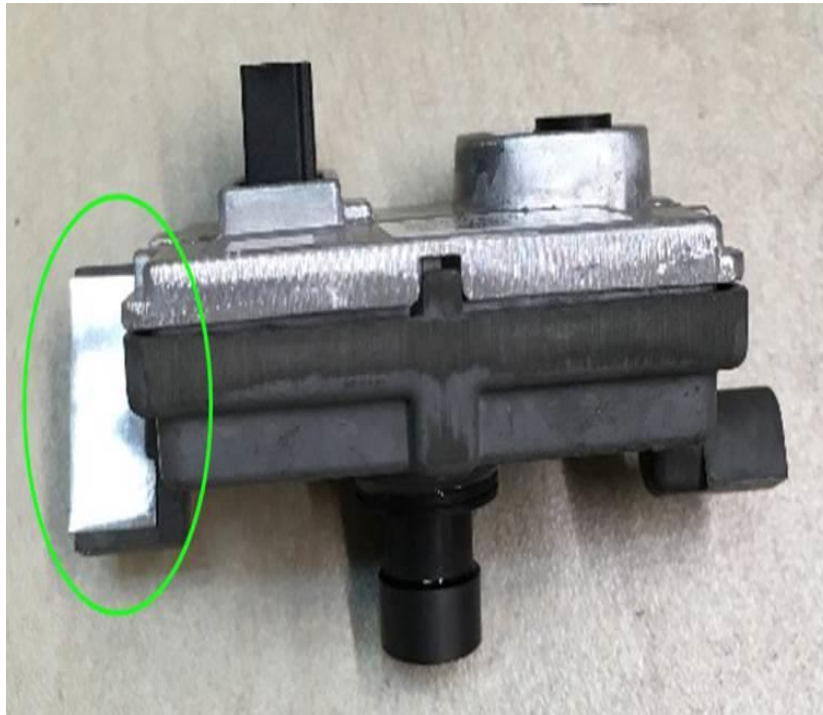
Figure 1. How to correctly attach the aluminum adhesive foil on the front camera for assistance systems -R242-.

1. Check whether an aluminum adhesive foil (part number **4K0 907 231 MTR**) with the dimensions 17mm x 7mm x 0.35 mm (length x width x height) is affixed to the front camera for assistance systems - R242- (Figure 1). It is needed to secure the front camera for assistance systems - R242- in the bracket.

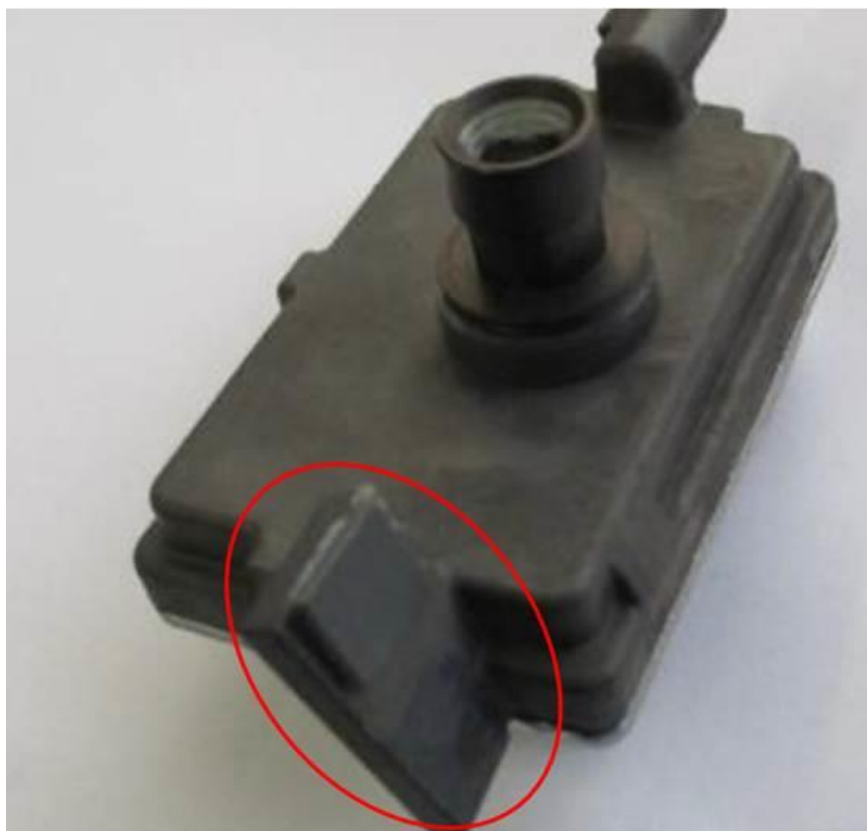
Figure 2. Incorrect attachment of spacer.

2. Install the aluminum spacer if it was missing or a spacer with other dimensions is fitted. Remove the old spacer and the adhesive residue from the front camera for assistance systems - R242- (Figure 2).

Be careful to prevent damage to the front camera for assistance systems -R242- when removing the adhesive residue.
