Technical Service Bulletin

Subject: CHECK ENGINE LIGHT ON WITH DTC P0012:00	Bulletin No.: 01-014/19
	Last Issued: 08/01/2019

APPLICABLE MODEL(S)/VINS

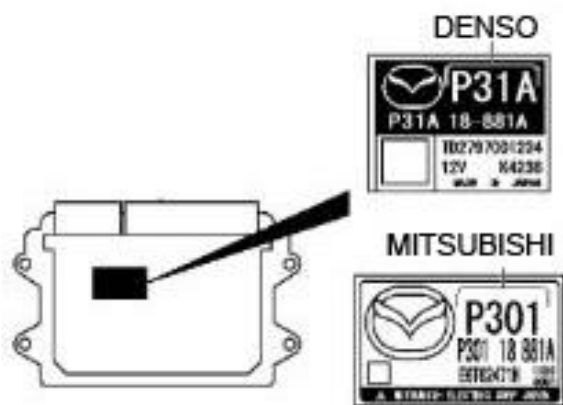
PCM Identification

NOTE: This concern occurs only on vehicles with PCMs manufactured by MITSUBISHI.

Due to improper control logic of the PCM, a false error may be detected. To eliminate this concern, the PCM software has been modified.
