Subject: N192210230 - Special Coverage
Camshaft Cover Replacement

Models: 2015-2016 Chevrolet Cruze
2015 Chevrolet Sonic
Equipped with 1.4L 4 Cyl. turbo (RPO LUV)

Special Coverage Adjustment

N192210230 – Camshaft Cover Replacement

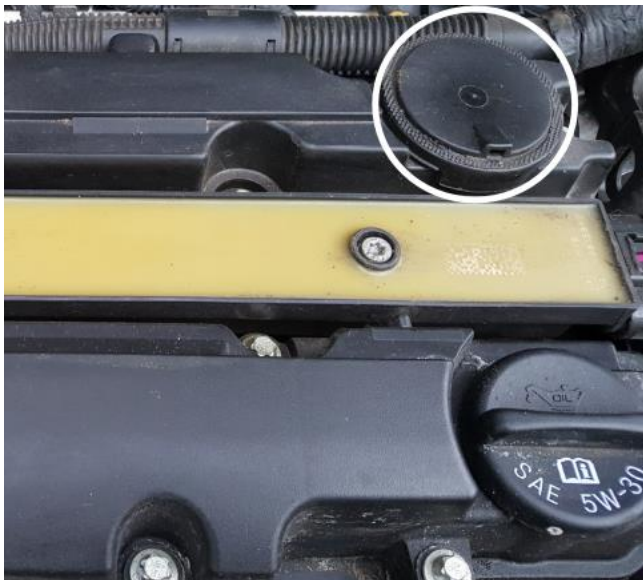
5354610

- 2.3 With the engine running, listen for noise coming from the PCV valve, shown above. If noise is heard, check to see if the noise gets quieter or disappears with the engine oil dipstick removed.
- 2.4 Reinsert the dipstick.

2.5 Check to see if there is vacuum at the PCV vent at the front of the PCV valve by placing a piece of tissue near it. The tissue will be sucked against the vent and held if vacuum is present.

- If the PCV valve is making noise and there is vacuum present at the PCV valve vent, replace the Camshaft Cover. Refer to *Camshaft Cover Replacement* in SI.
- If the PCV valve does NOT make noise or leak vacuum, no further diagnosis or repair is covered under this special coverage. Claim diagnostic time and inform the customer that any further diagnostics or repair will have to be covered by customer pay, warranty, or good will.
